**ASTM E2018-24 PROPERTY CONDITION ASSESSMENT REPORT (PCR)**

**Commercial Building  
550 West 25th Street  
New York, New York 10001**

**Project Number:  
26.01121.10**

**Conditions as of:  
February 6, 2026**

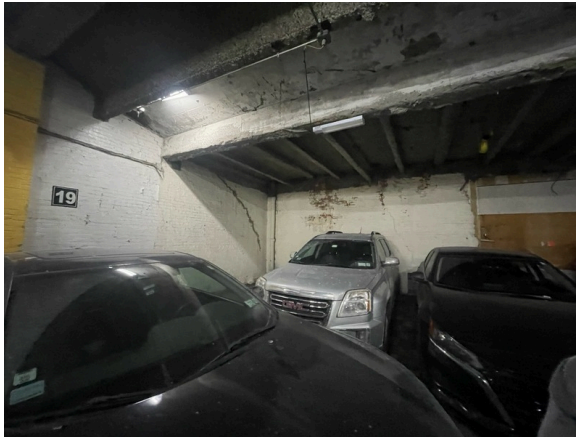
The building is comprised of poured concrete, brick masonry and structural steel. Walls and floors appeared plumb and level, respectively. LCS observed moderate cracking through the brick masonry, potential evidence of water infiltration and damaged concrete along support columns. LCS recommends a structural assessment to be completed to determine the significance of the cracking. Immediate costs have been included for the assessment, with additional costs warranted as determined by the structural engineer to complete the necessary repairs.

Cracking observed to brick masonry walls

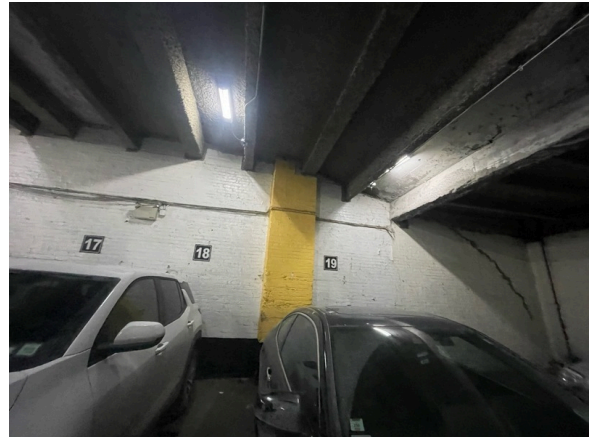
Cracking observed to brick masonry walls

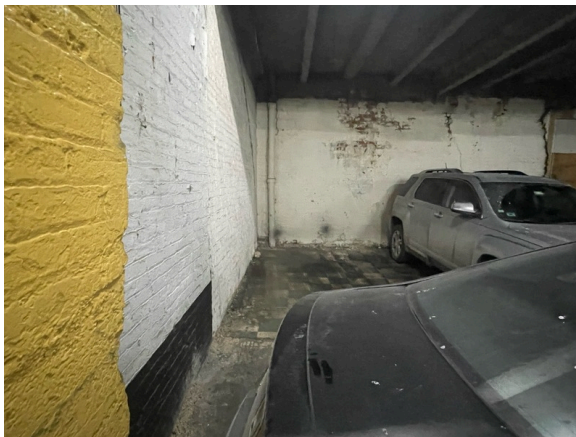
Cracking observed to brick masonry walls

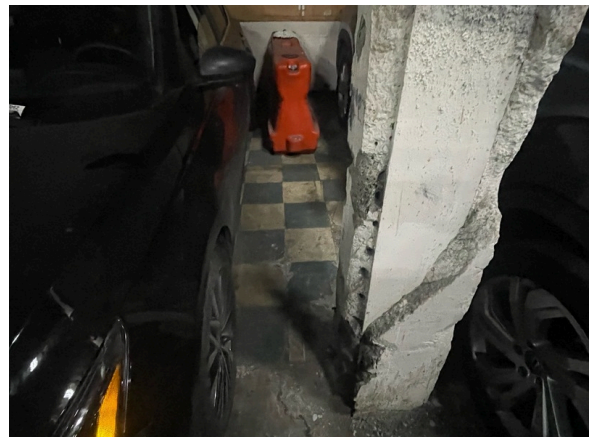
Damaged concrete on support columns

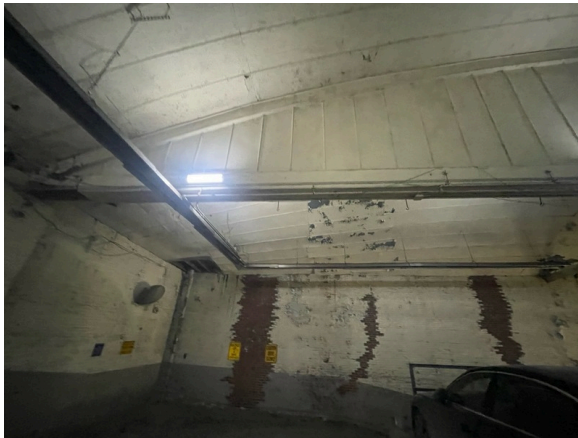
Potentially previous damaged brick masonry

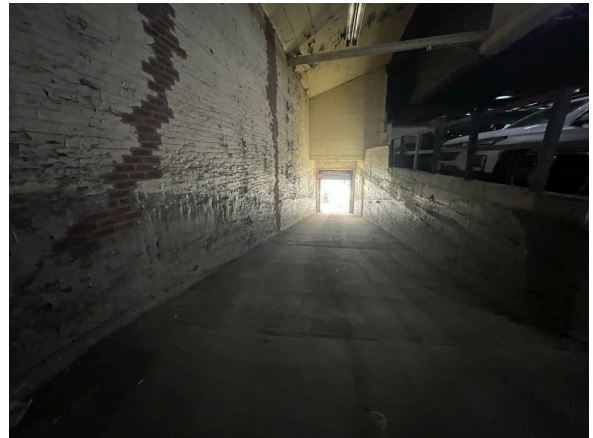
Potentially previous damaged brick masonry

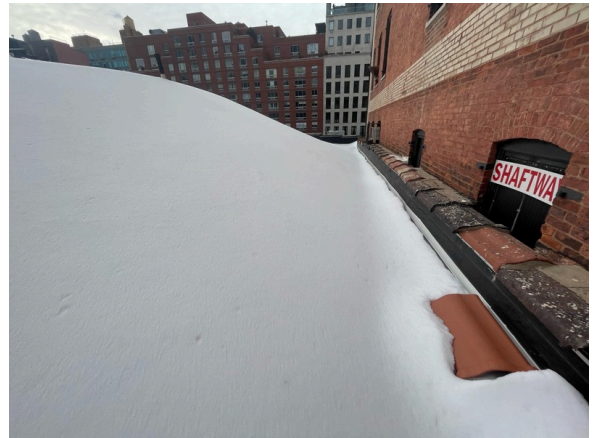
8. LCS observed moderate damage to the parapet wall clay tile coping along the perimeter of the roof. LCS recommends that these areas be repaired to prevent further degradation, a cost for this work has been included.

Damaged Coping

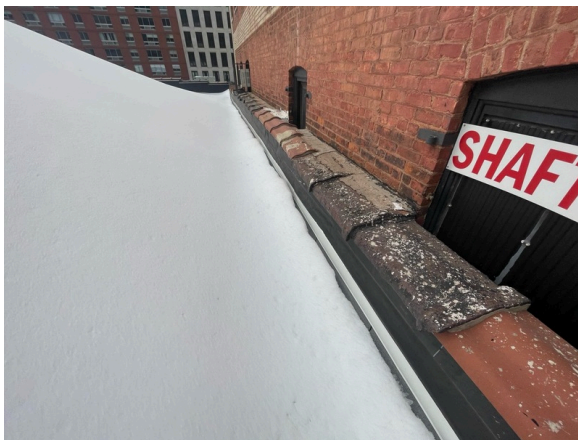
Damaged Coping

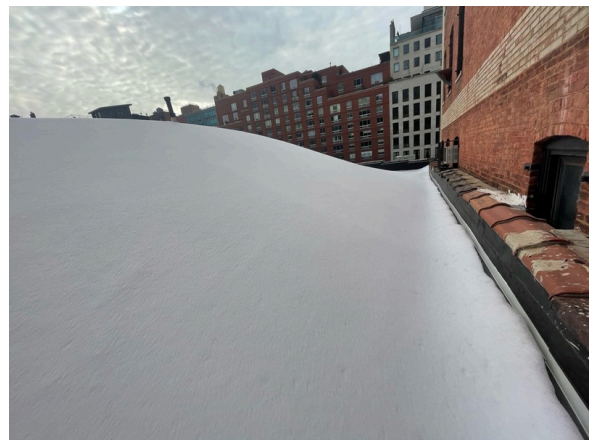
Damaged Coping

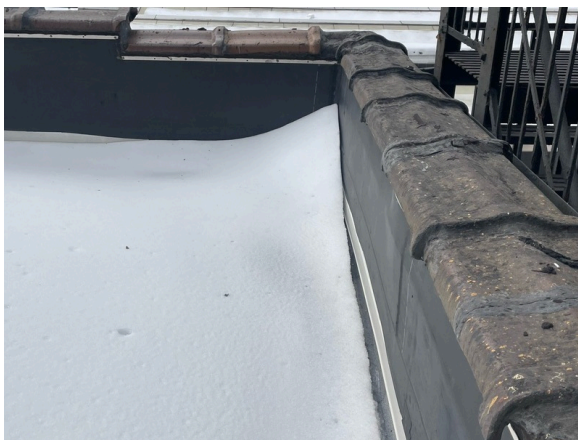
Damaged Coping

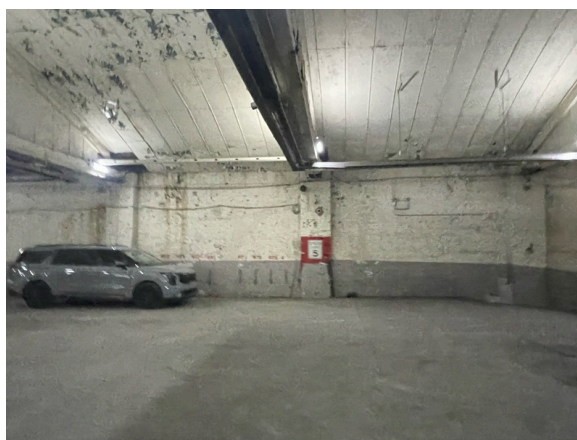
9. The building utilizes four ceiling mounted radiant heaters. At the time of inspection, the units were non operational. LCS recommends that the units be replaced, a cost for this work has been included.

Radiant Heaters

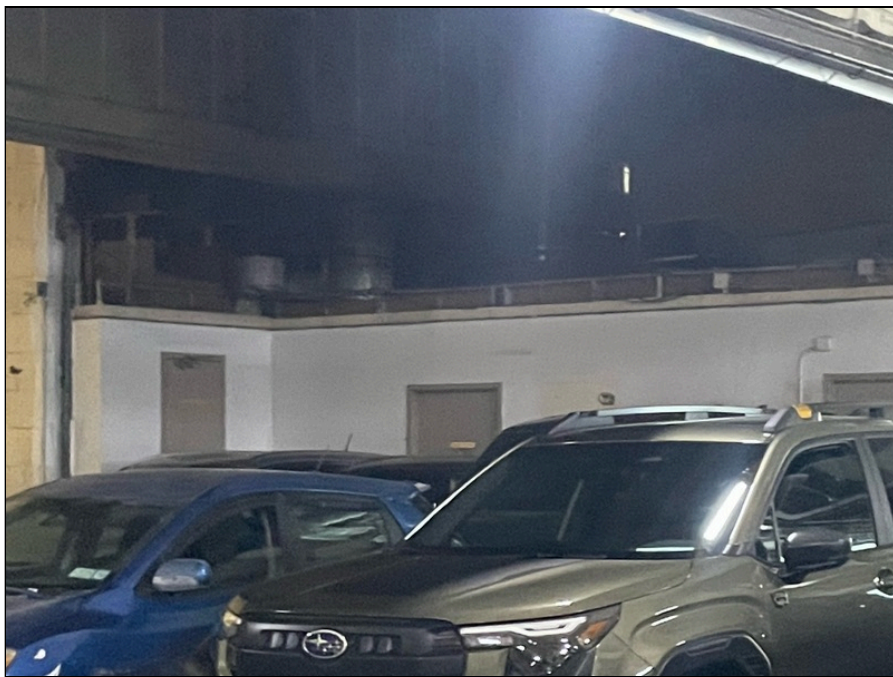
10. Domestic hot water is provided by three 5-gallon electric storage tank water heaters. The units were non operational at the time of inspection and was reported that the building does not have hot water. LCS recommends these units be replaced. The cost to replace these units is below the \$3,000 reporting threshold, as such, no cost has been included.

**Photo 136:** Hot water heaters, second floor
