**ASTM E2018-24 PROPERTY CONDITION ASSESSMENT REPORT (PCR)**

**Commercial Building  
550 West 25th Street  
New York, New York 10001**

**Project Number:  
26.01121.10**

**Conditions as of:  
February 6, 2026**

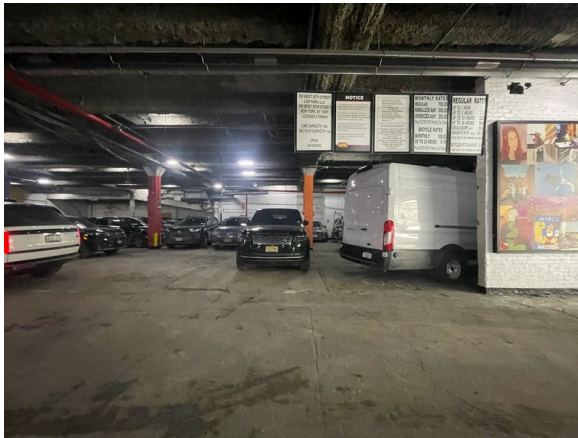
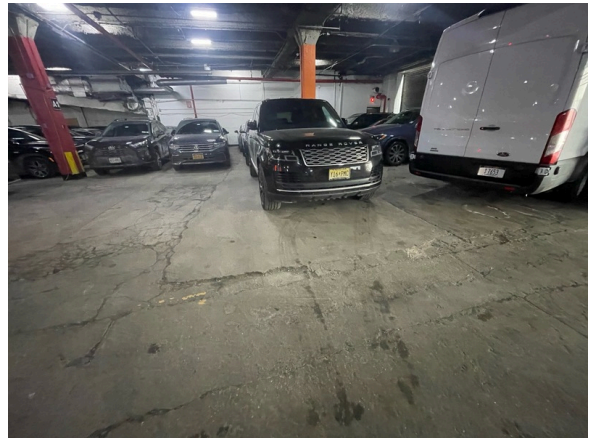
1. The concrete utilized in the parking garage was observed in fair condition with moderate cracking and damaged concrete noted throughout the garage. LCS recommends that the damaged portions of the concrete be patched and/or replaced to prevent further degradation.

First floor parking garage finishes

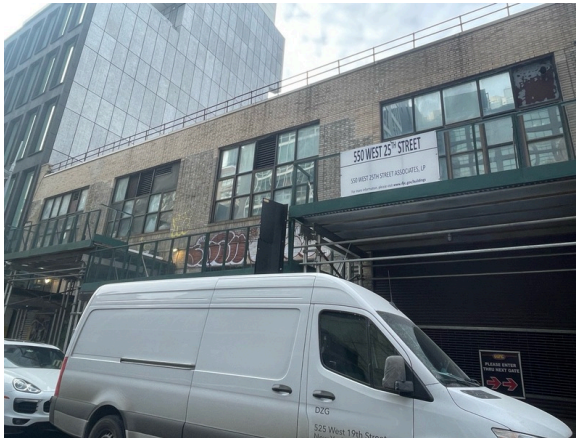
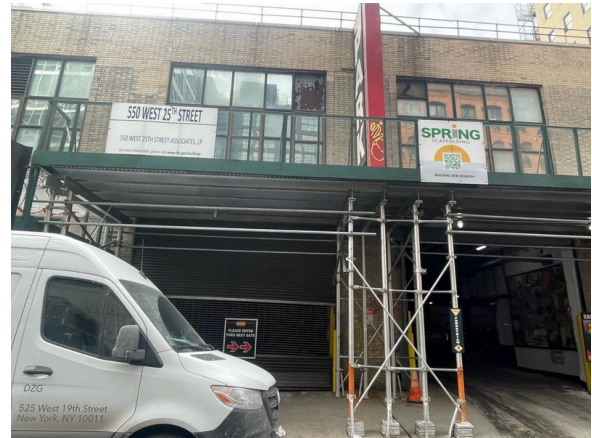
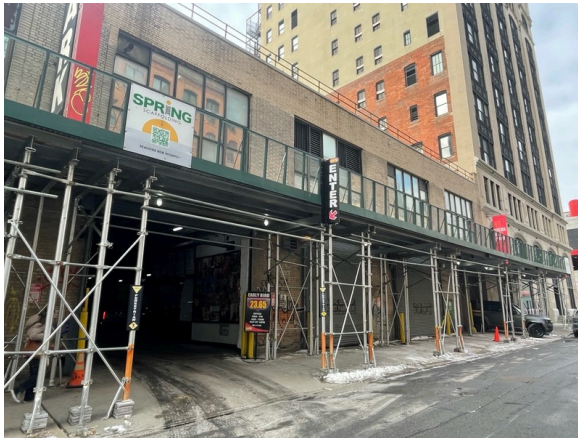
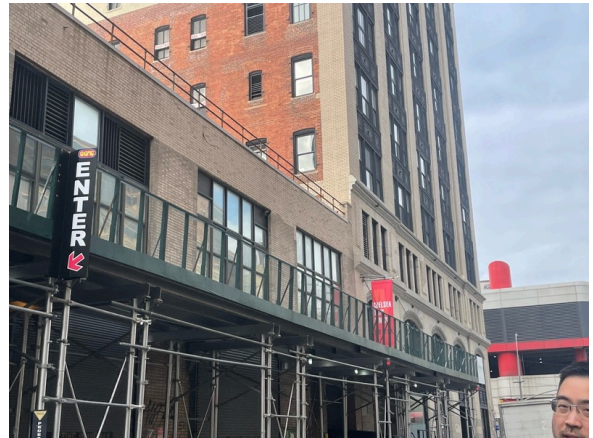
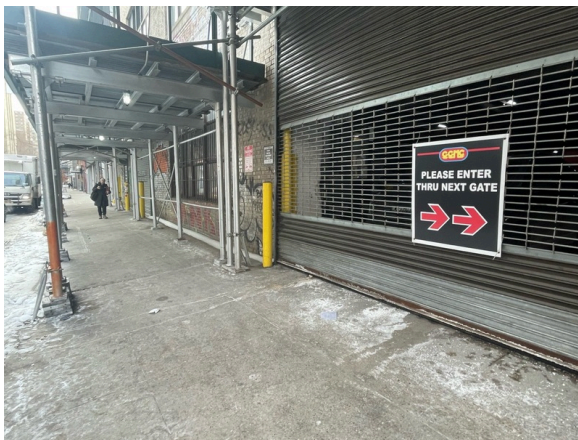
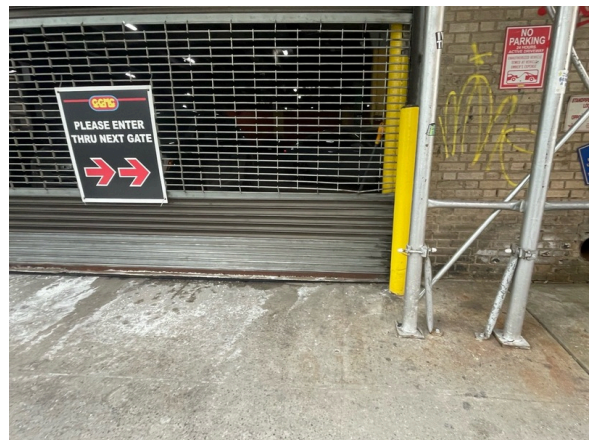
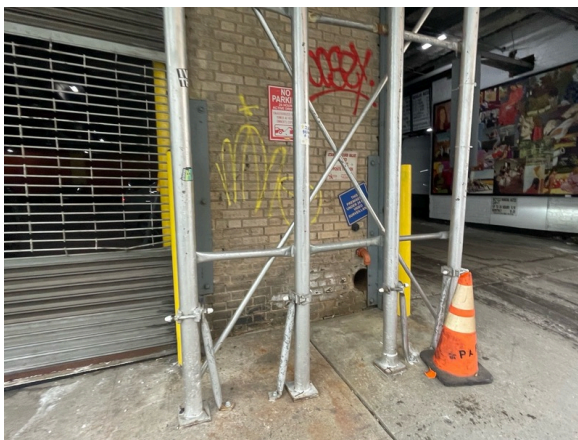
3. LCS observed moderate cracking through the brick masonry, potential water infiltration and damaged concrete along support columns. LCS recommends a structural assessment to be completed to determine the significance of the cracking. Immediate costs have been included for the assessment, with additional costs warranted as determined by the structural engineer to complete the necessary repairs.

4. LCS observed evidence of former masonry repointing, and potential areas of damaged masonry and deteriorated mortar. Masonry repointing and localized repair will need to be completed throughout the long term reserve; LCS has included a cost allowance for this work twice throughout the reserve.

5. Moderate amounts of graffiti were observed along the building exterior. LCS recommends the areas be cleaned and power washed to prevent degradation to the masonry brick.

North side of the building

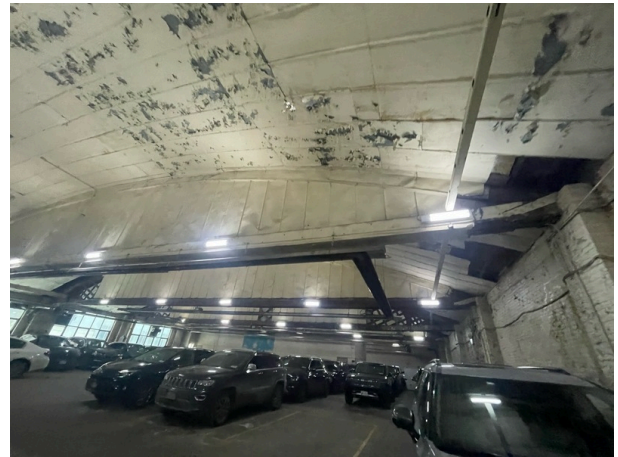
Second floor finishes

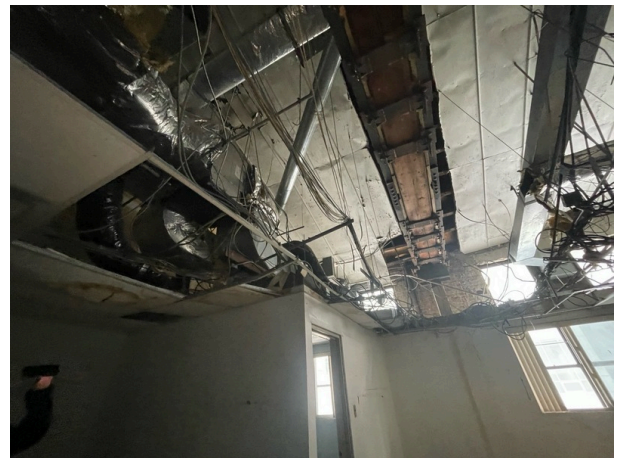
Second floor finishes

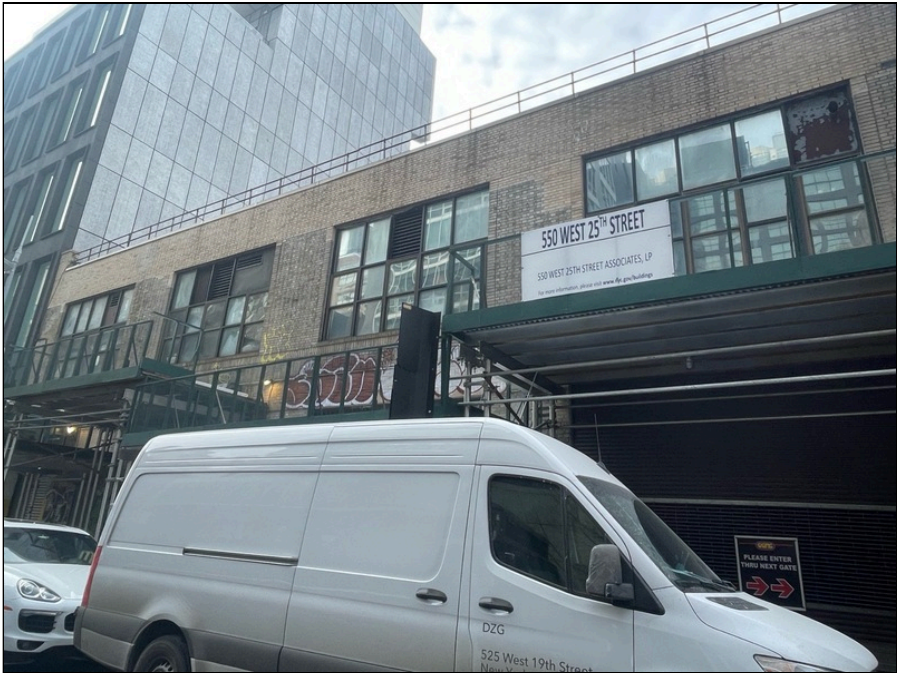
Photo 1: North side of the building

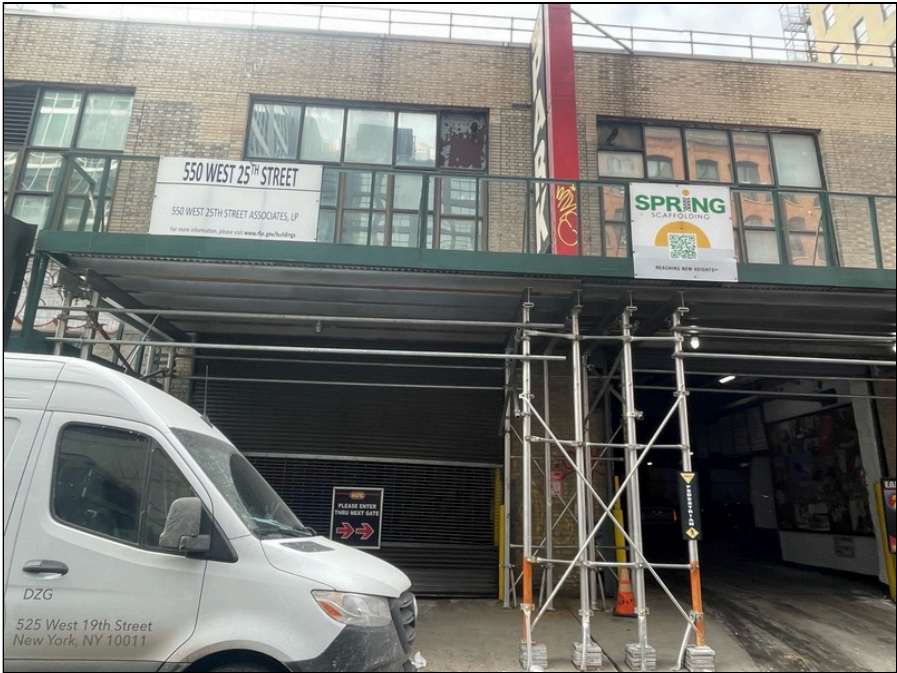
Photo 2: North side of the building

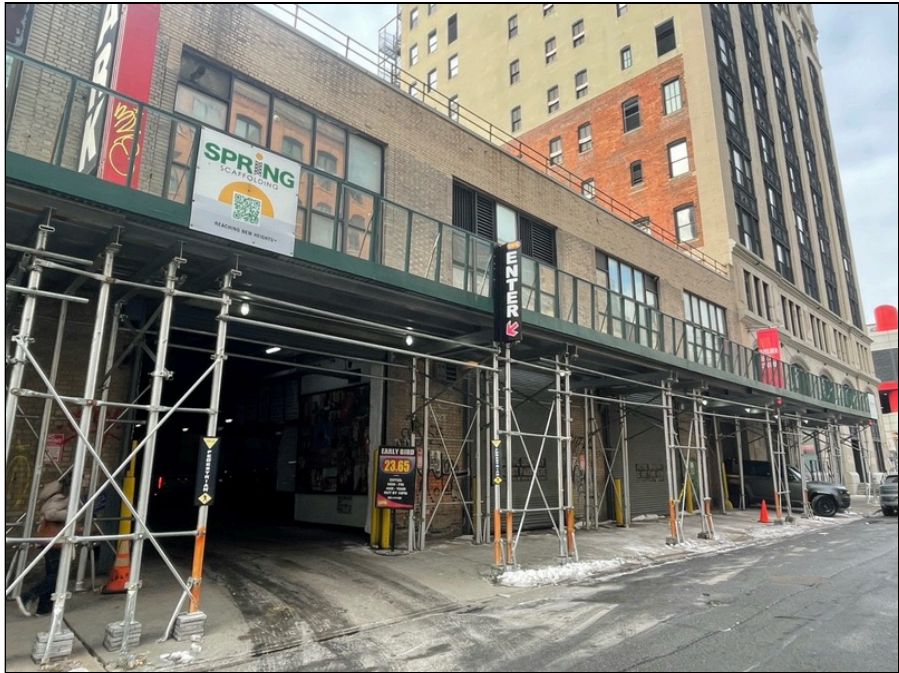
**Photo 3:** North side of the building

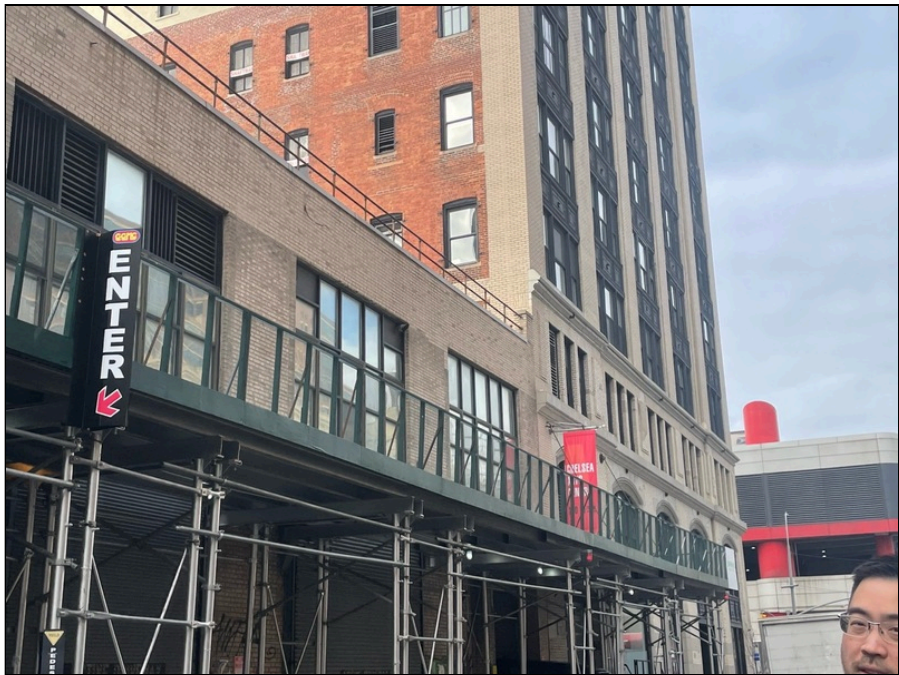
**Photo 4:** North side of the building

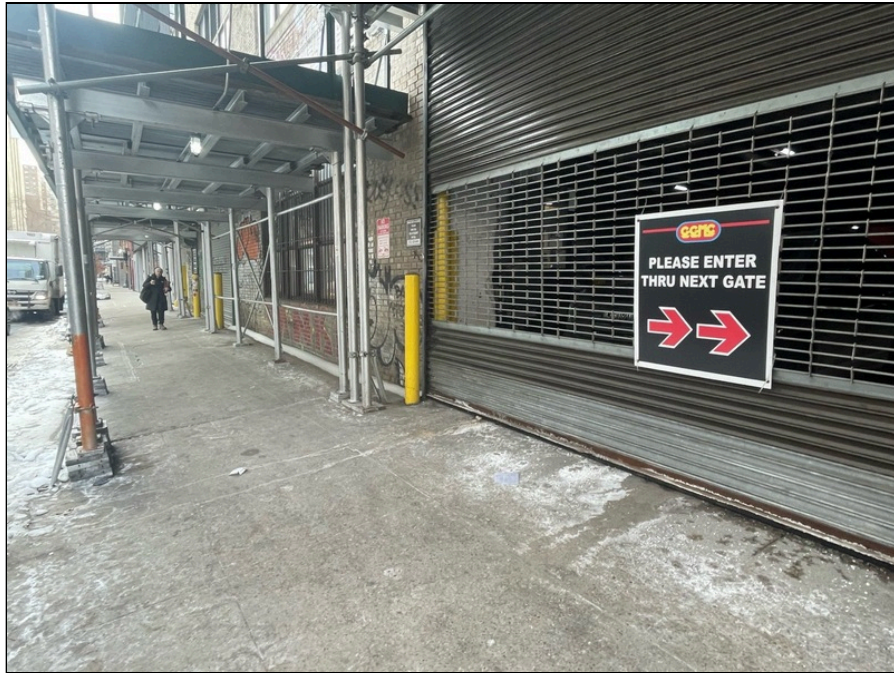
**Photo 5:** North side of the building

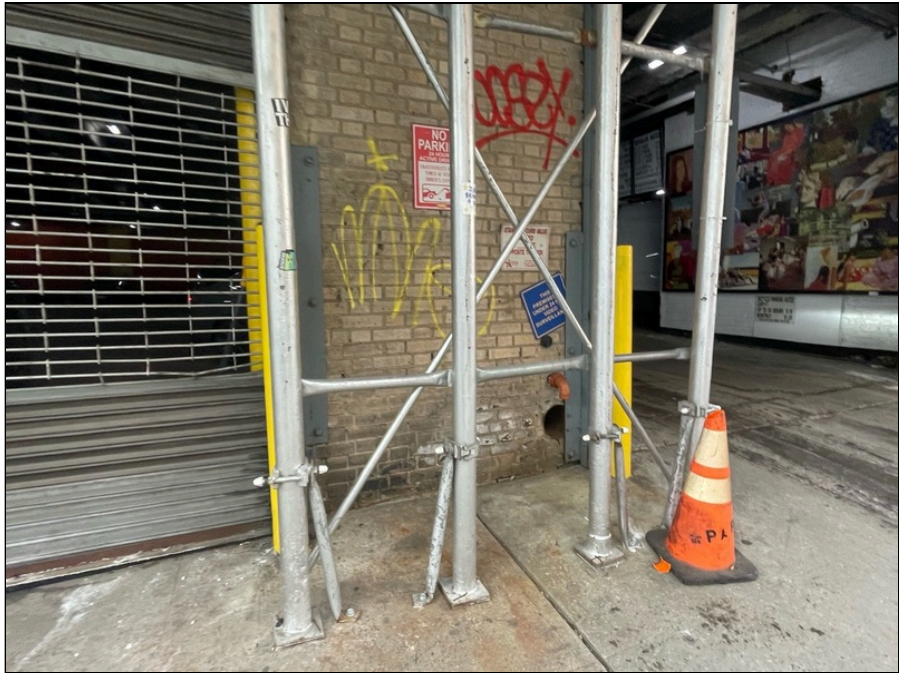
**Photo 7:** North side of the building

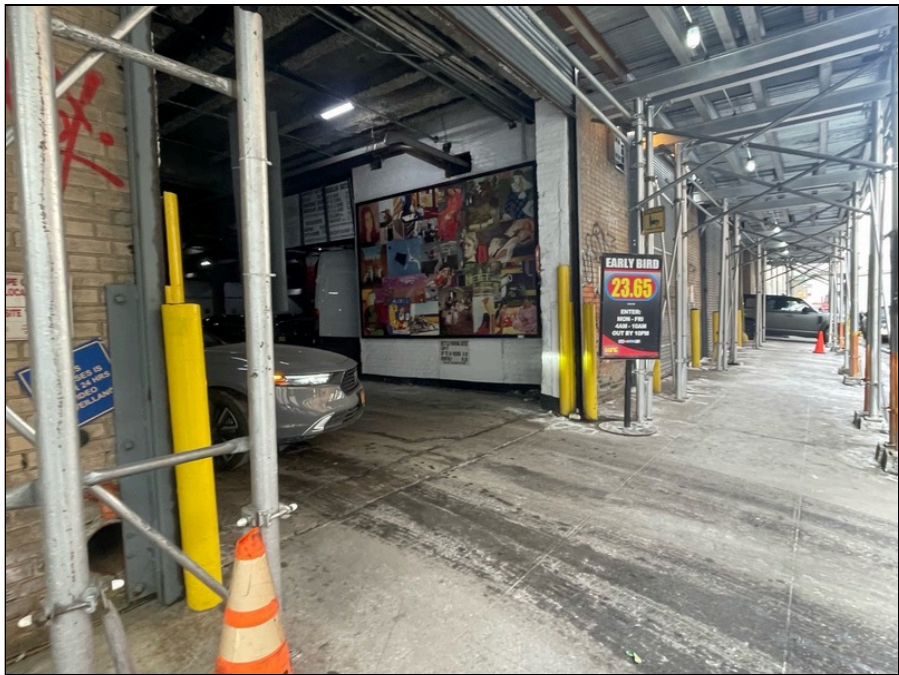
**Photo 8:** First floor parking garage finishes

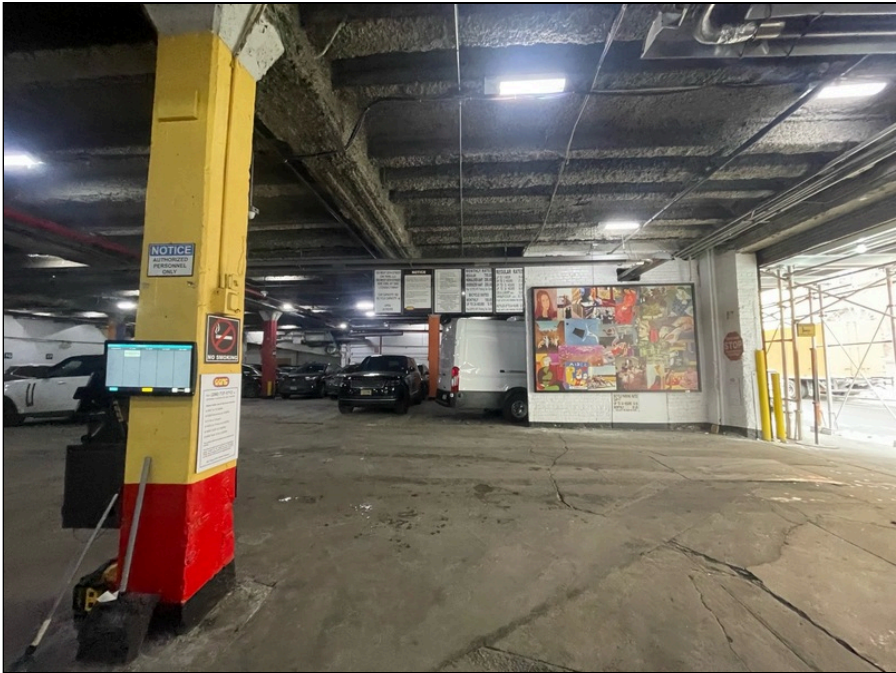
Photo 9: First floor parking garage finishes

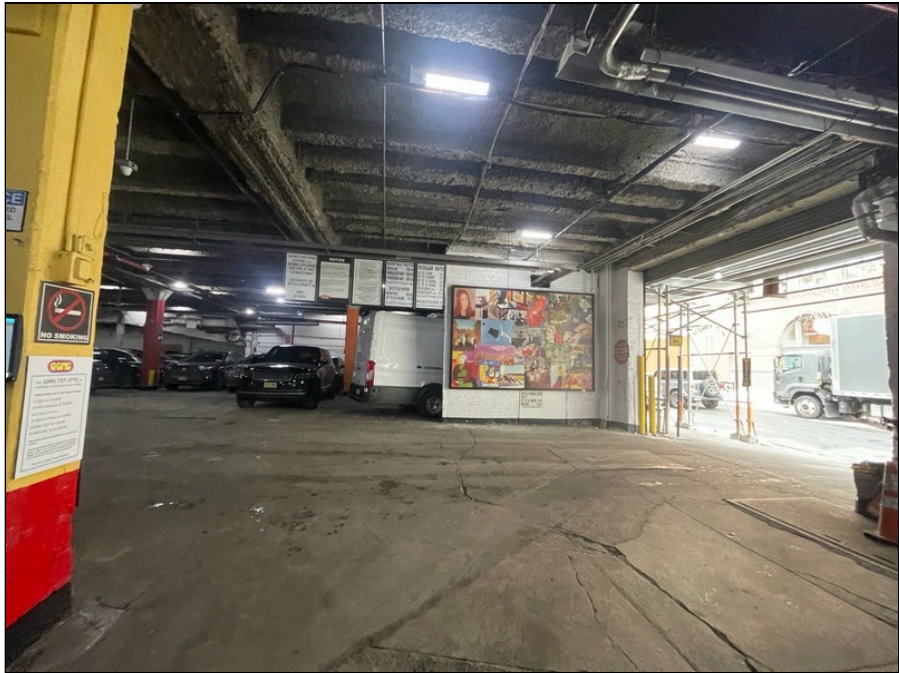
**Photo 11:** First floor parking garage finishes

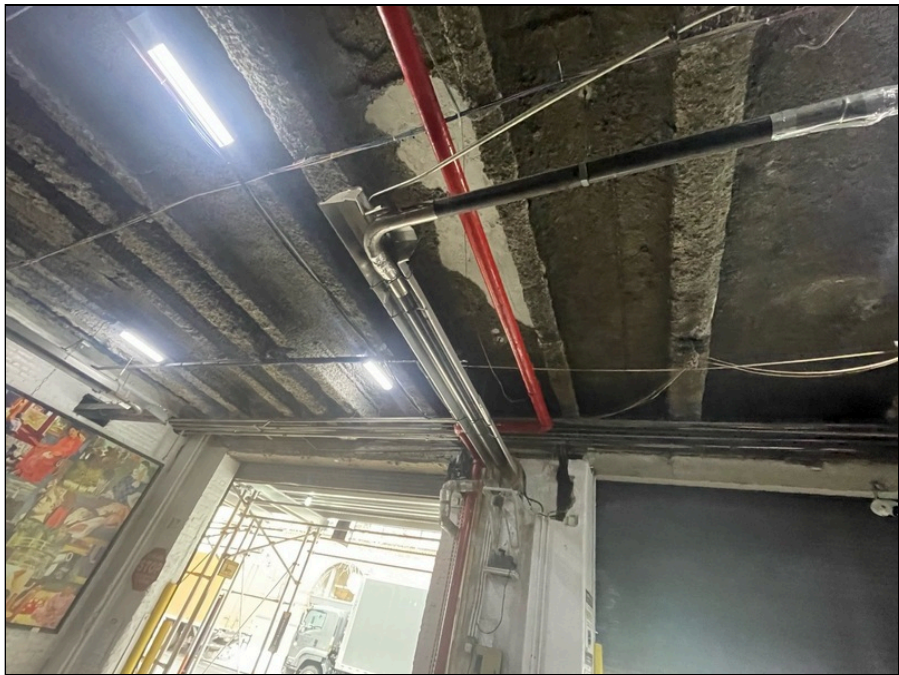
**Photo 12:** First floor parking garage finishes

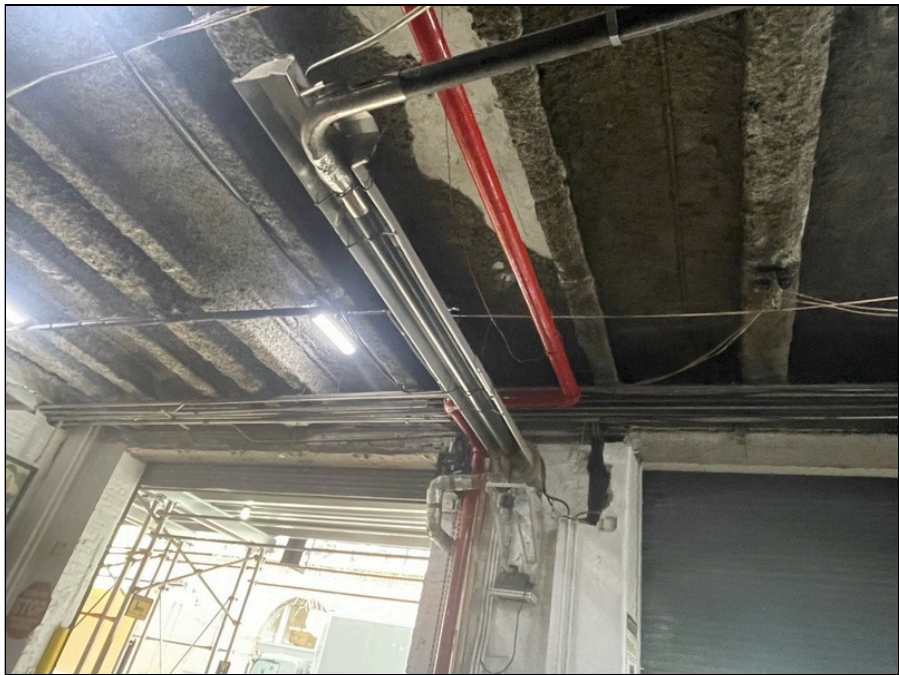
**Photo 13:** First floor heating system

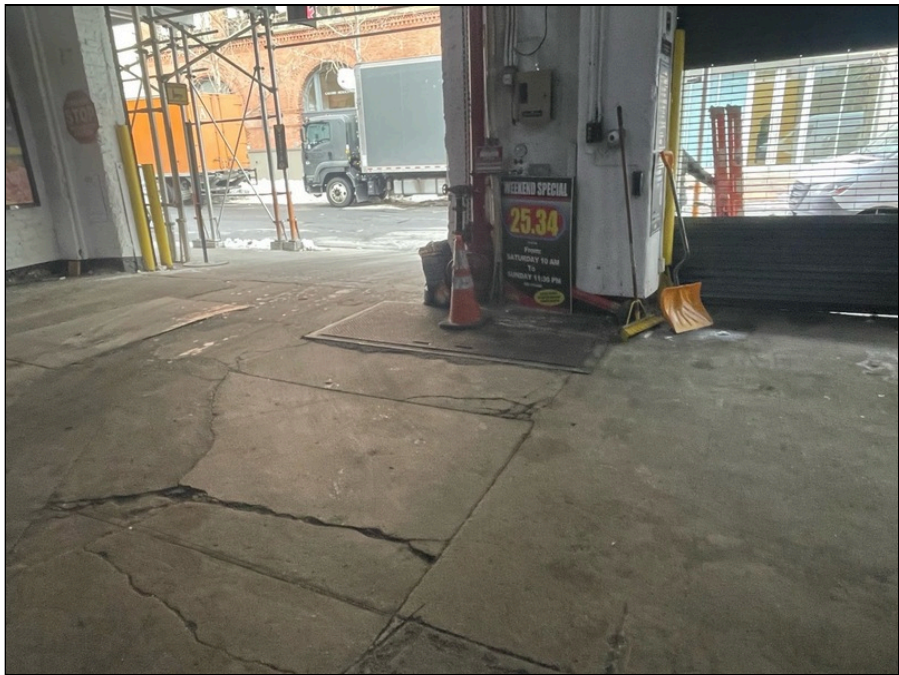
**Photo 14:** Sewer and water connections, first floor

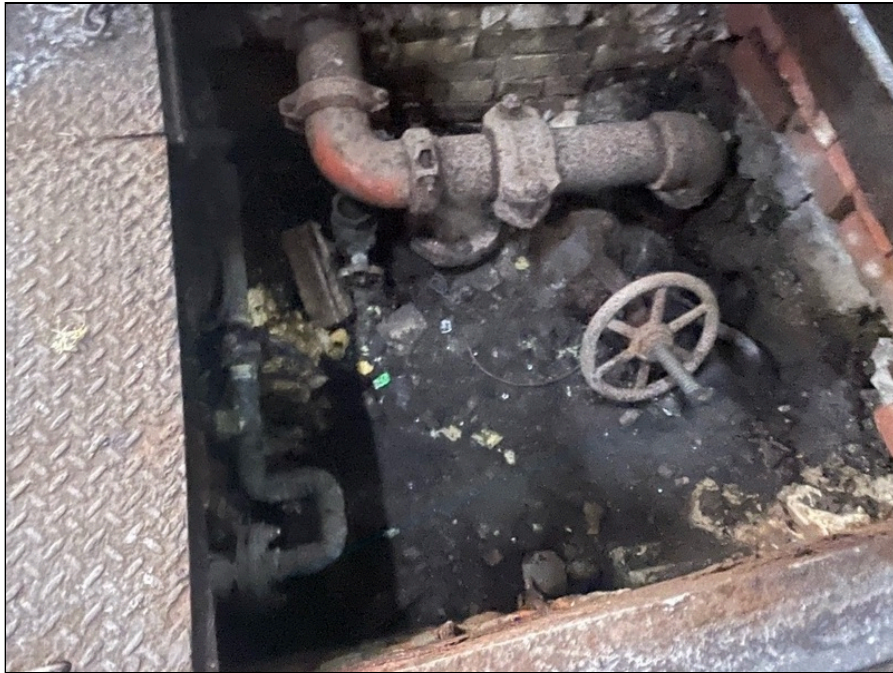
**Photo 15:** Sewer and water connections, first floor

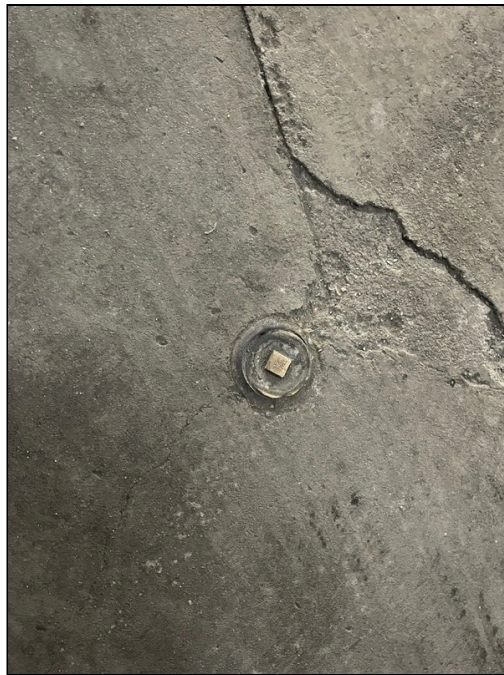
**Photo 16:** Cleanout, first floor

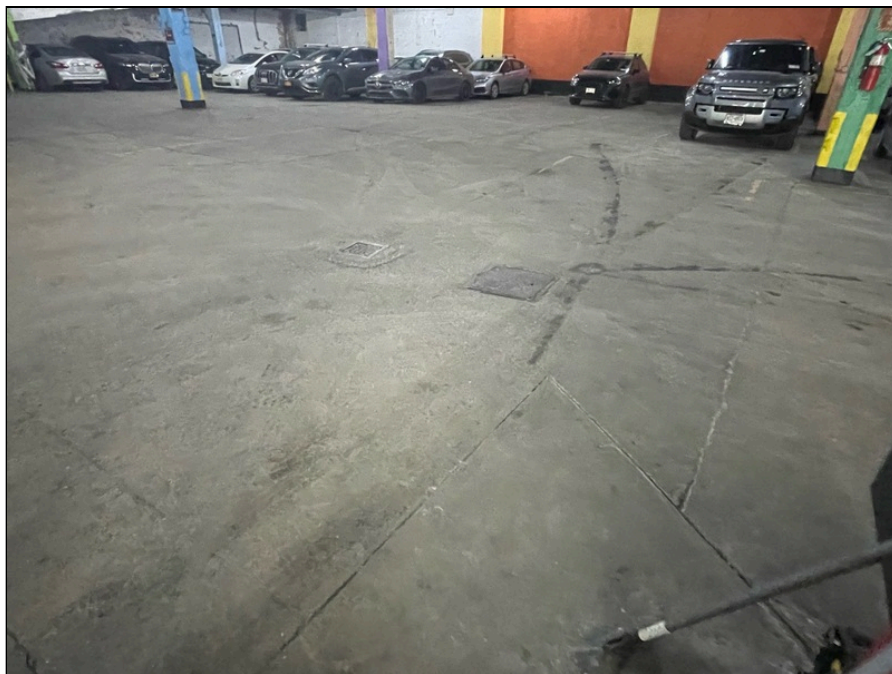
**Photo 18:** First floor parking garage finishes

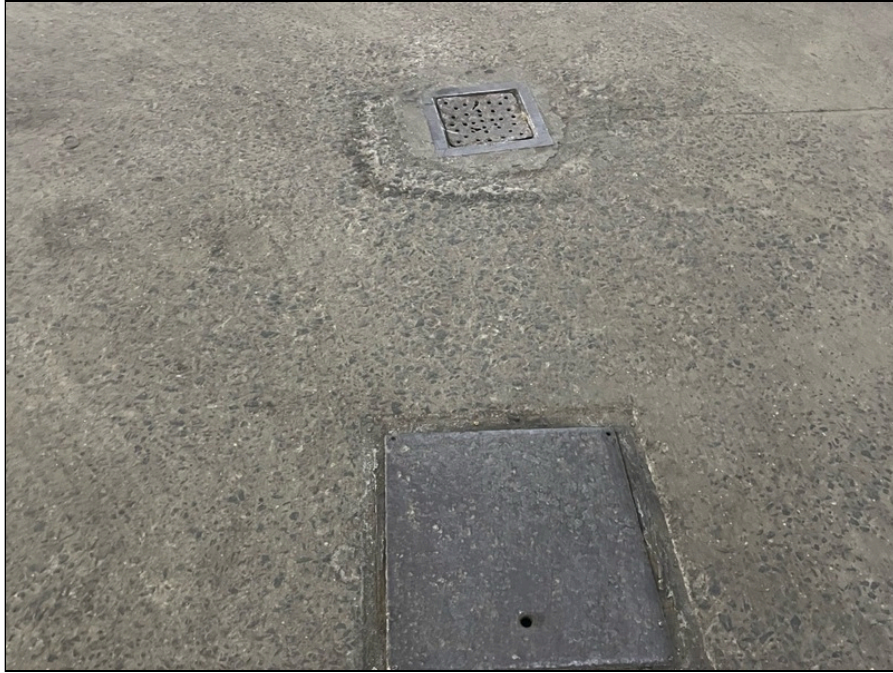
**Photo 19:** Floor drain, first floor

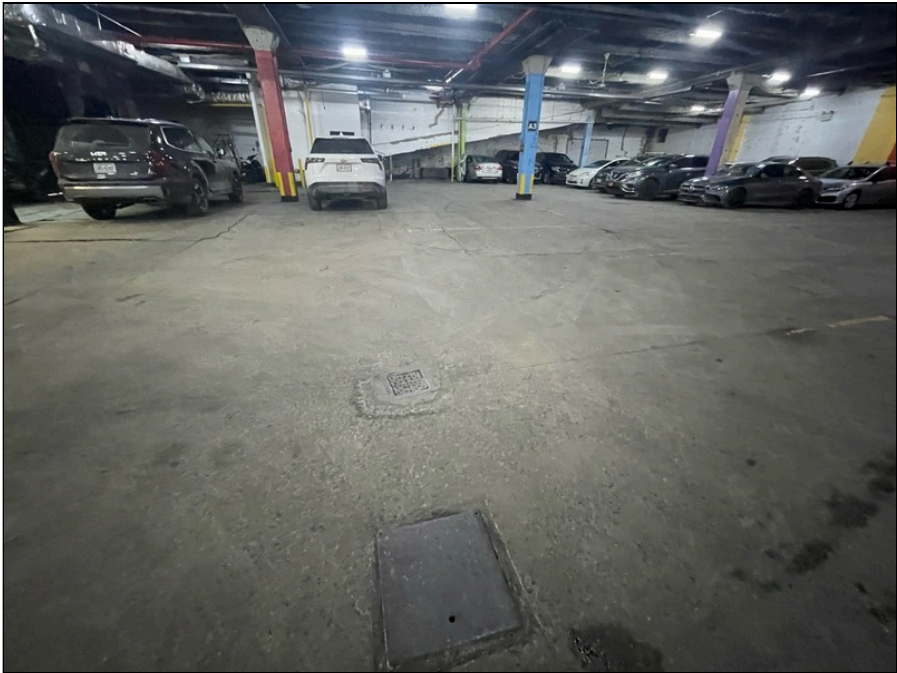
Photo 21: First floor parking garage finishes

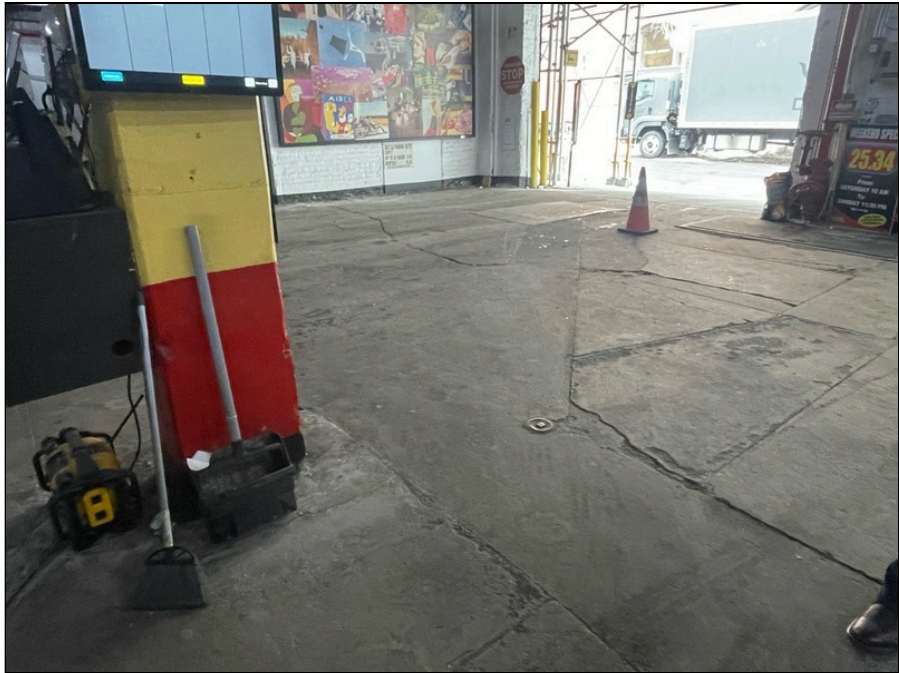
**Photo 23:** First floor parking garage finishes

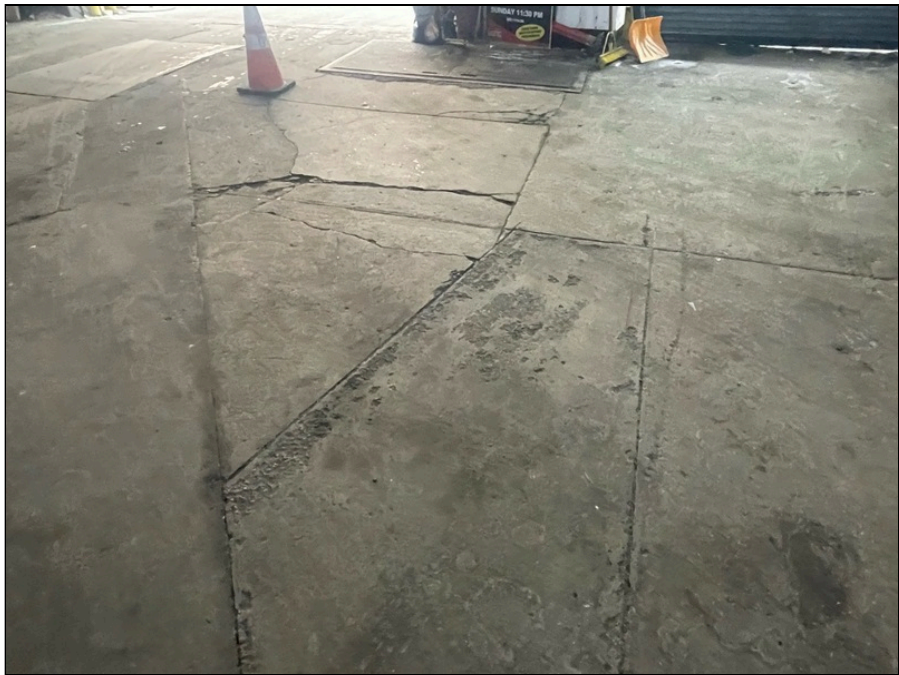
**Photo 24:** First floor parking garage finishes

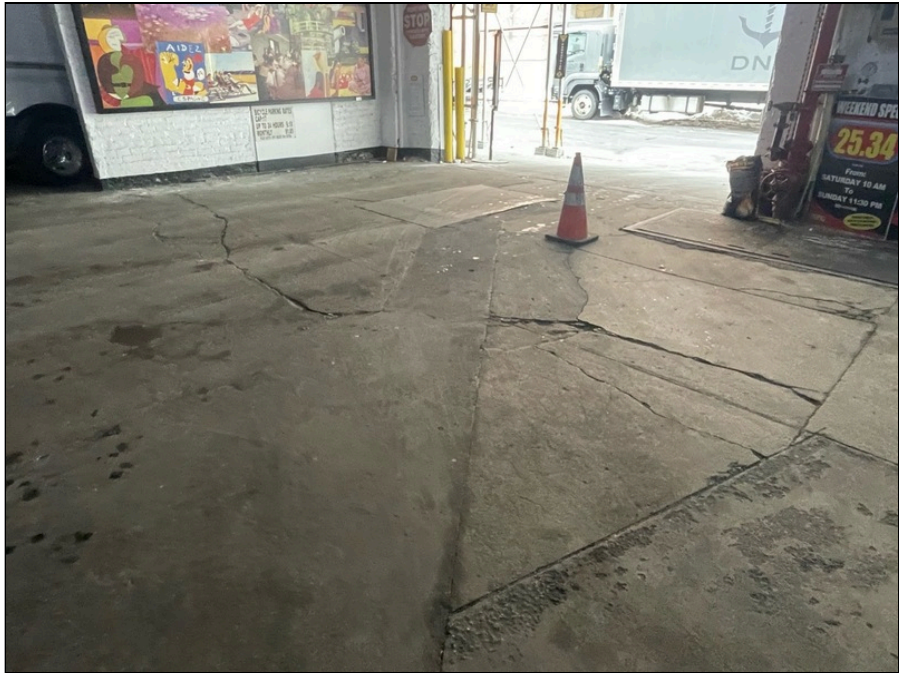
**Photo 25:** First floor parking garage finishes

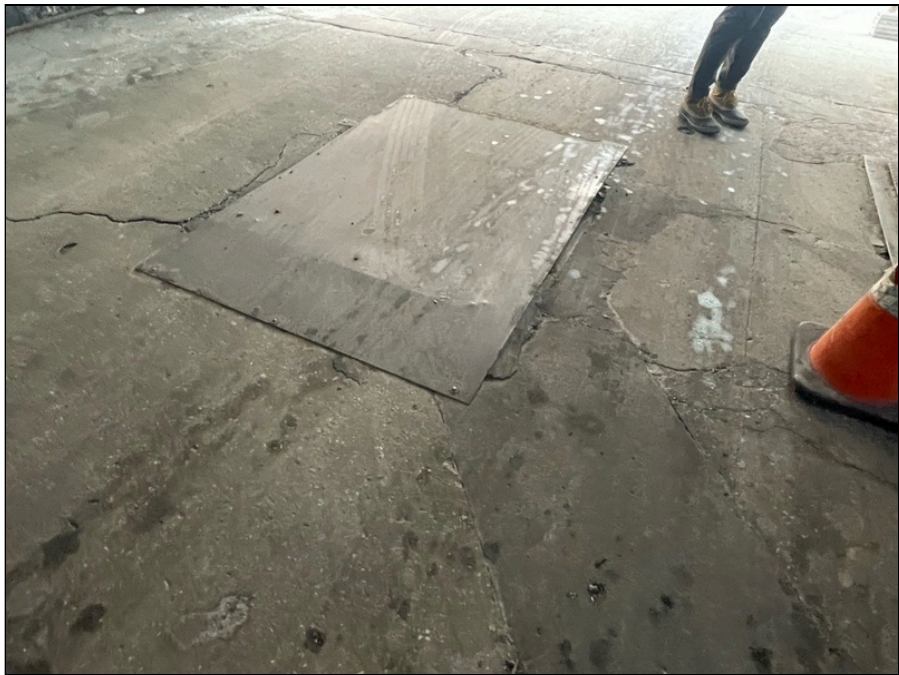
**Photo 26:** Oil-water separator, first floor

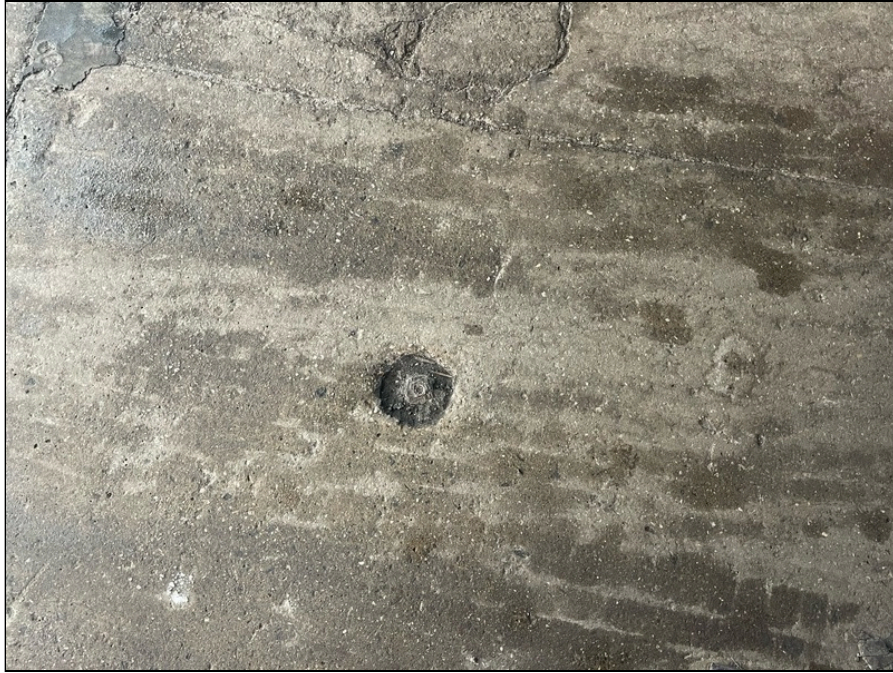
**Photo 27:** Floor drain cleanout, first floor

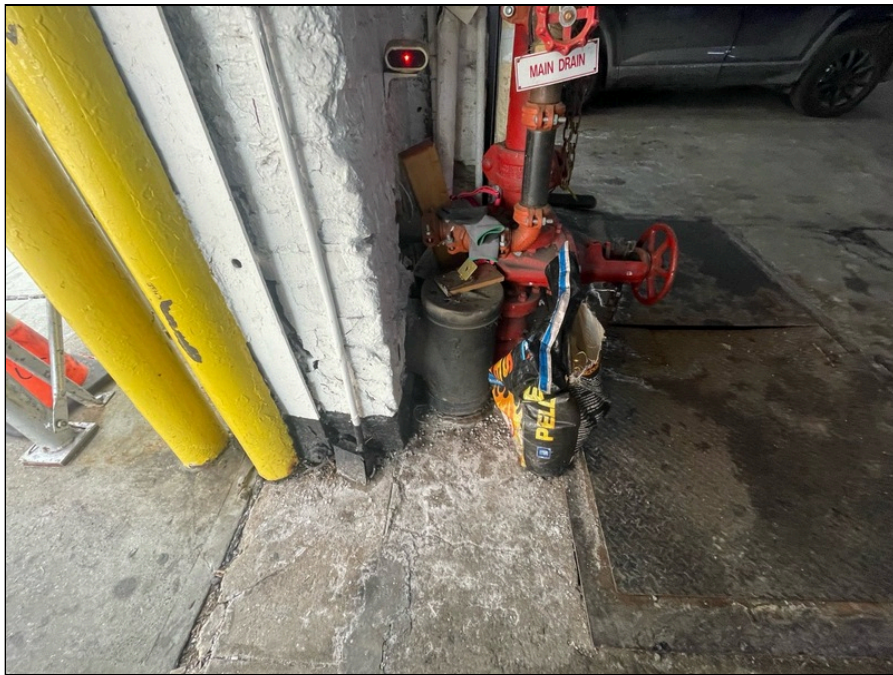
**Photo 28:** Sprinkler main, first floor

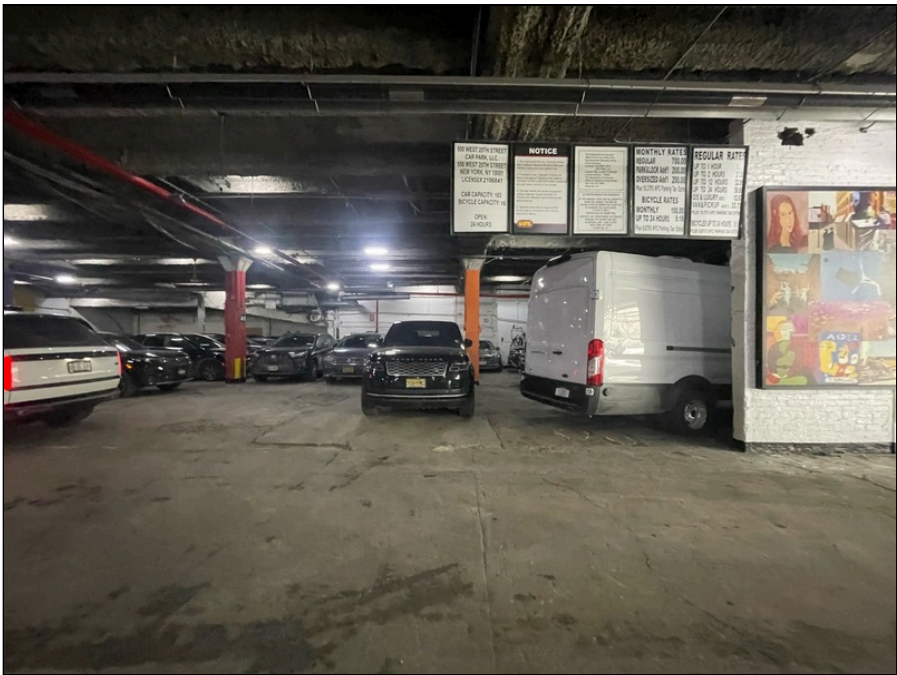
Photo 29: First floor parking garage finishes

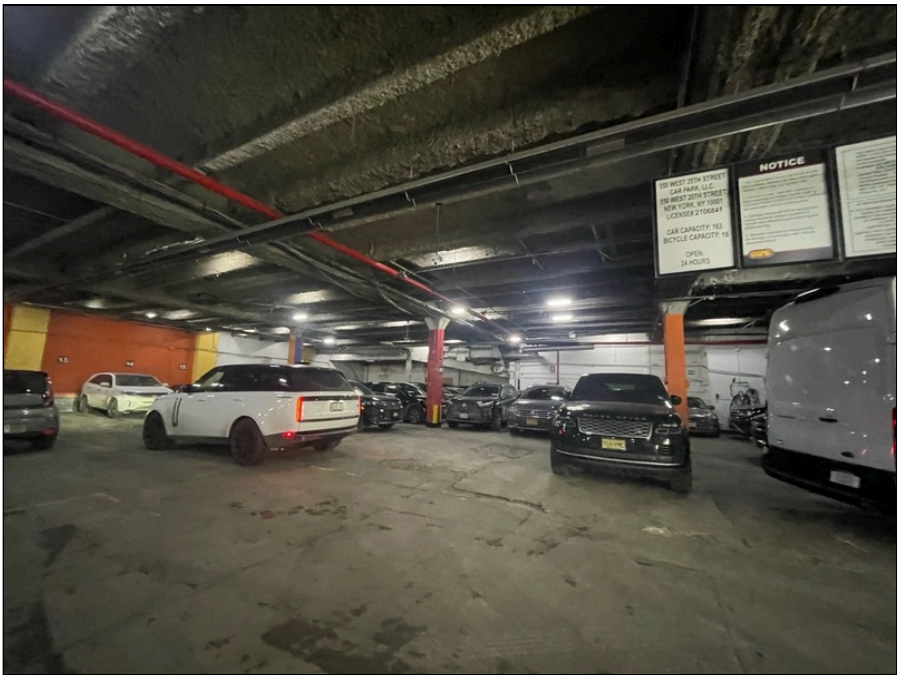
Photo 30: First floor parking garage finishes

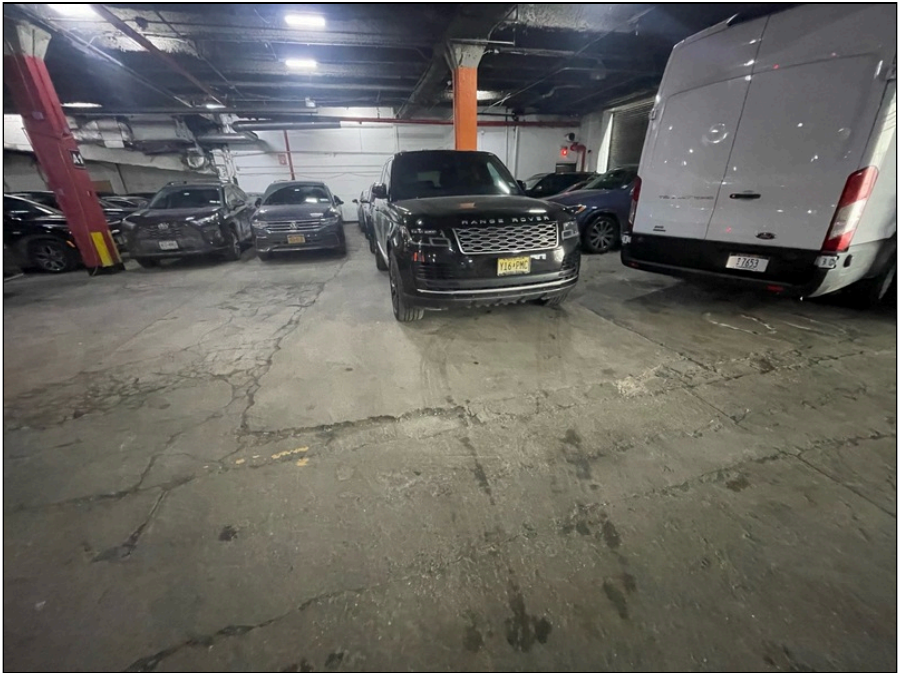
**Photo 31:** First floor parking garage finishes

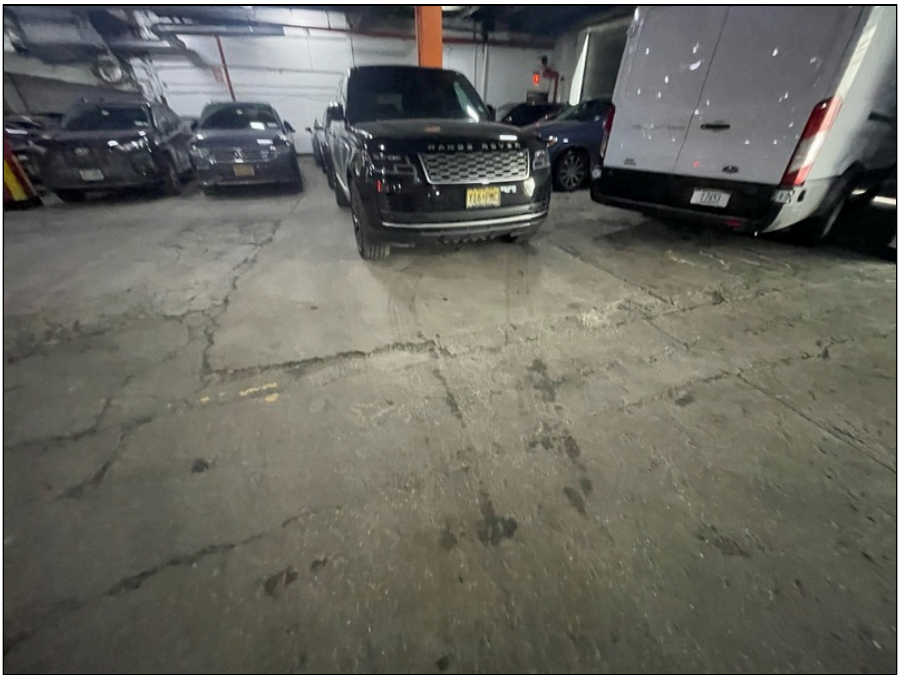
**Photo 32:** First floor parking garage finishes

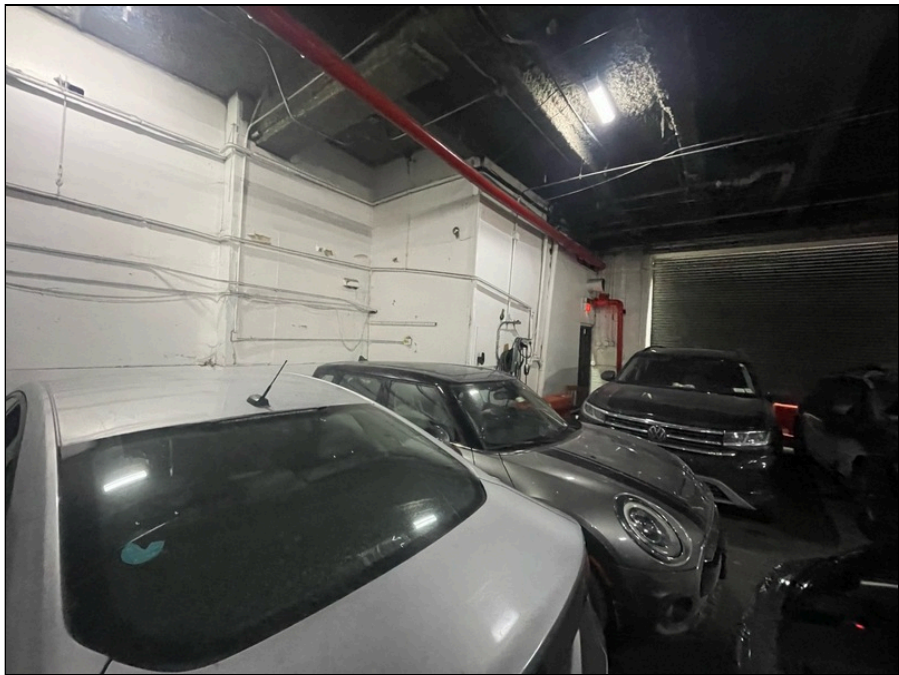
**Photo 33:** First floor parking garage finishes

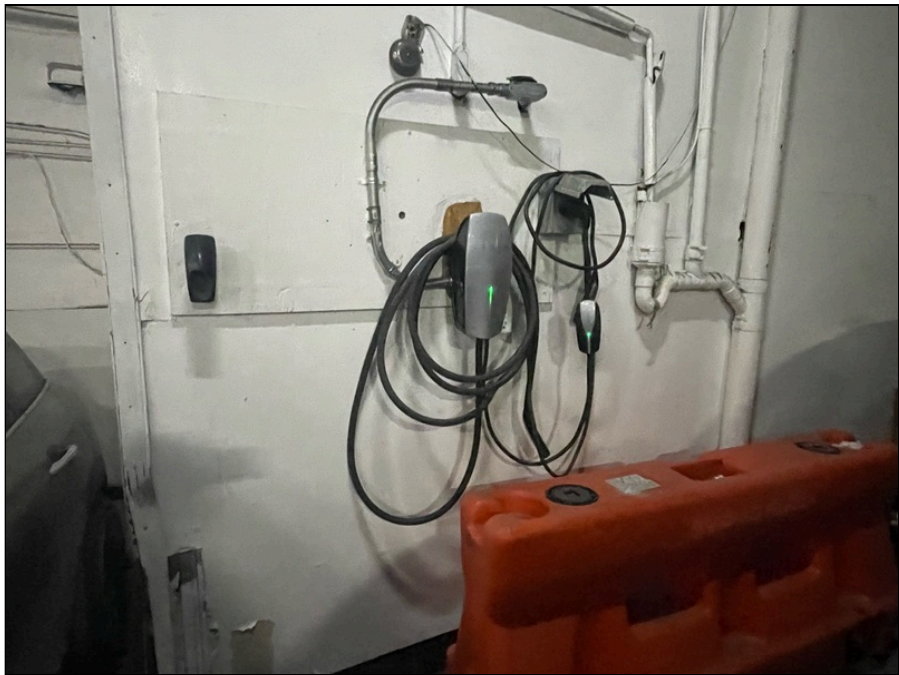
**Photo 34:** First floor parking garage finishes

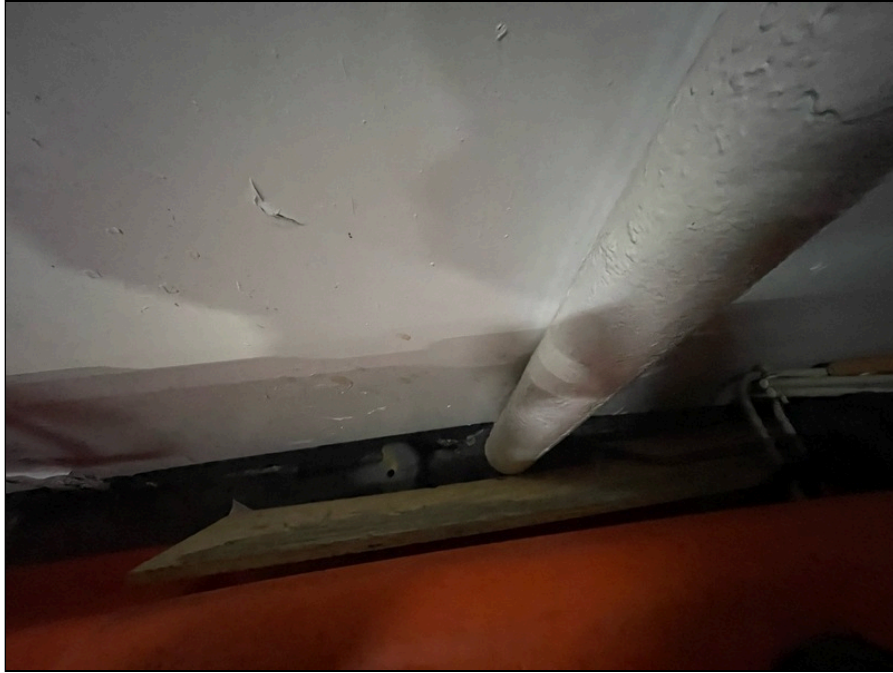
**Photo 35:** First floor parking garage finishes

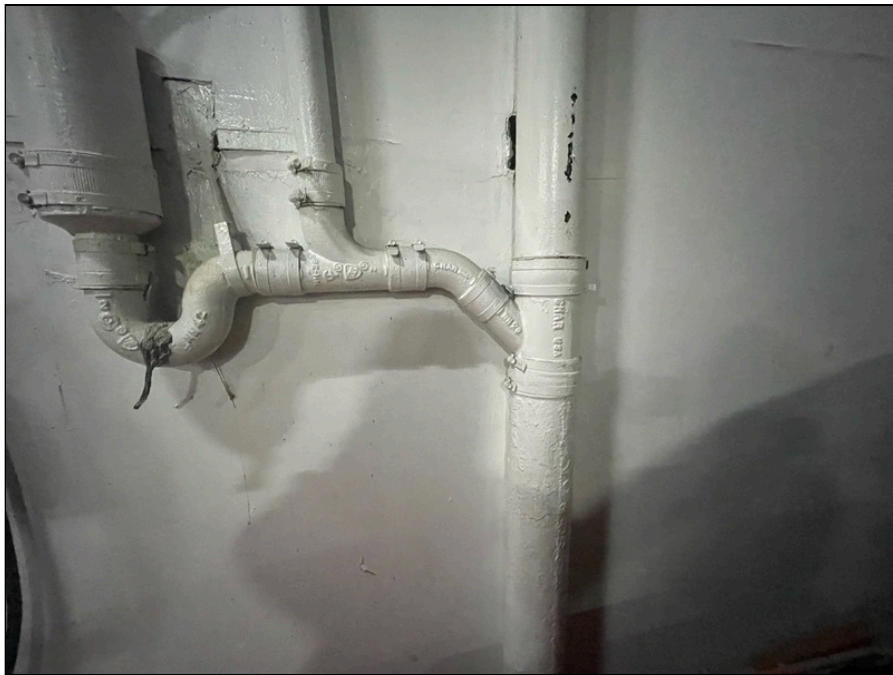
**Photo 36:** Roof drain piping, first floor

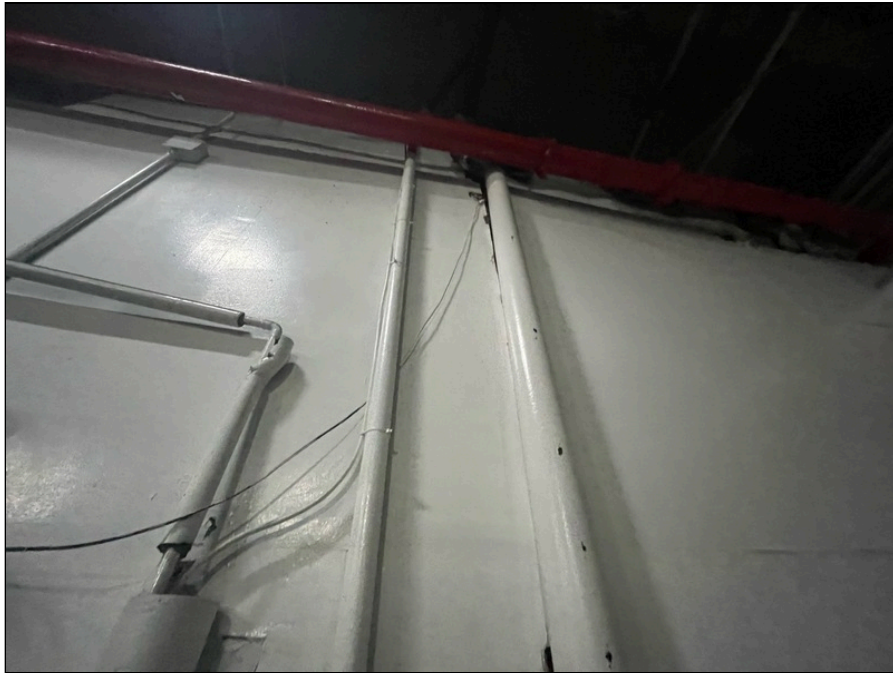
**Photo 37:** Roof drain piping, first floor

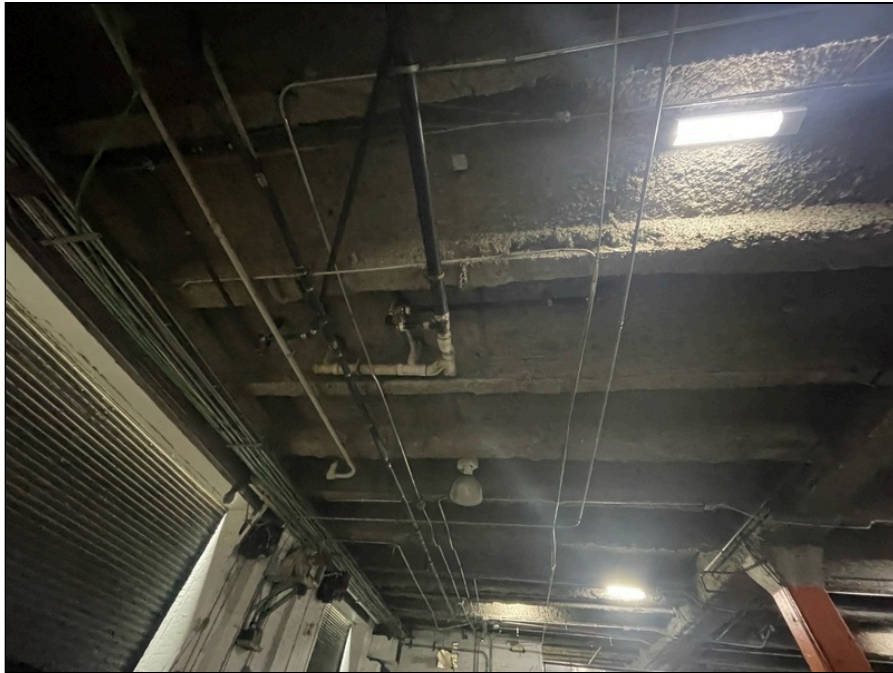
**Photo 39:** First floor parking garage finishes
