**ASTM E2018-24 PROPERTY CONDITION ASSESSMENT REPORT (PCR)**

**Commercial Building  
550 West 25th Street  
New York, New York 10001**

**Project Number:  
26.01121.10**

**Conditions as of:  
February 6, 2026**

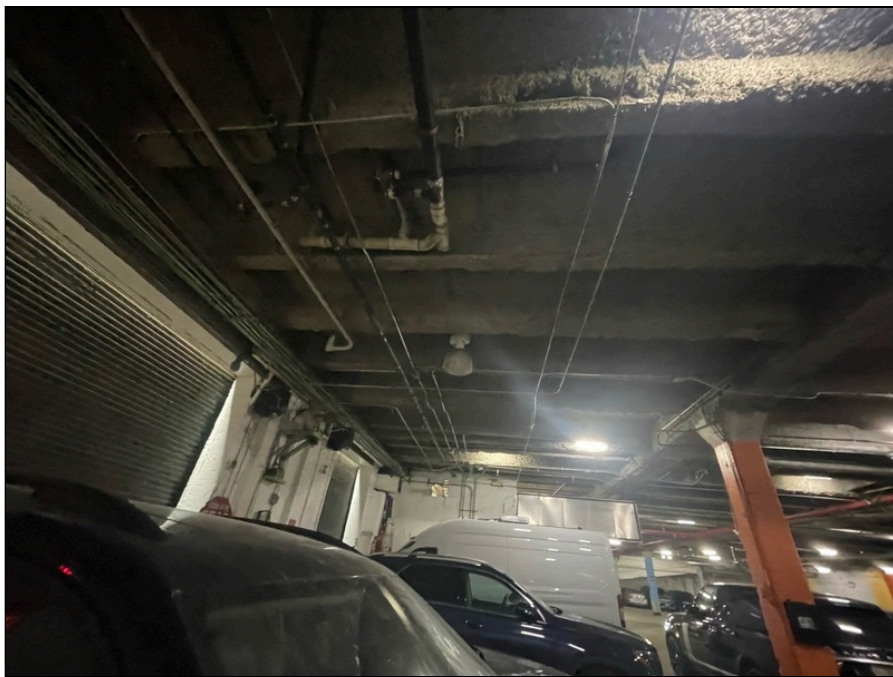
**Photo 40:** First floor parking garage finishes

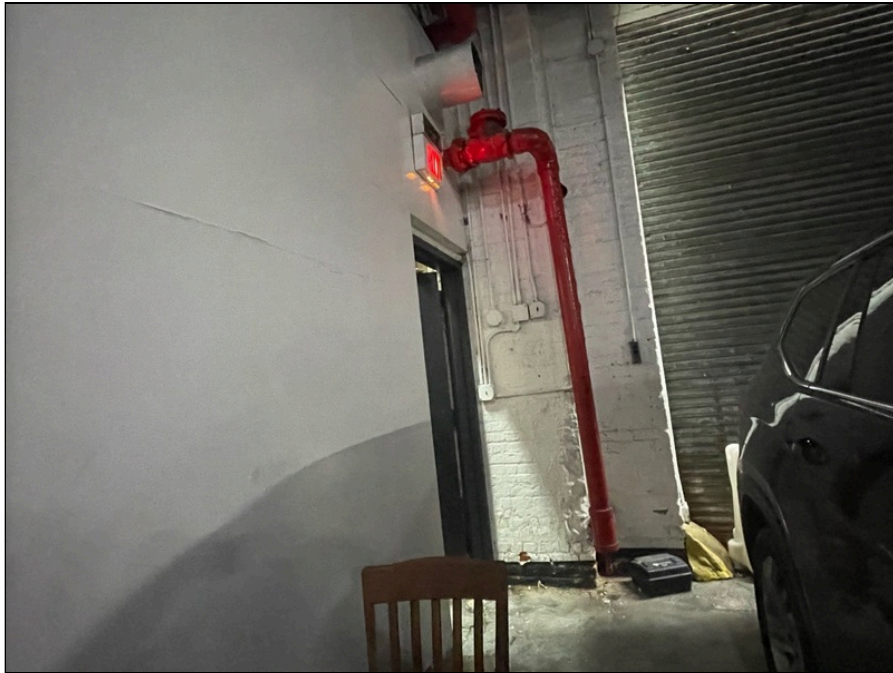
**Photo 41:** First floor parking garage finishes

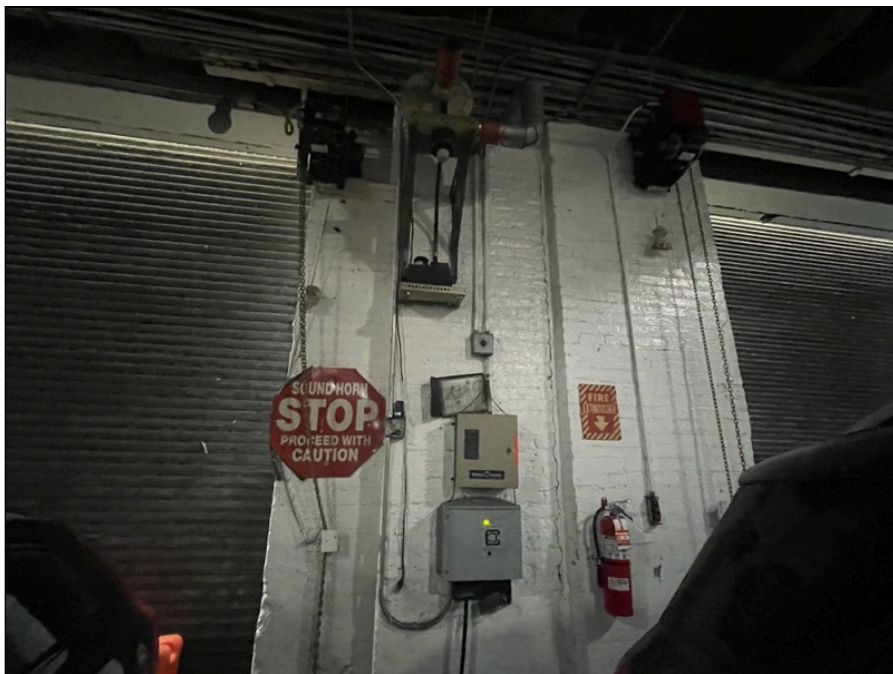
**Photo 42:** First floor parking garage finishes

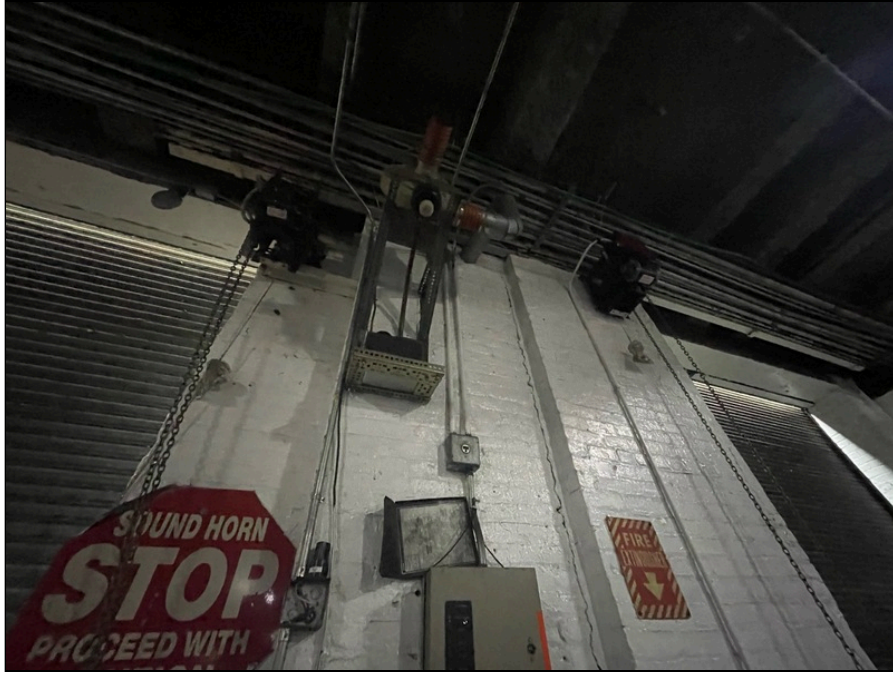
**Photo 43:** First floor parking garage finishes

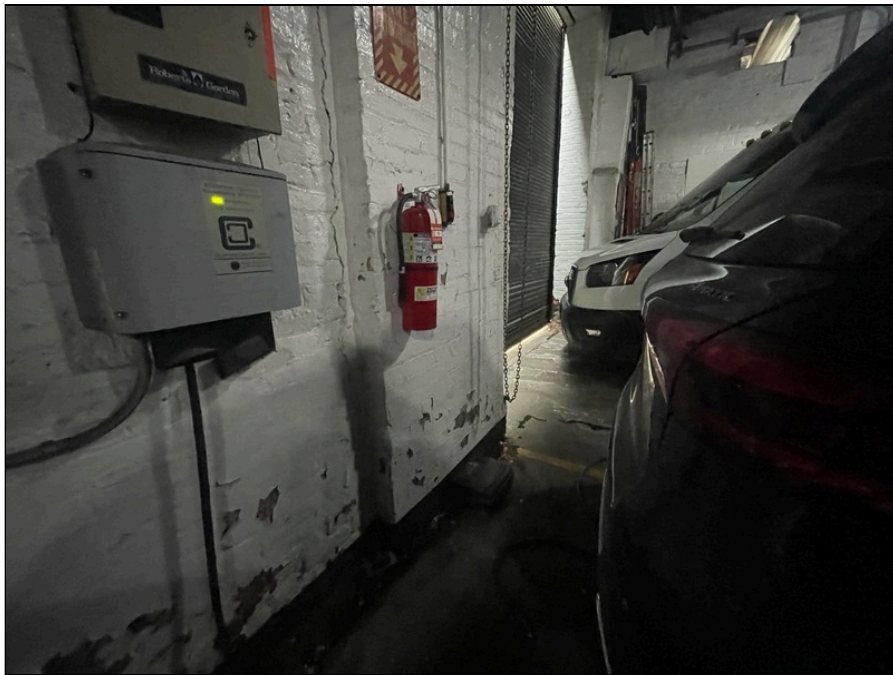
**Photo 44:** First floor parking garage finishes

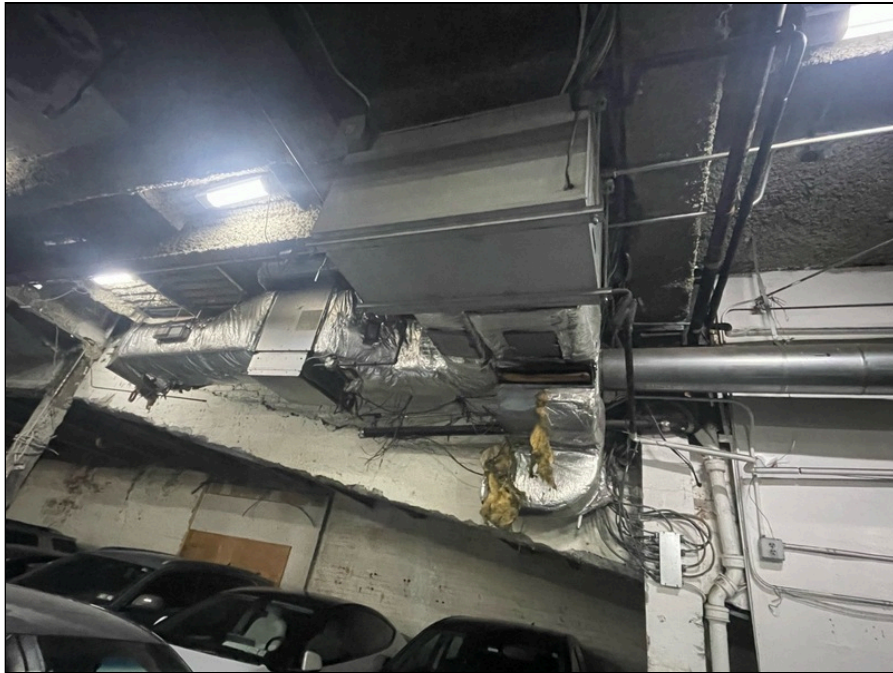
**Photo 45:** First floor HVAC system

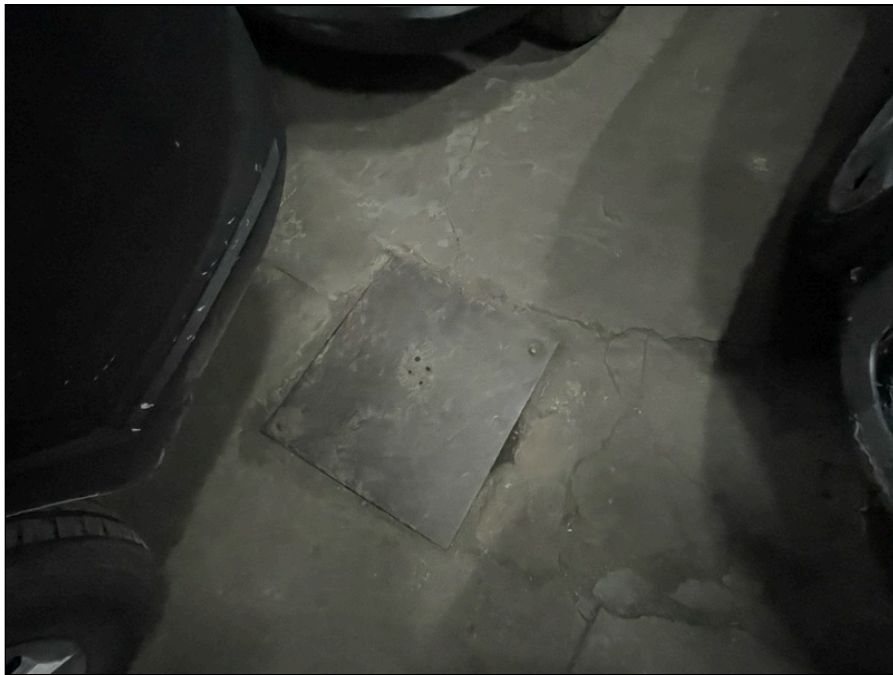
**Photo 46:** Floor drain, first floor

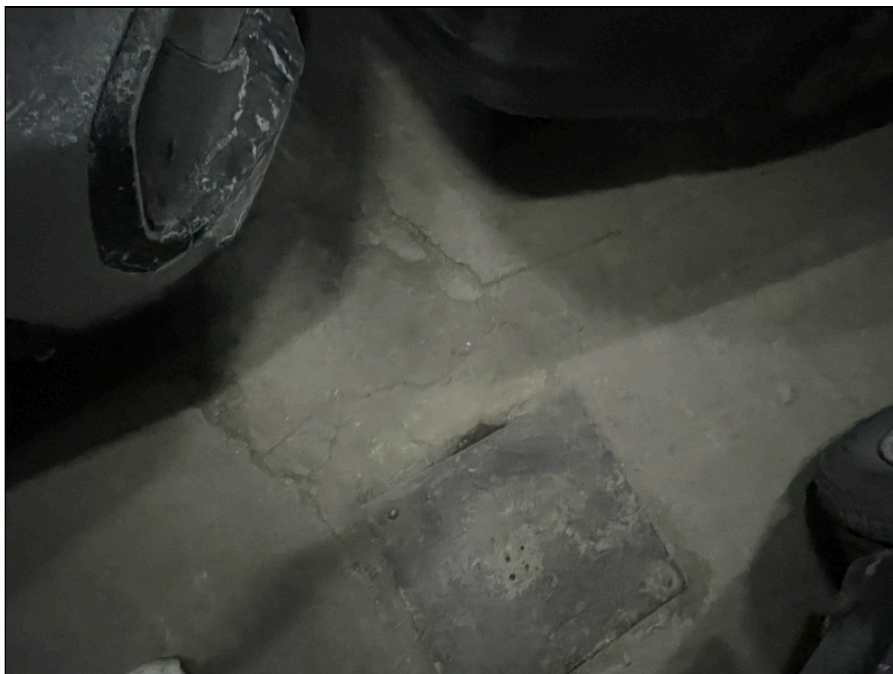
**Photo 48:** Floor drain, first floor

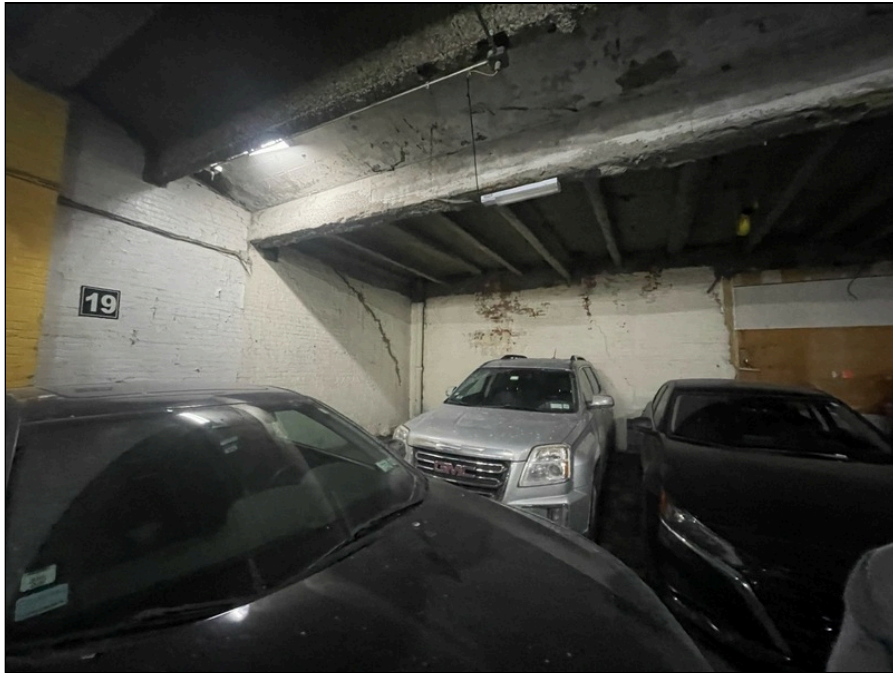
**Photo 49:** First floor parking garage finishes

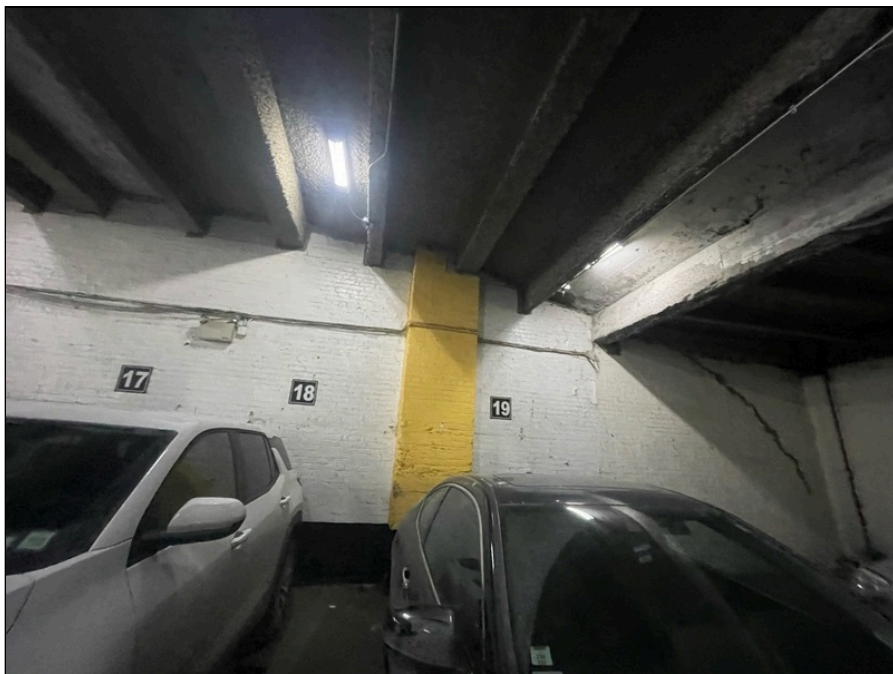
**Photo 50:** First floor parking garage finishes

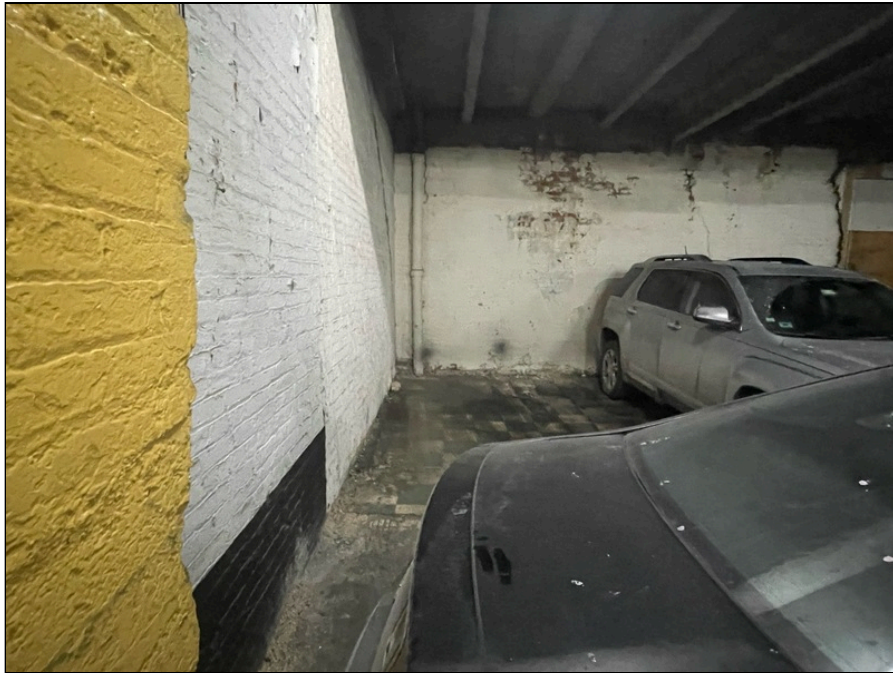
**Photo 51:** First floor parking garage finishes

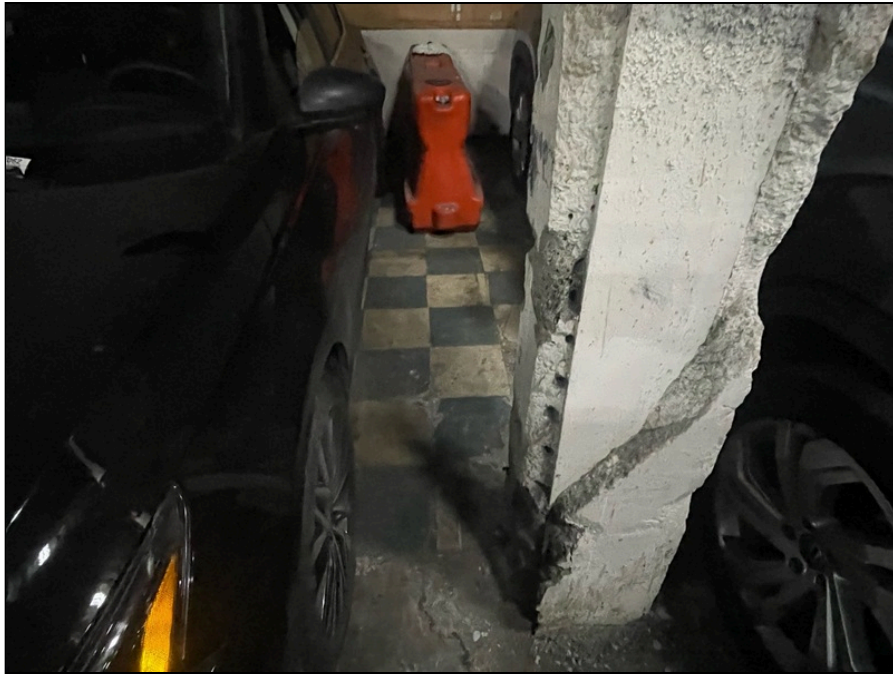
**Photo 53:** First floor parking garage finishes

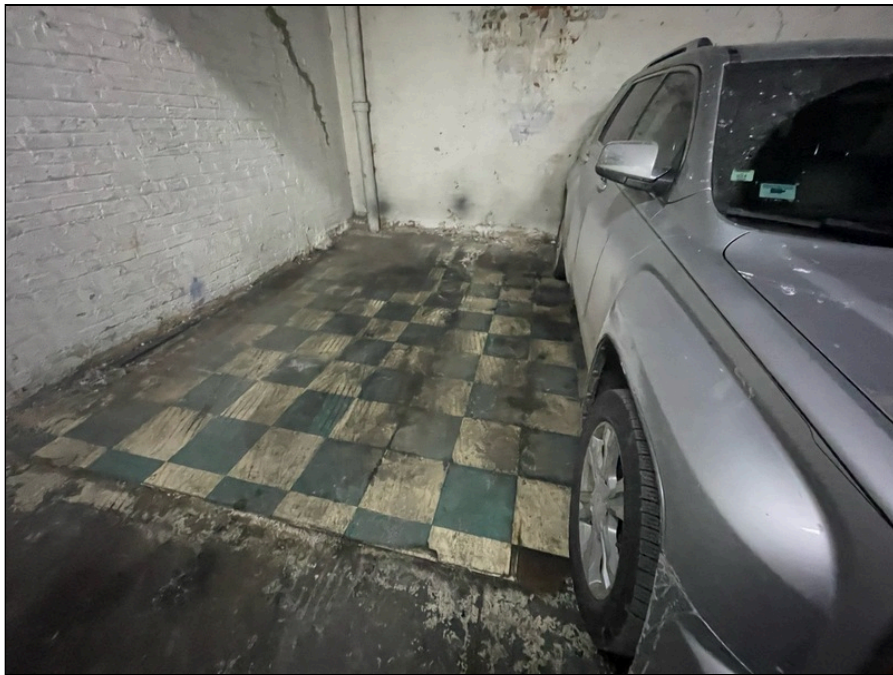
**Photo 54:** First floor parking garage finishes

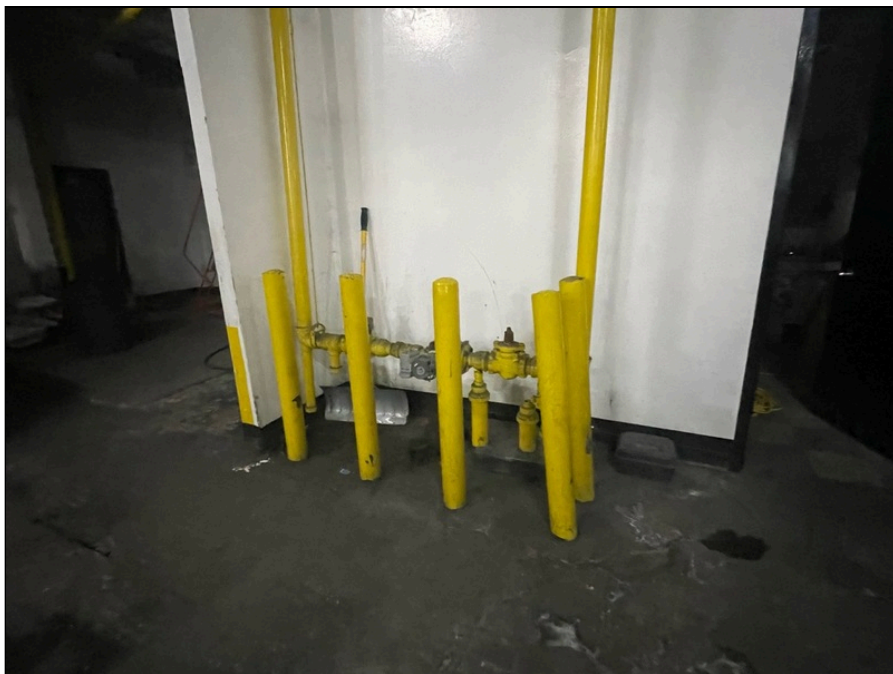
**Photo 56:** Natural gas meter, first floor

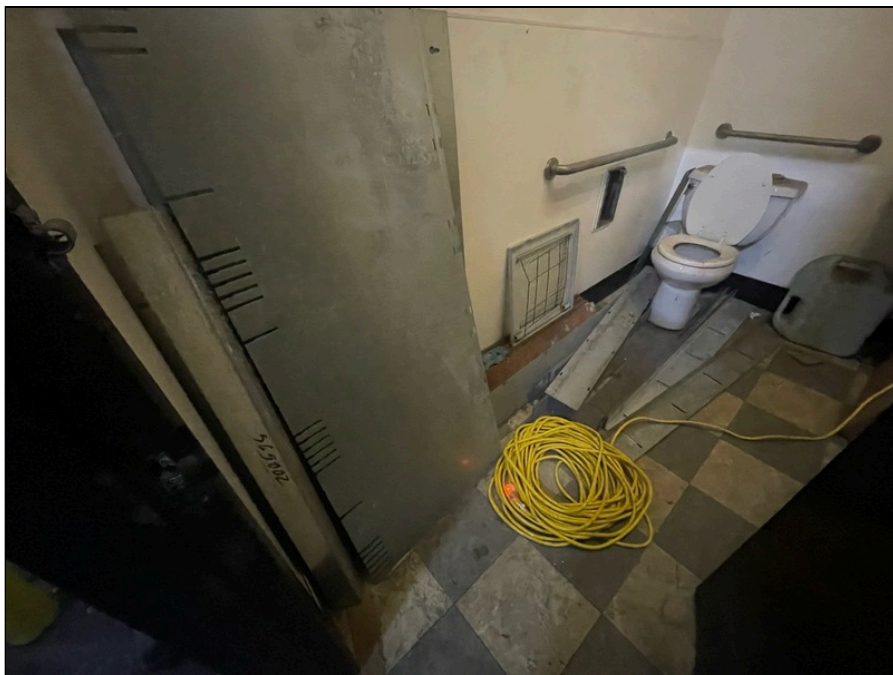
**Photo 57:** Bathroom finishes, first floor

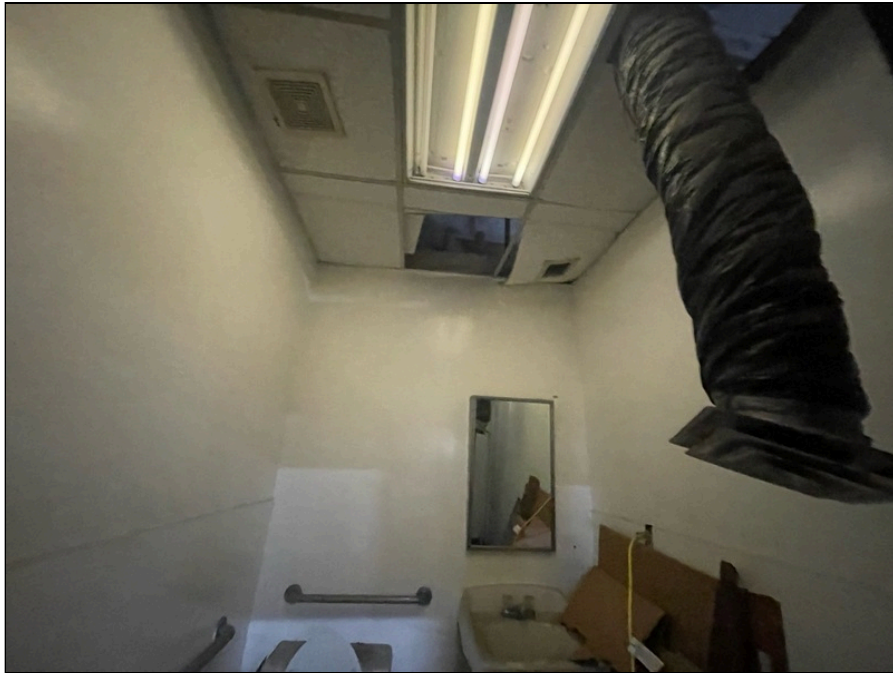
**Photo 59:** Bathroom finishes, first floor

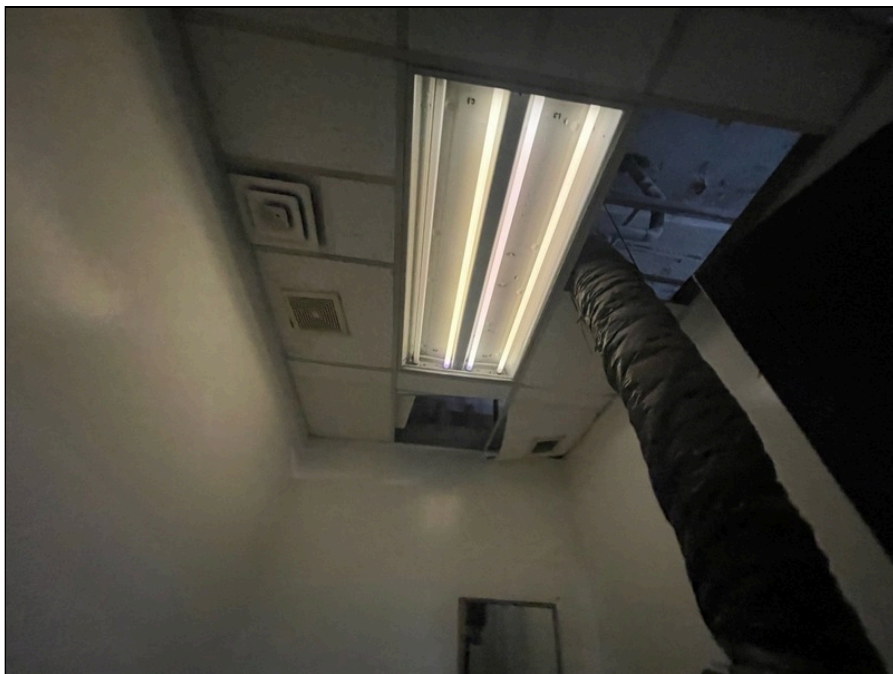
**Photo 60:** Bathroom finishes, first floor

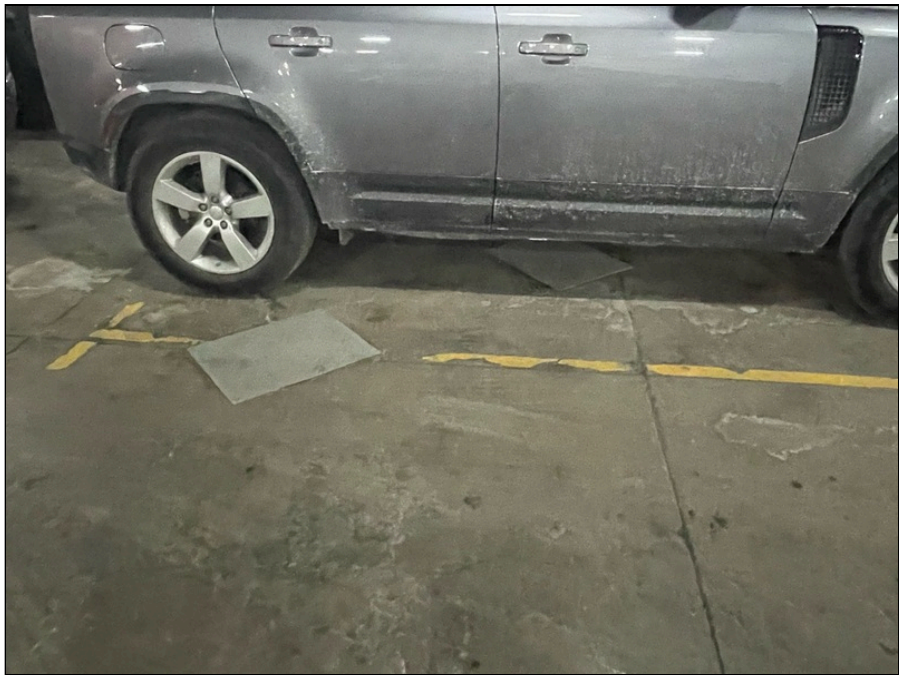
**Photo 61:** First floor parking garage finishes

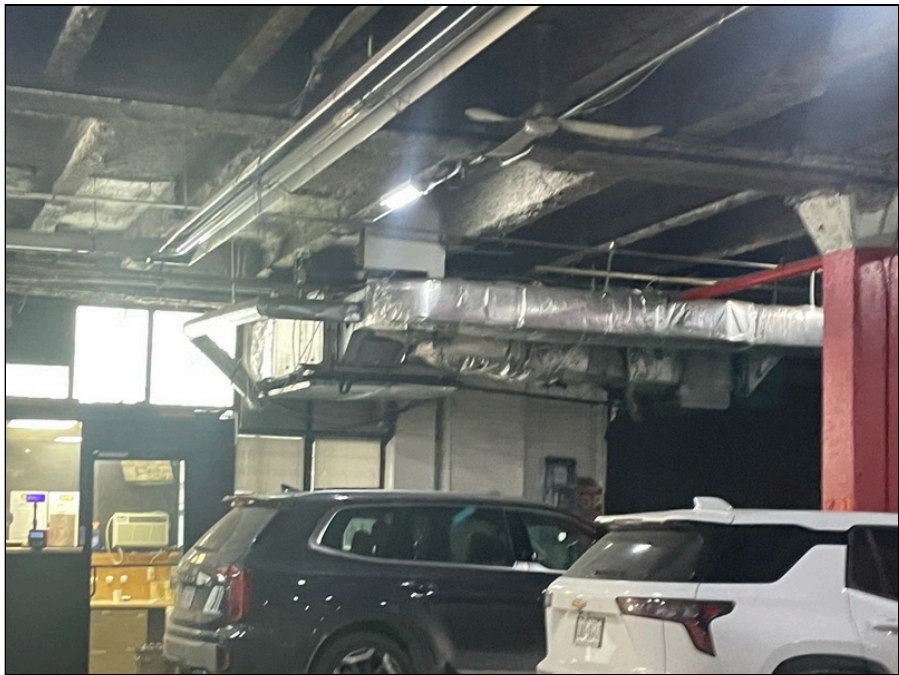
**Photo 62:** First floor HVAC system

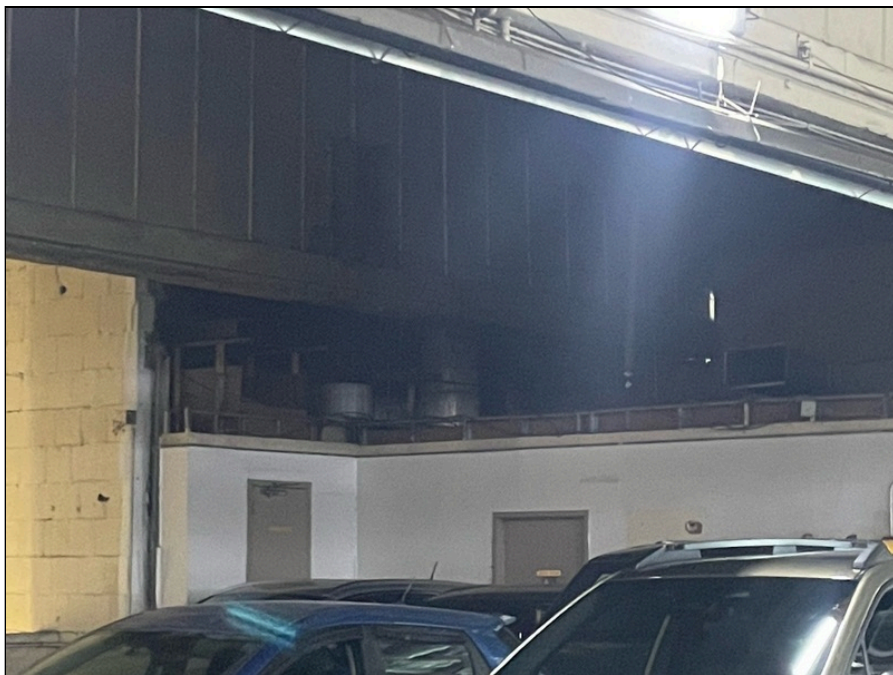
**Photo 135:** Hot water heaters, second floor

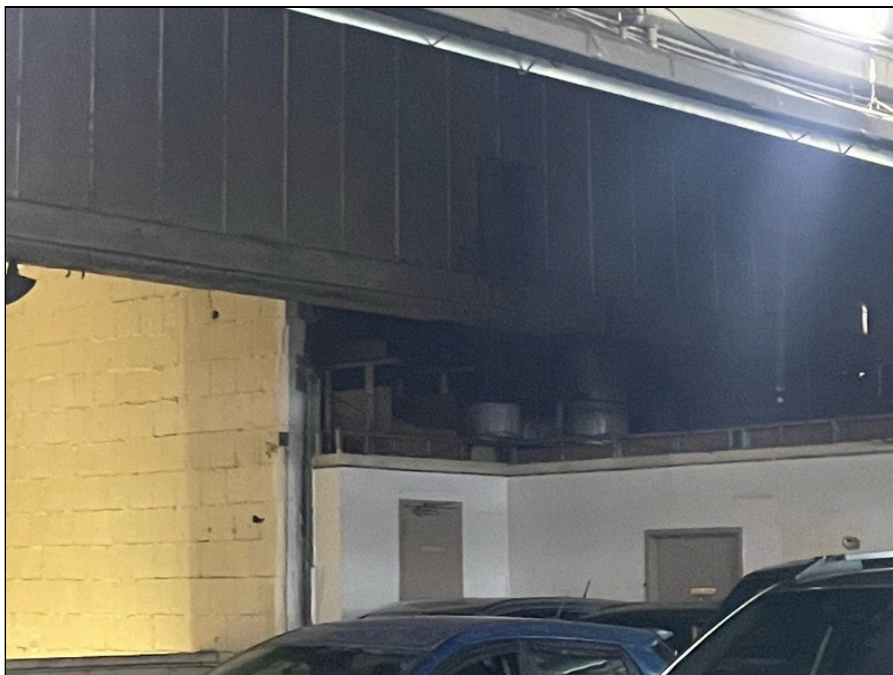
**Photo 137:** Hot water heaters, second floor

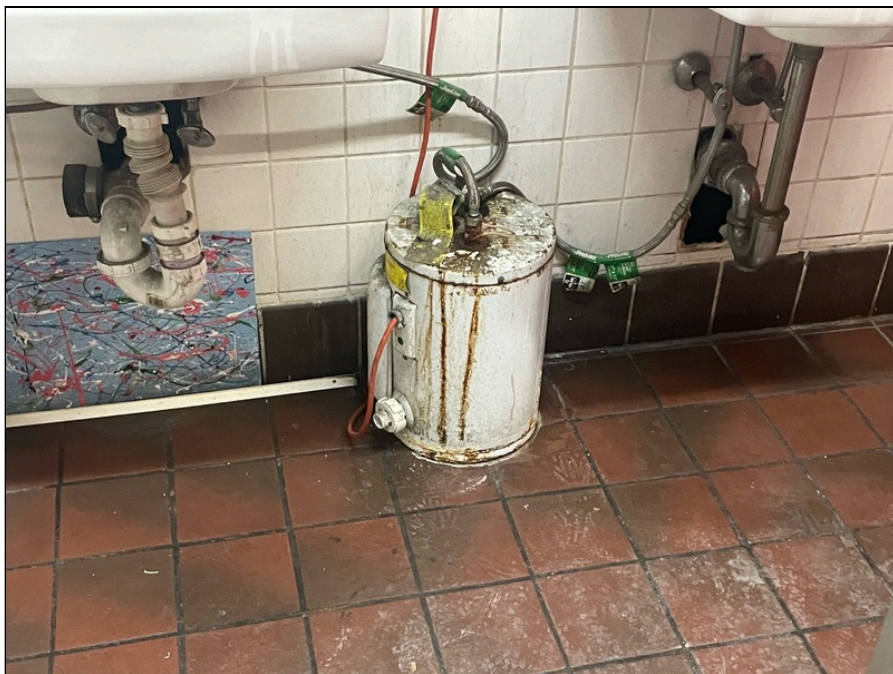
**Photo 138:** Hot water heaters, second floor

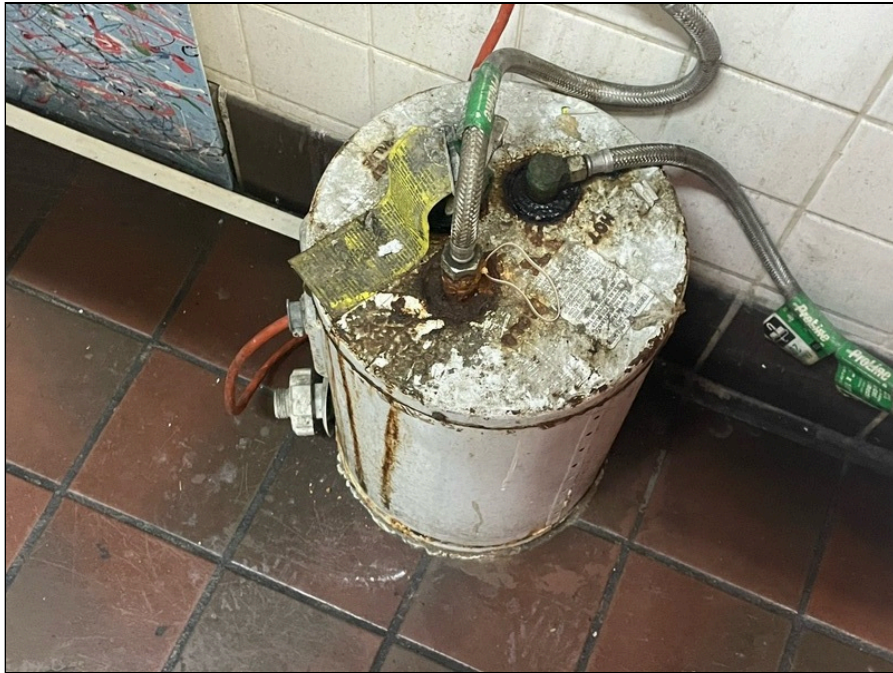
**Photo 139:** Hot water heaters, second floor

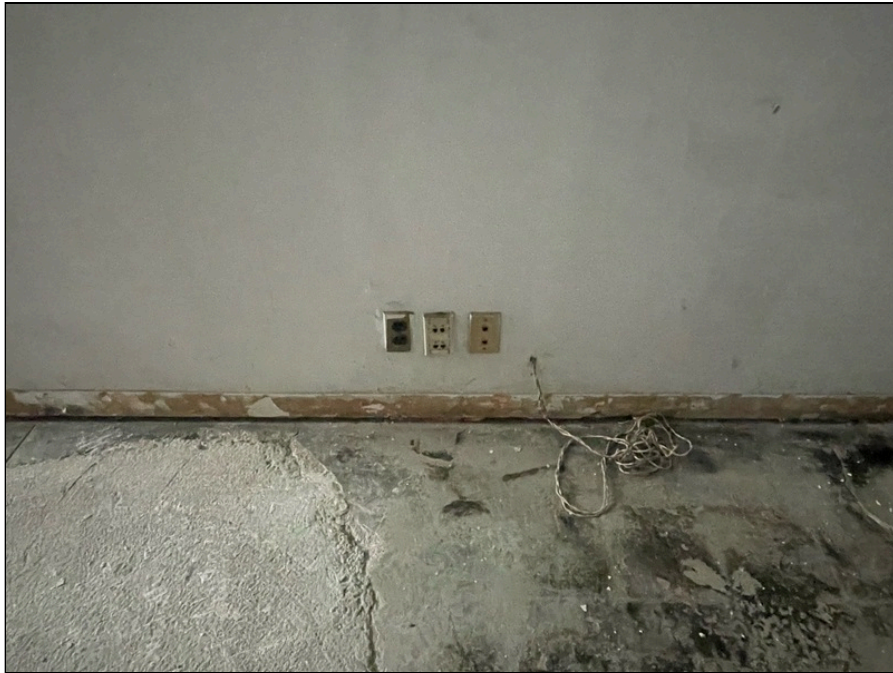
**Photo 157:** Second floor finishes

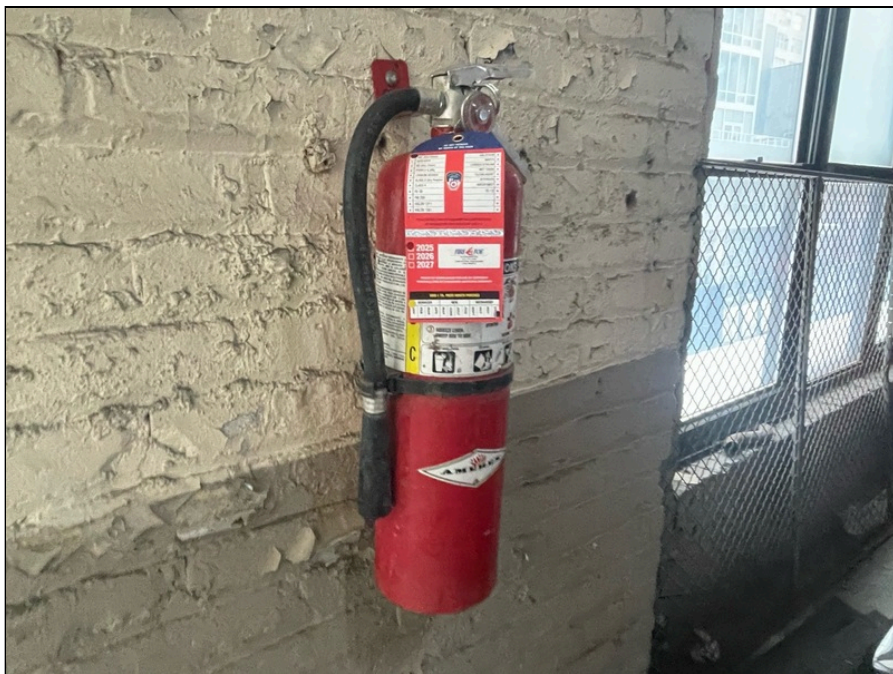
**Photo 158:** Fire extinguisher, second floor

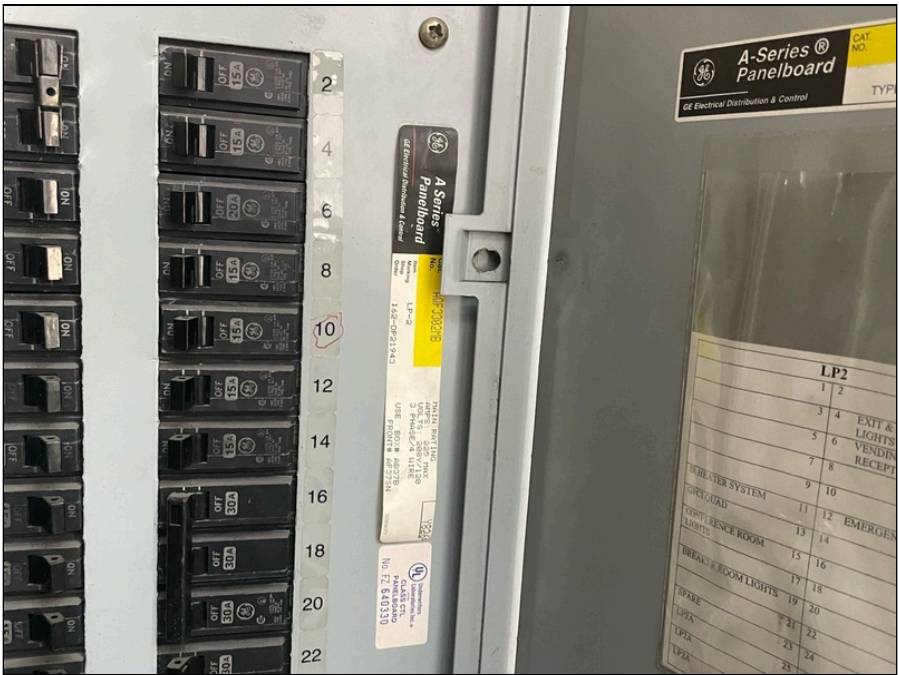
Photo 160: First floor electric panel

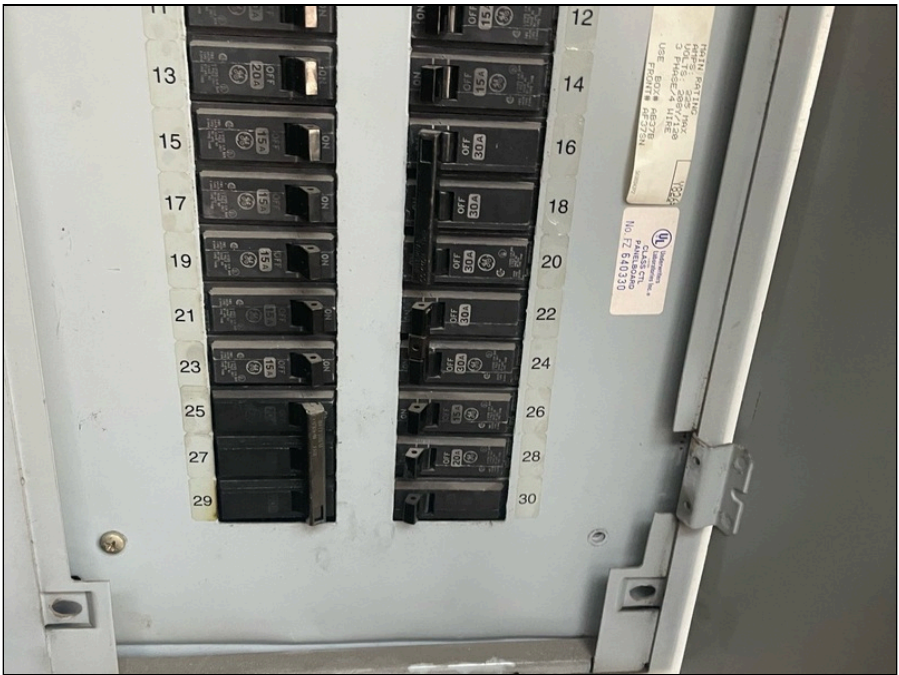
Photo 161: First floor electric panel

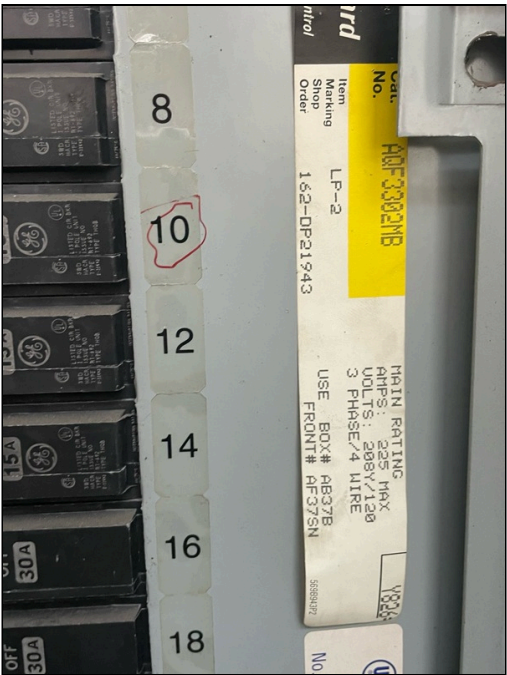
Photo 162: First floor electric panel

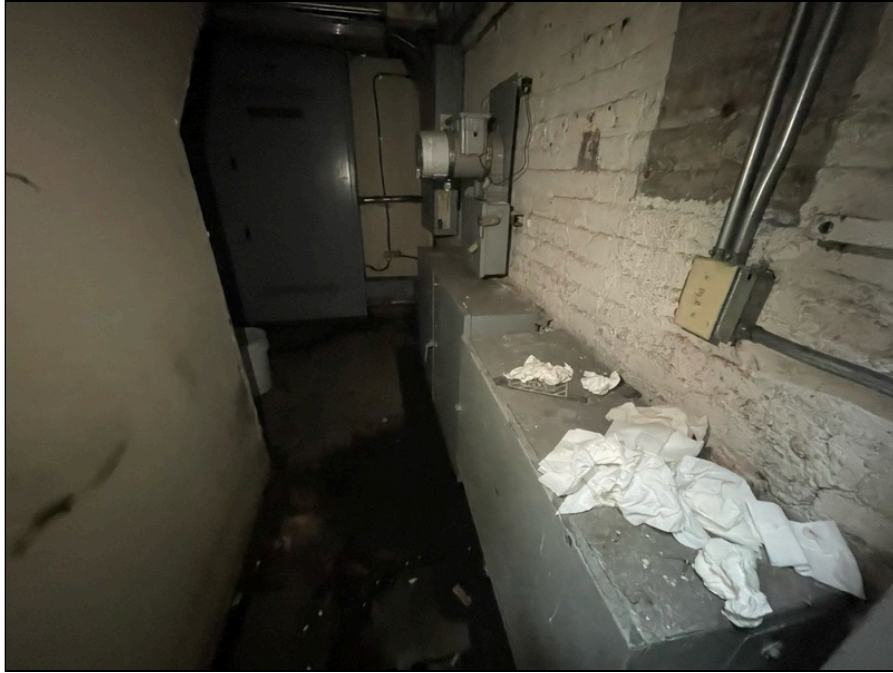
**Photo 163:** First floor electric room

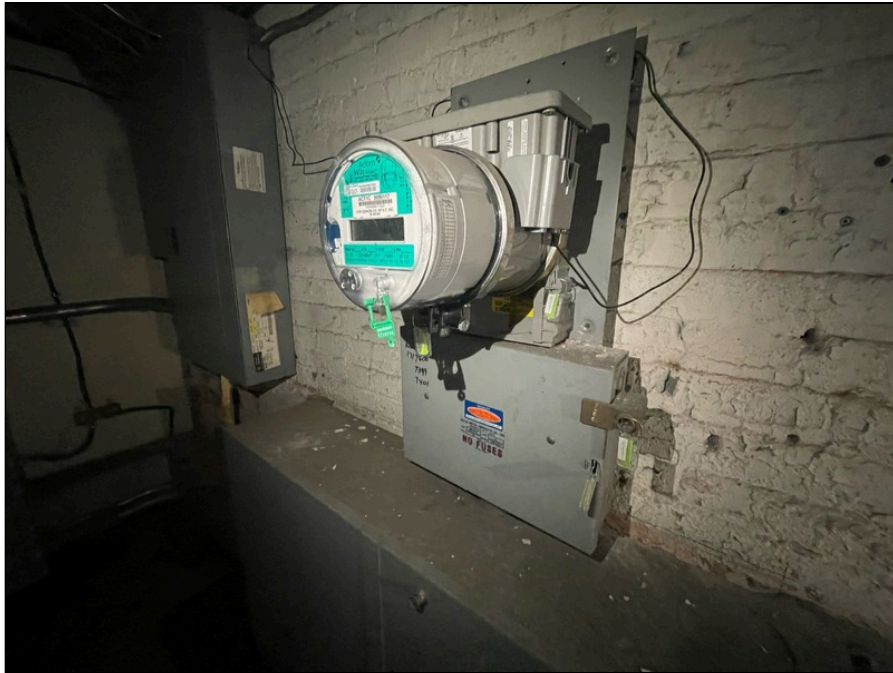
**Photo 165:** Electric meter, first floor

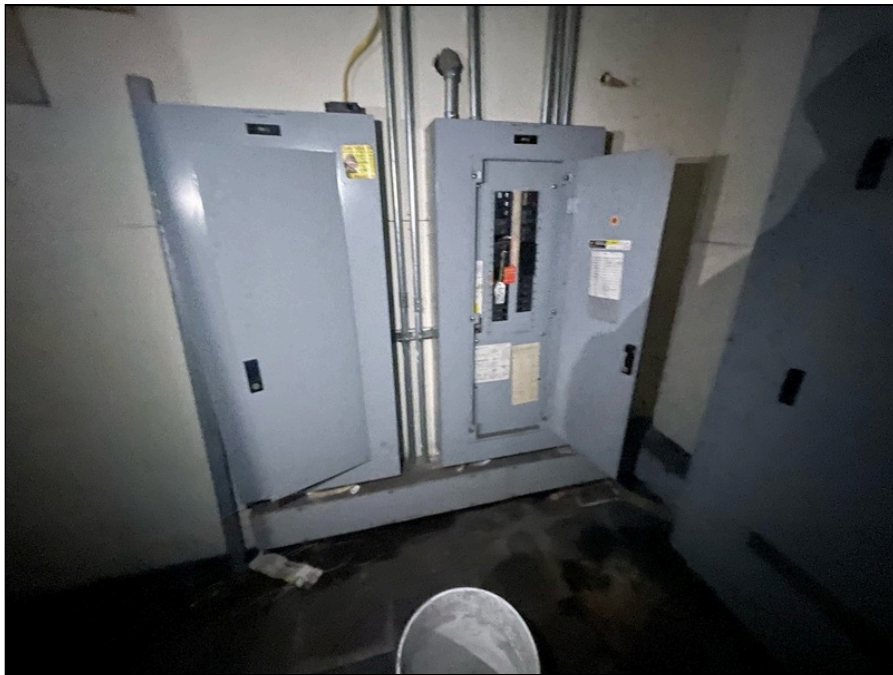
**Photo 166:** Main electric panels, first floor

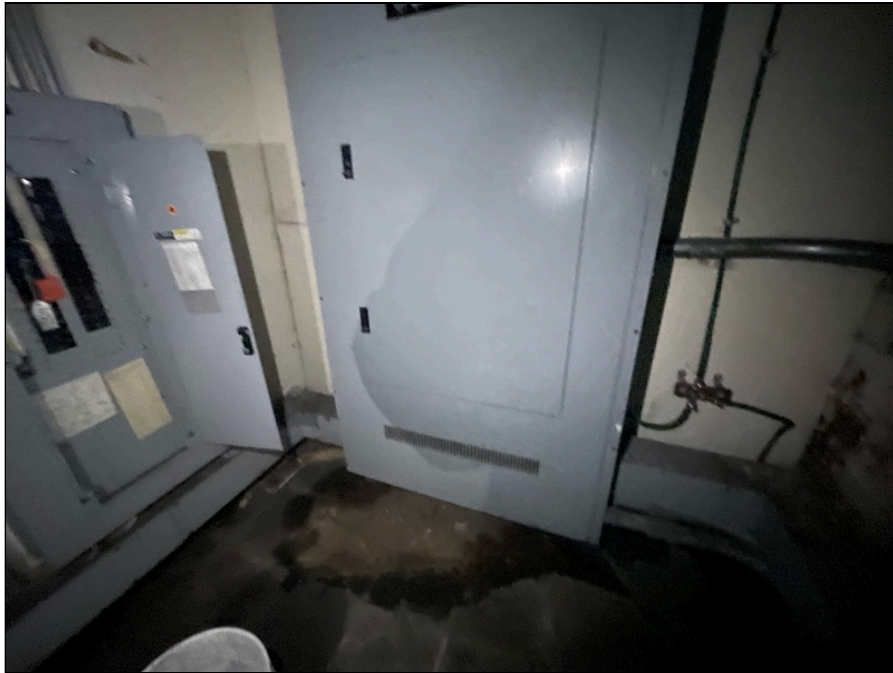
**Photo 167:** Main electric panels, first floor

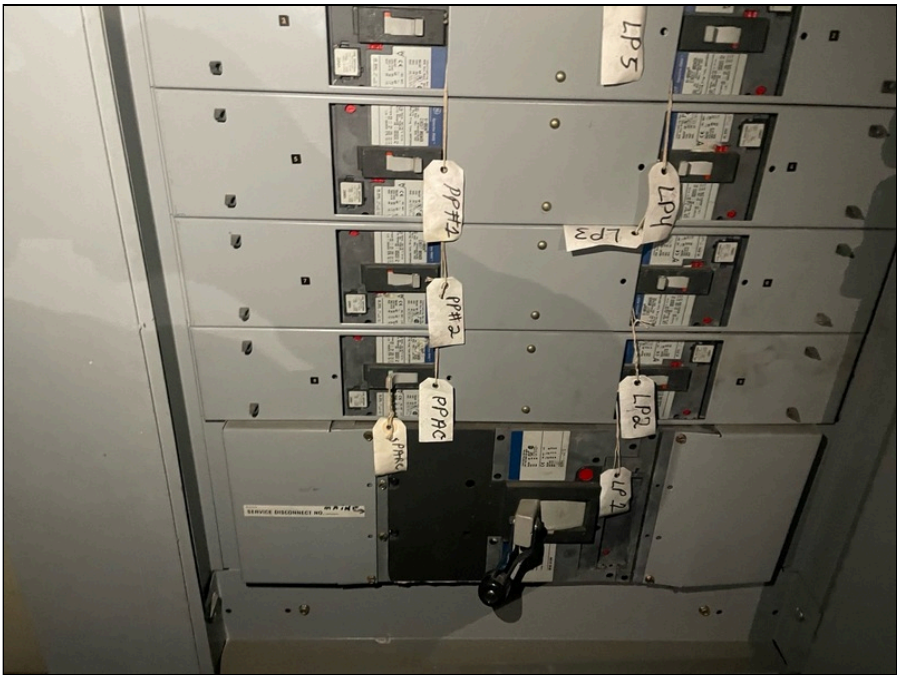
Photo 170: Main electric panels, first floor

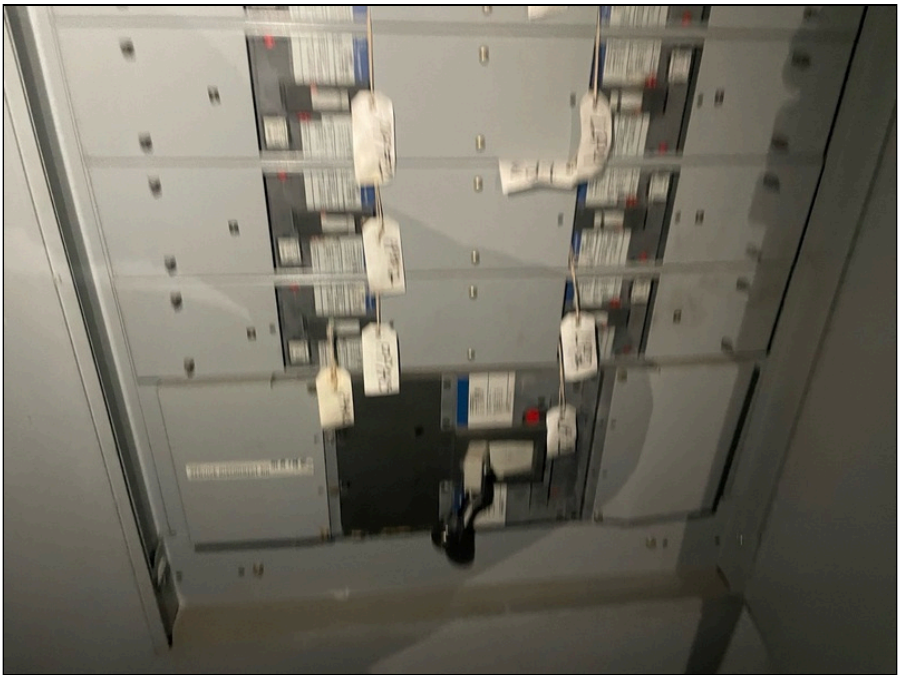
Photo 171: Main electric panels, first floor

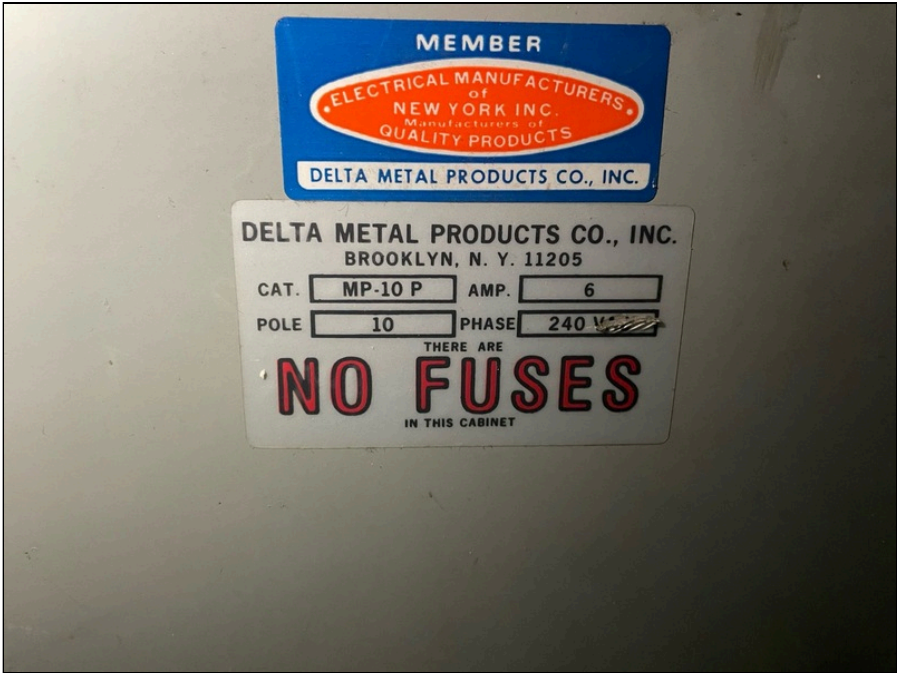
Photo 173: Main electric panels, first floor

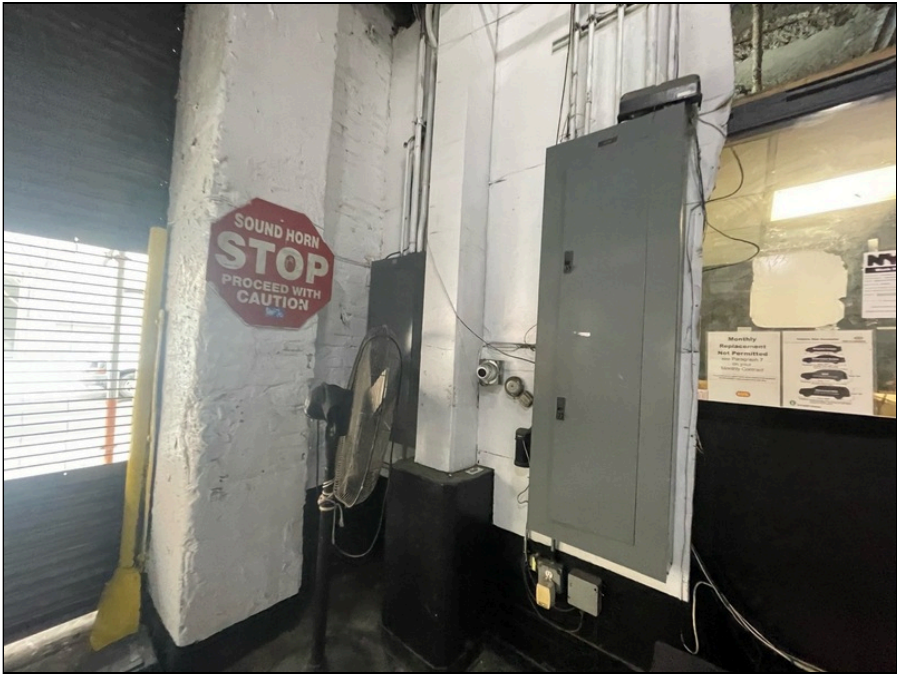
Photo 174: First floor electric panel

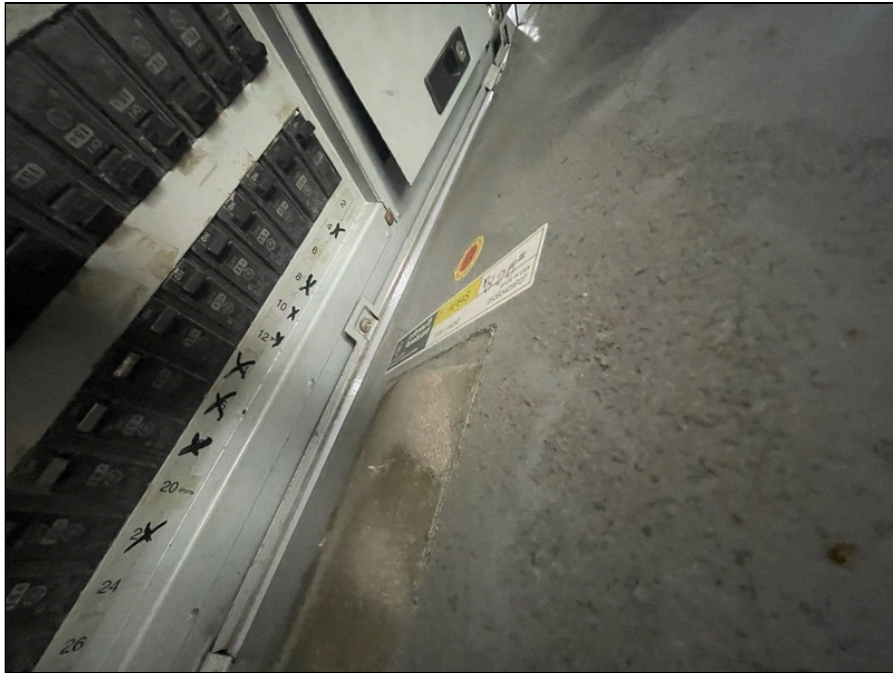
**Photo 175:** First floor electric panel

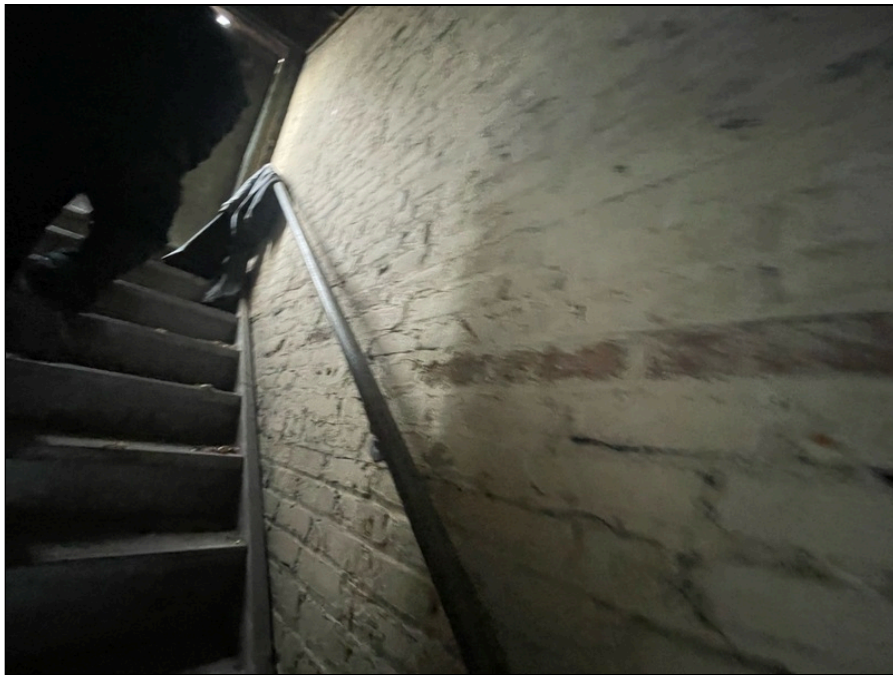
**Photo 176:** Stairwell to the roof
