**ASTM E2018-24 PROPERTY CONDITION ASSESSMENT REPORT (PCR)**

**Commercial Building  
550 West 25th Street  
New York, New York 10001**

**Project Number:  
26.01121.10**

**Conditions as of:  
February 6, 2026**

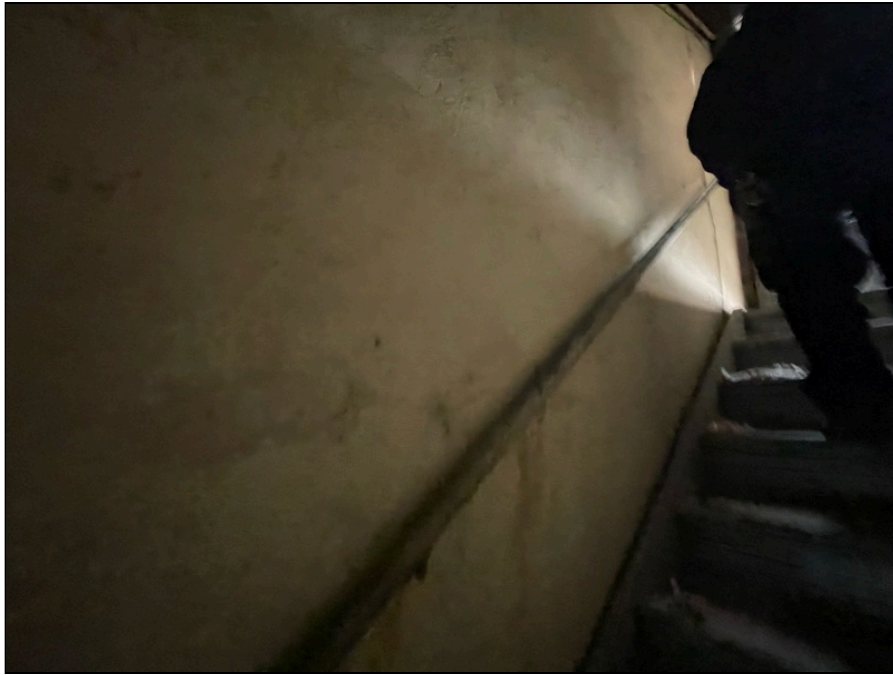
**Photo 177:** Stairwell to the roof

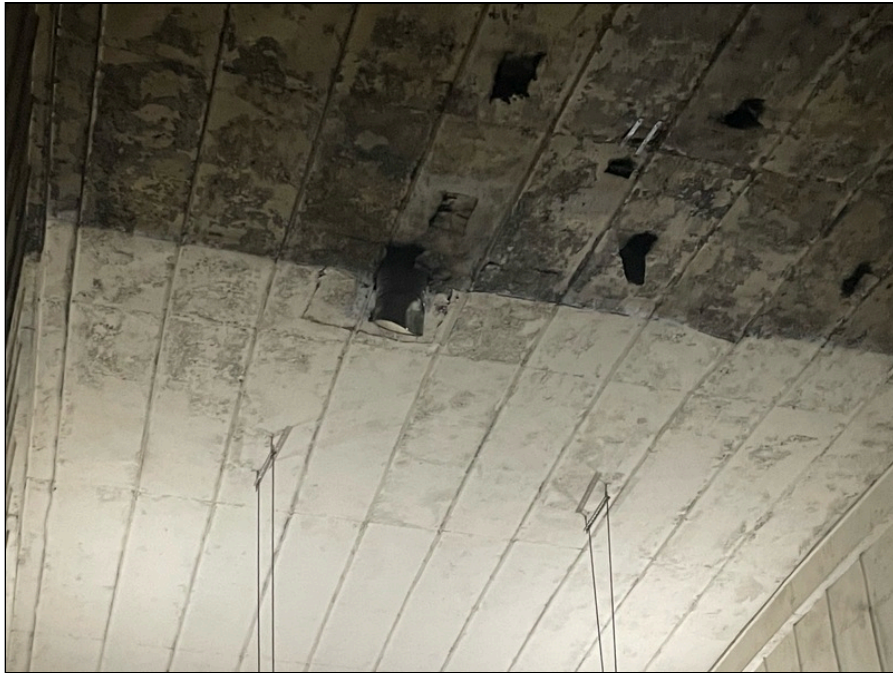
**Photo 201:** Second floor finishes

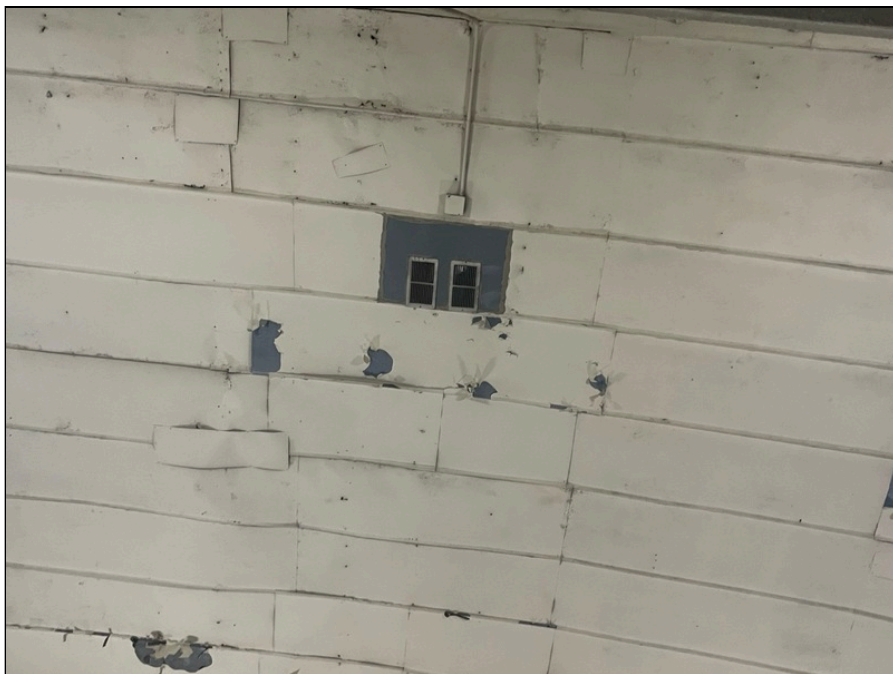
**Photo 202:** Second floor finishes

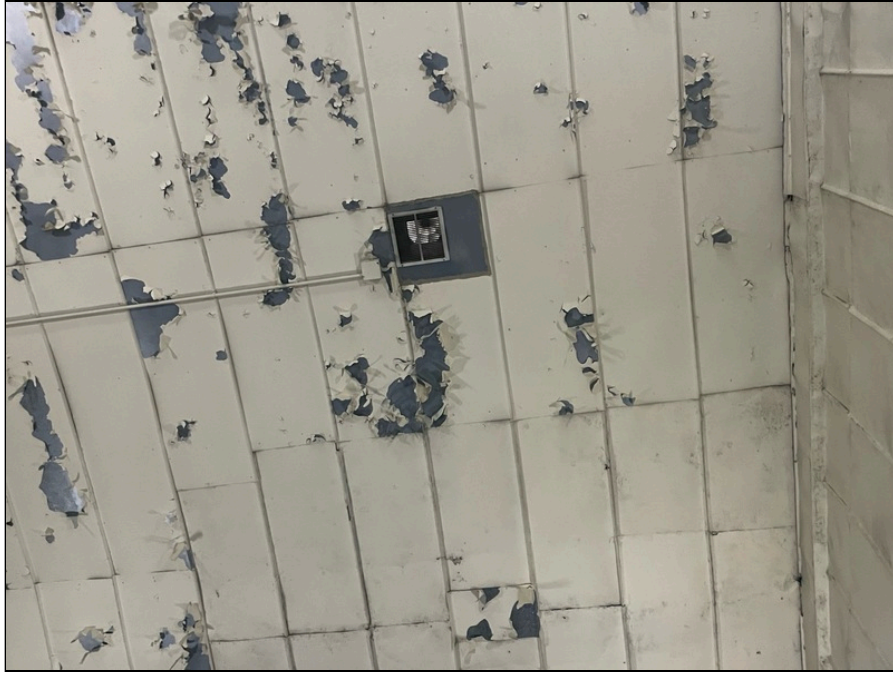
**Photo 203:** Second floor finishes
