**ASTM E2018-24 PROPERTY CONDITION ASSESSMENT REPORT (PCR)**

**Commercial Building  
550 West 25th Street  
New York, New York 10001**

**Project Number:  
26.01121.10**

**Conditions as of:  
February 6, 2026**

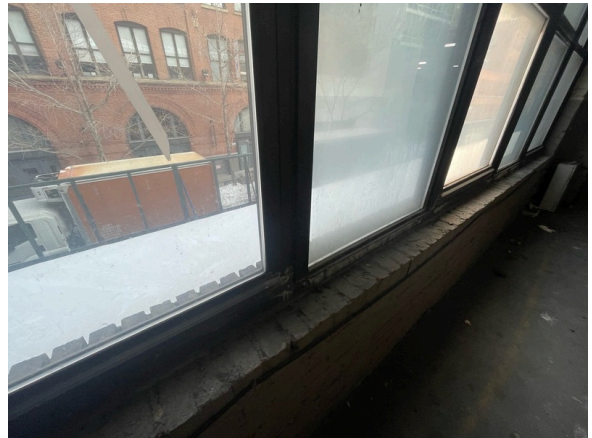
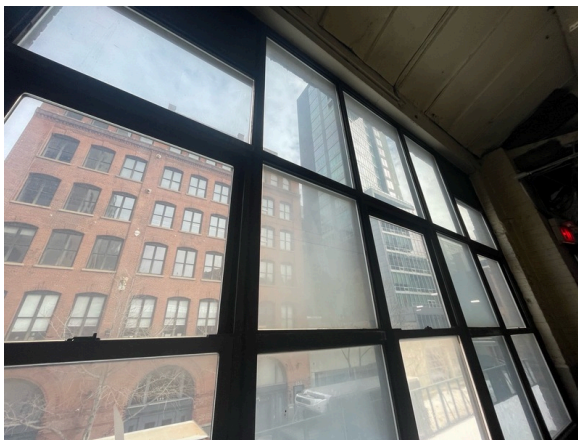
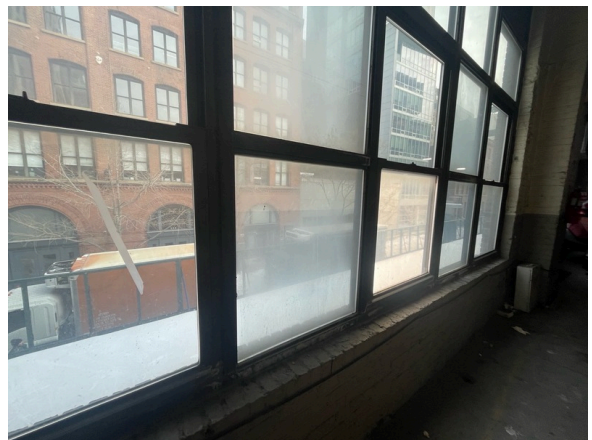
6. The building includes single-pane double hung and casement style windows along the second floor of the building. Windows were observed in poor condition with damaged frames, evidence of water infiltration, broken seals and fogging glass. Based on the condition of the windows, LCS recommends the window units be replaced. A cost for this has been included.

Windows

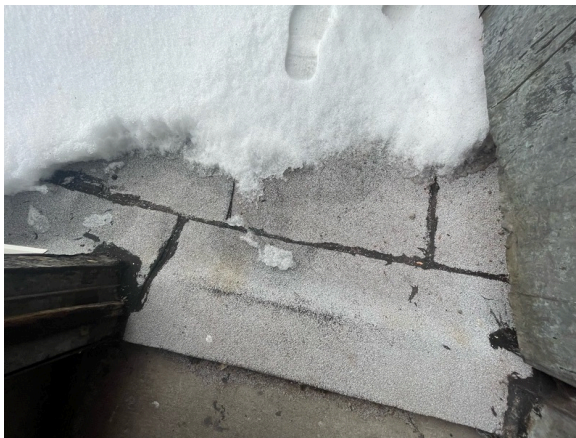
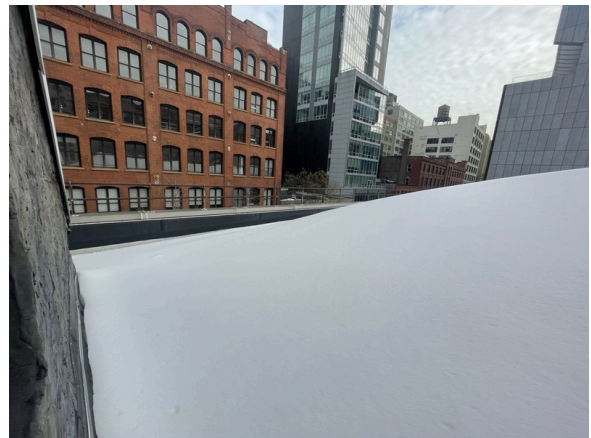
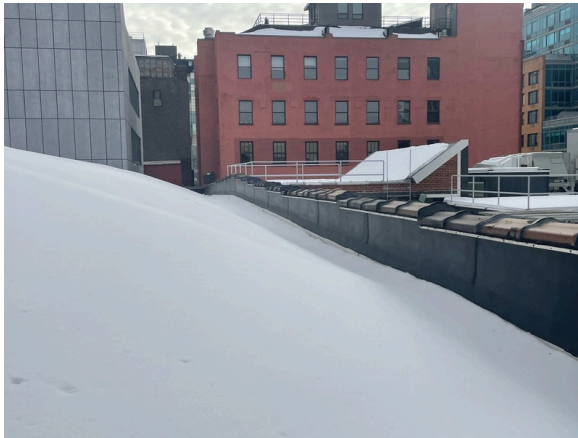
8. LCS observed moderate damage to the parapet wall clay tile coping along the perimeter of the roof. LCS recommends that these areas be repaired to prevent further degradation, a cost for this work has been included.

Roof

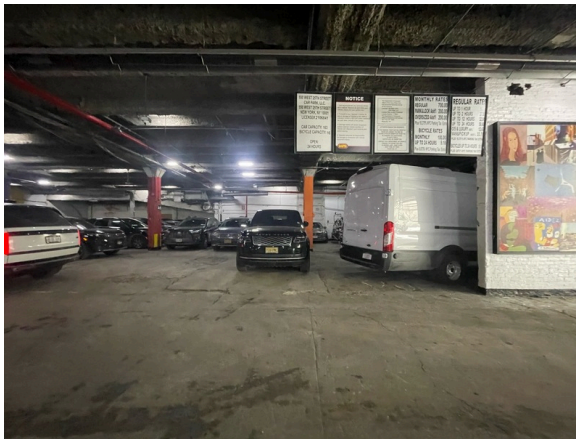
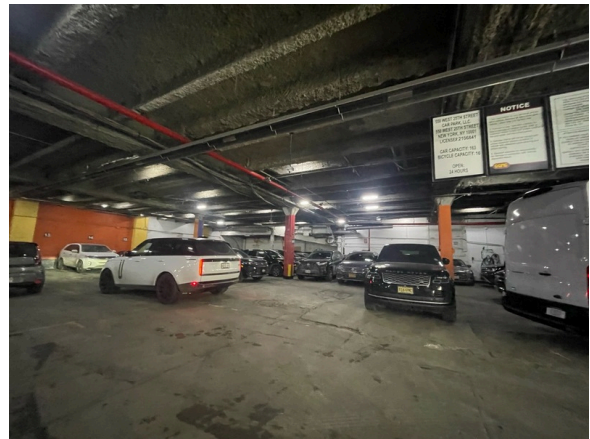
9. The building utilizes four ceiling mounted radiant heaters. At the time of inspection, the units were non operational. LCS recommends that the units be replaced, a cost for this work has been included.

Radiant Heaters

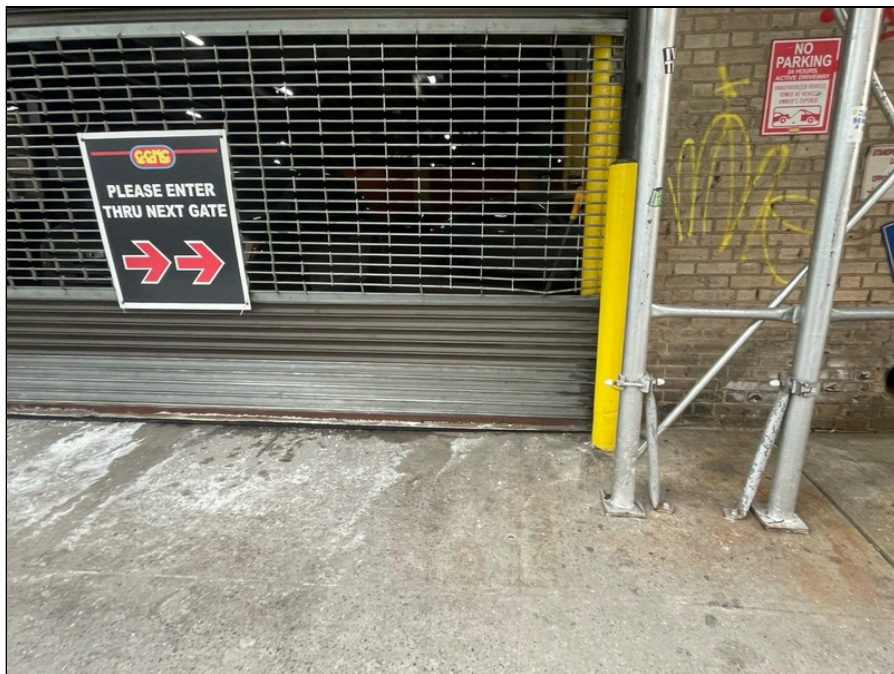
**Photo 6:** North side of the building

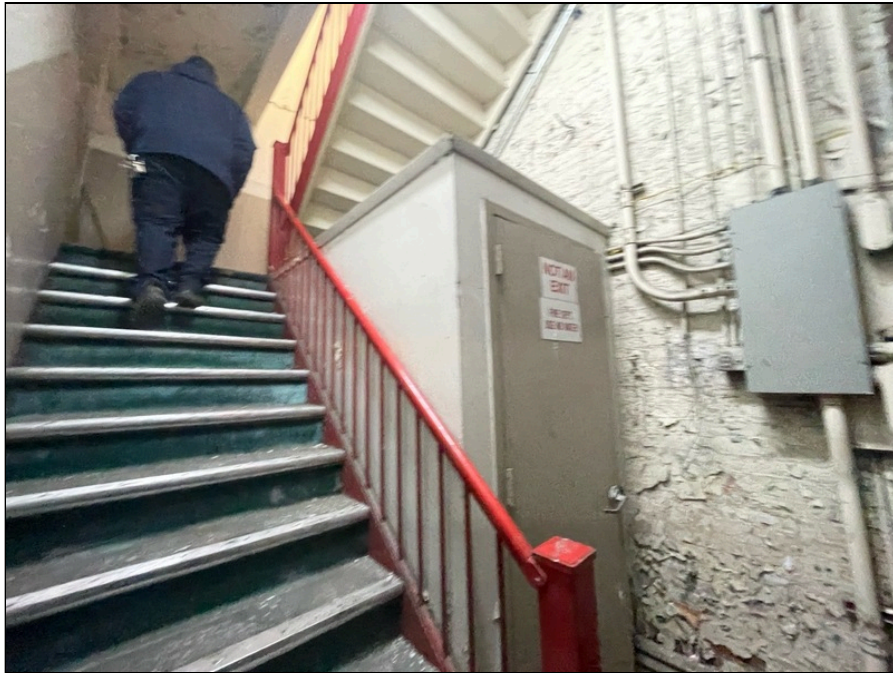
**Photo 63:** Stairwell finishes

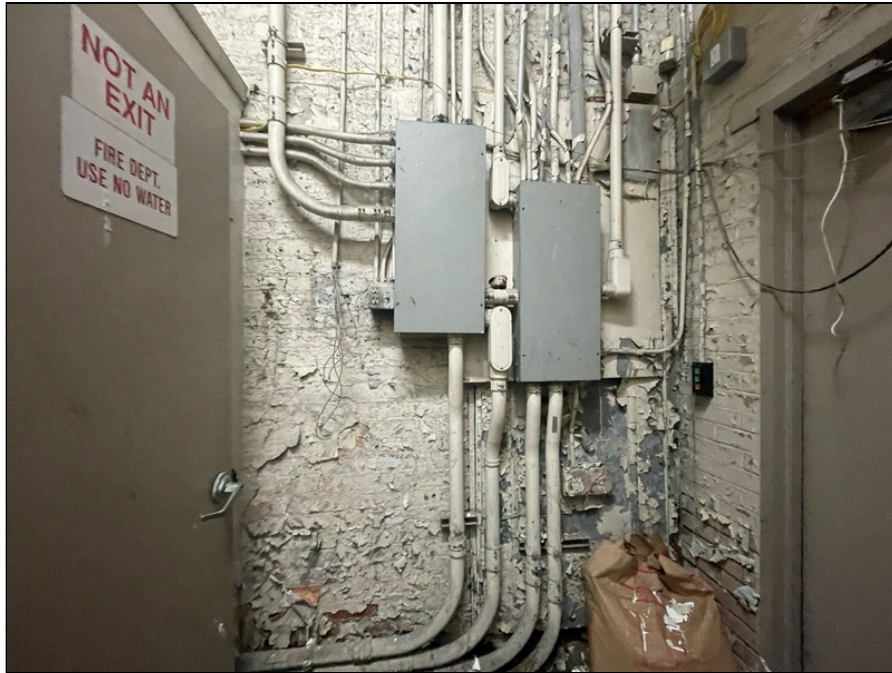
**Photo 65:** Stairwell finishes

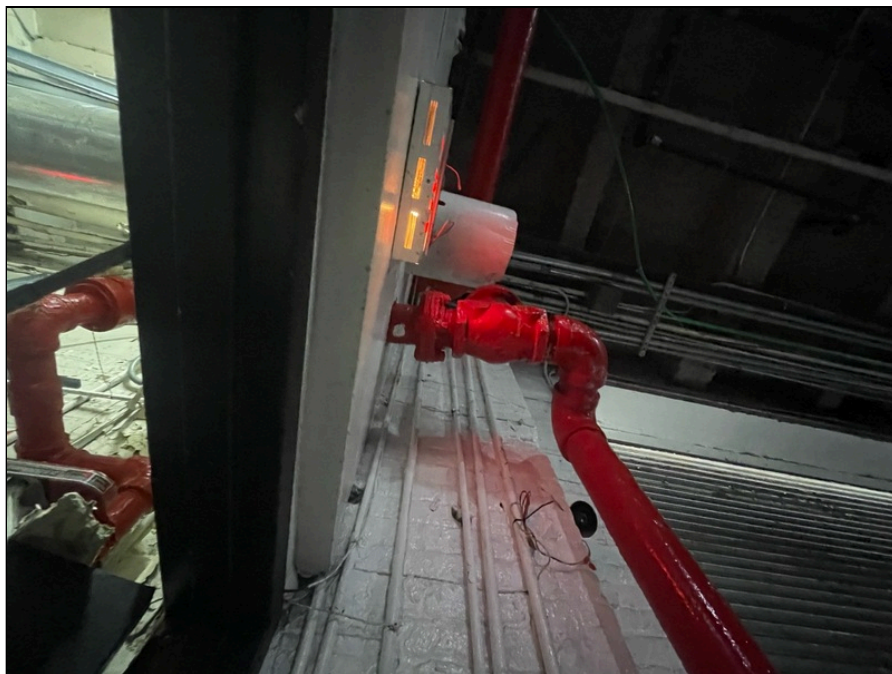
**Photo 66:** Stairwell finishes

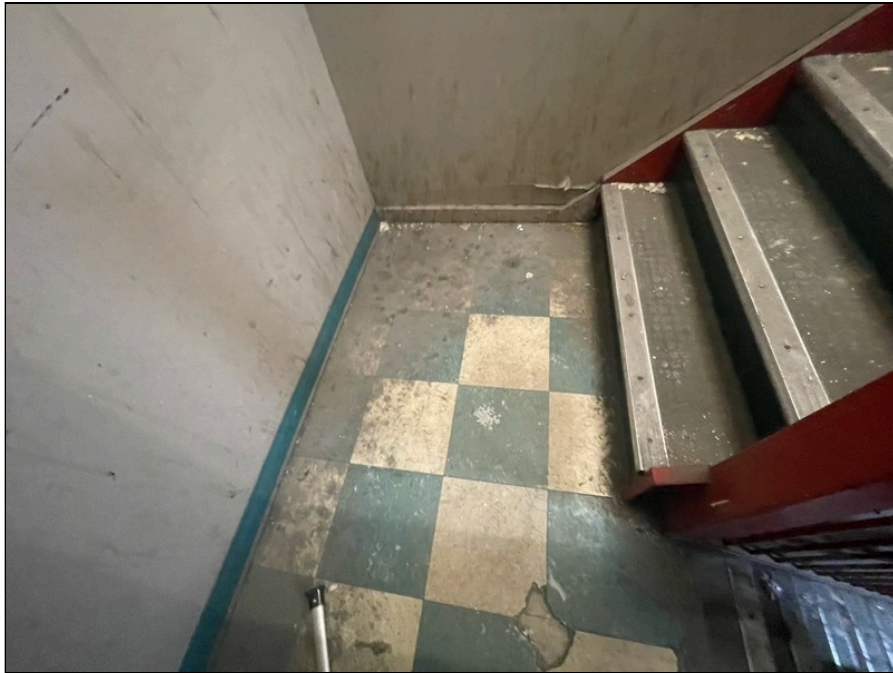
**Photo 67:** Stairwell finishes

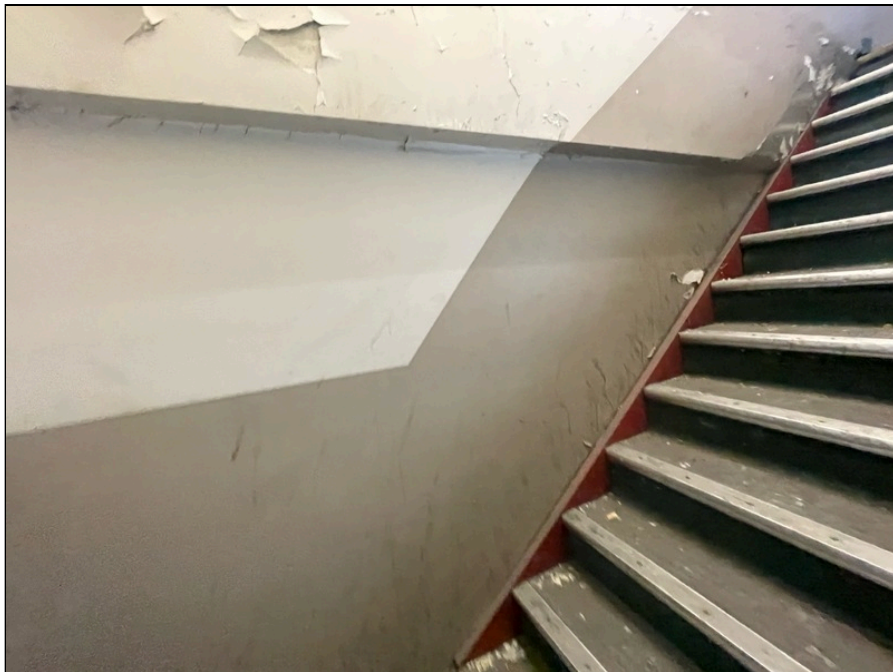
**Photo 68:** Stairwell finishes

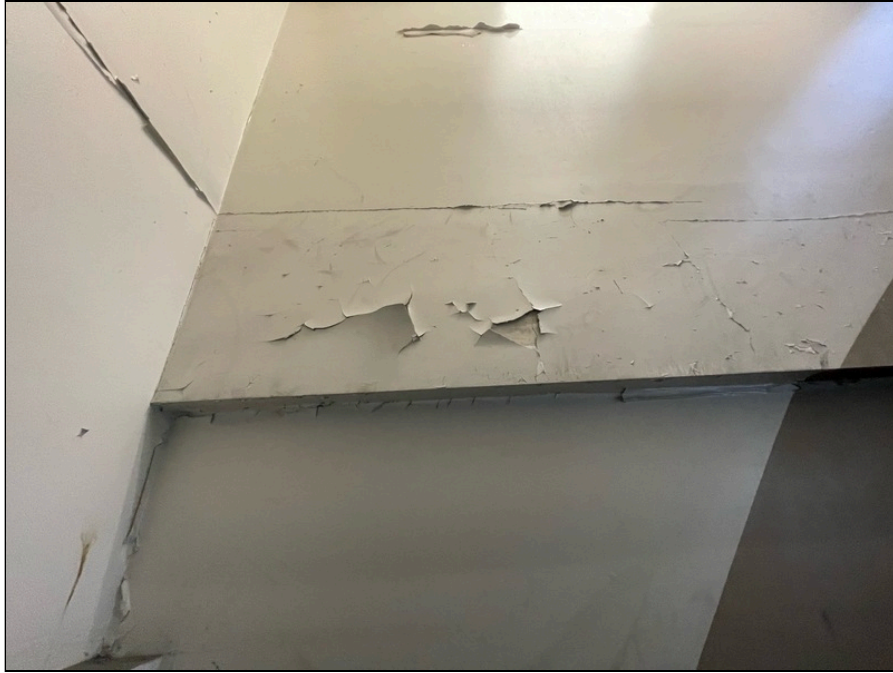
**Photo 69:** Stairwell finishes

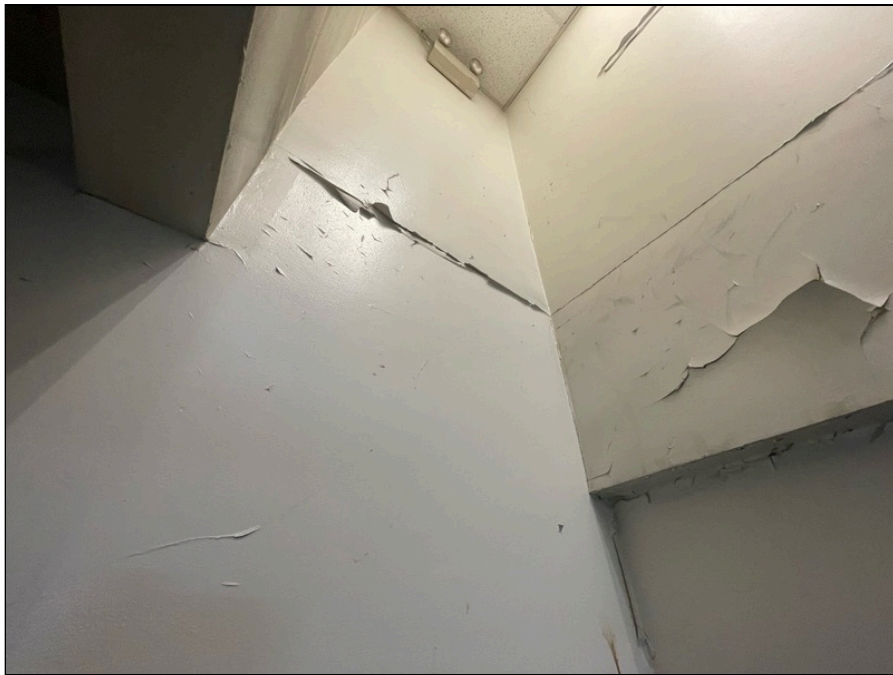
**Photo 70:** Stairwell finishes

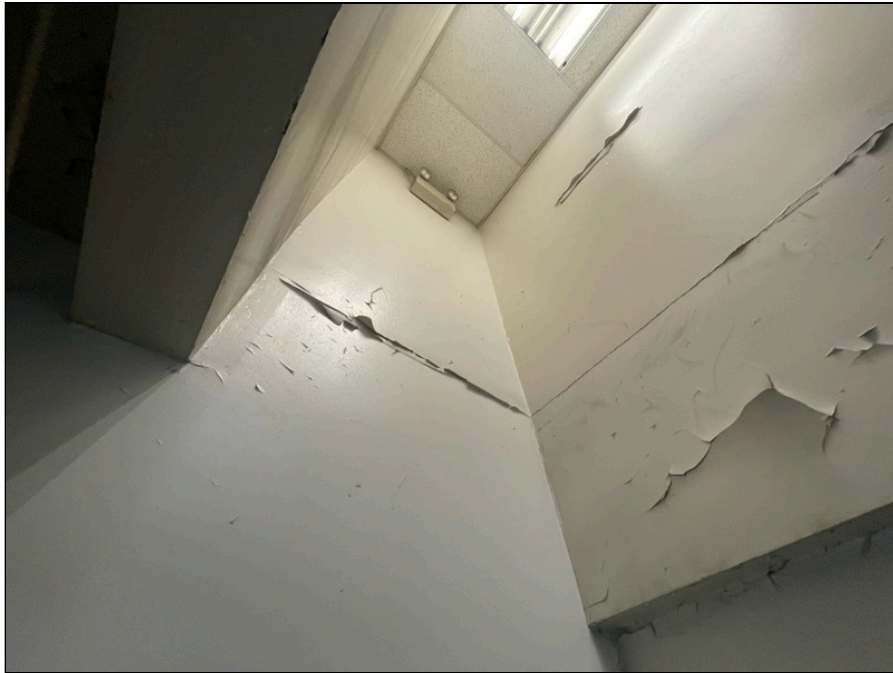
**Photo 71:** Stairwell finishes

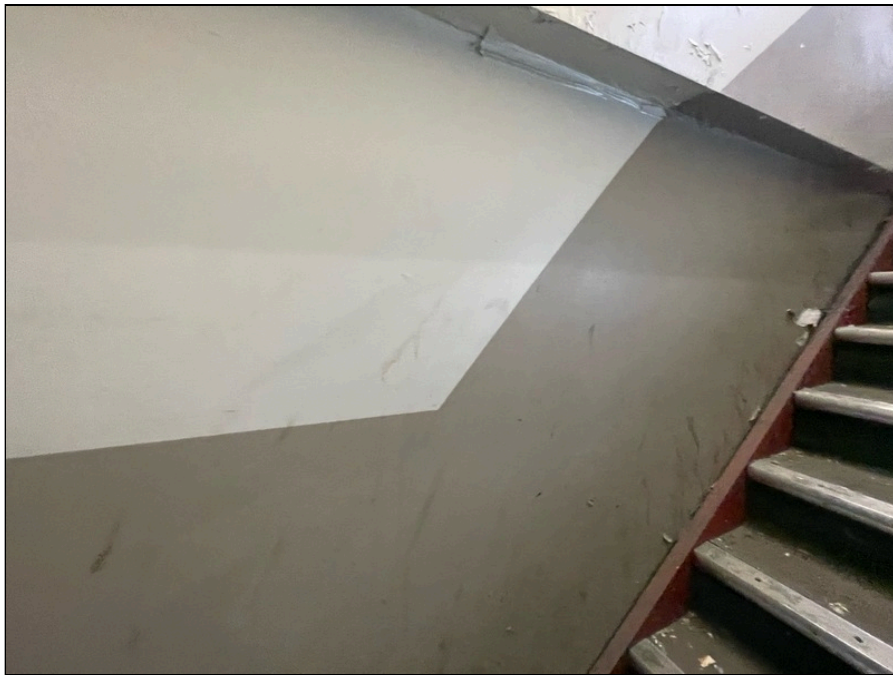
**Photo 72:** Stairwell finishes

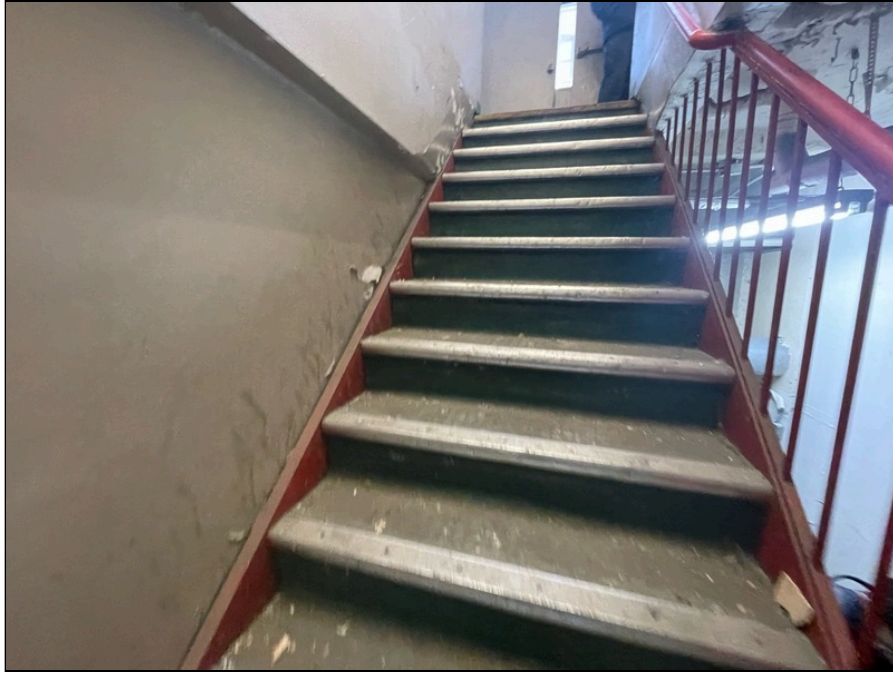
**Photo 73:** Stairwell finishes

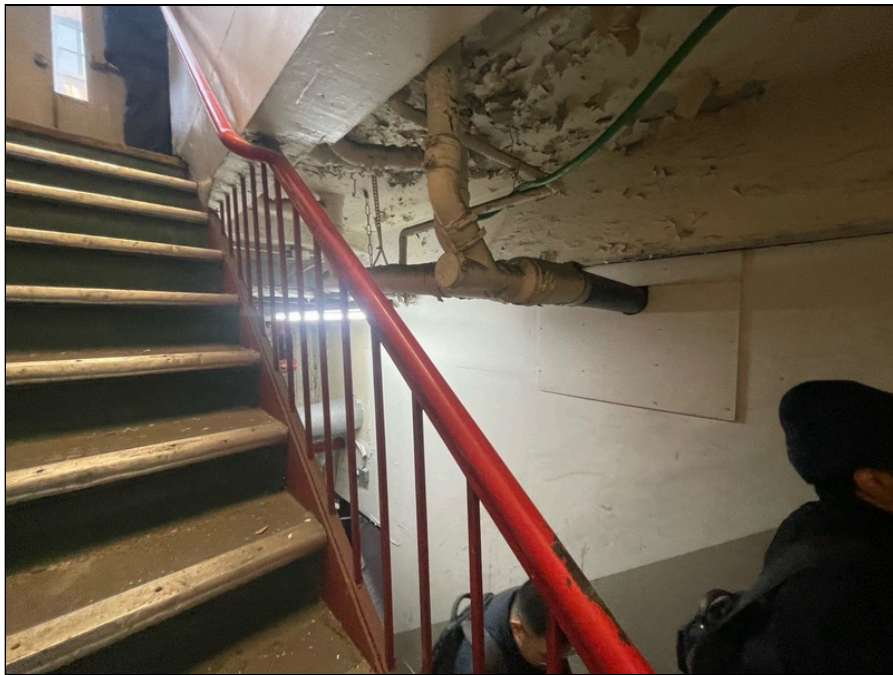
**Photo 74:** Stairwell finishes

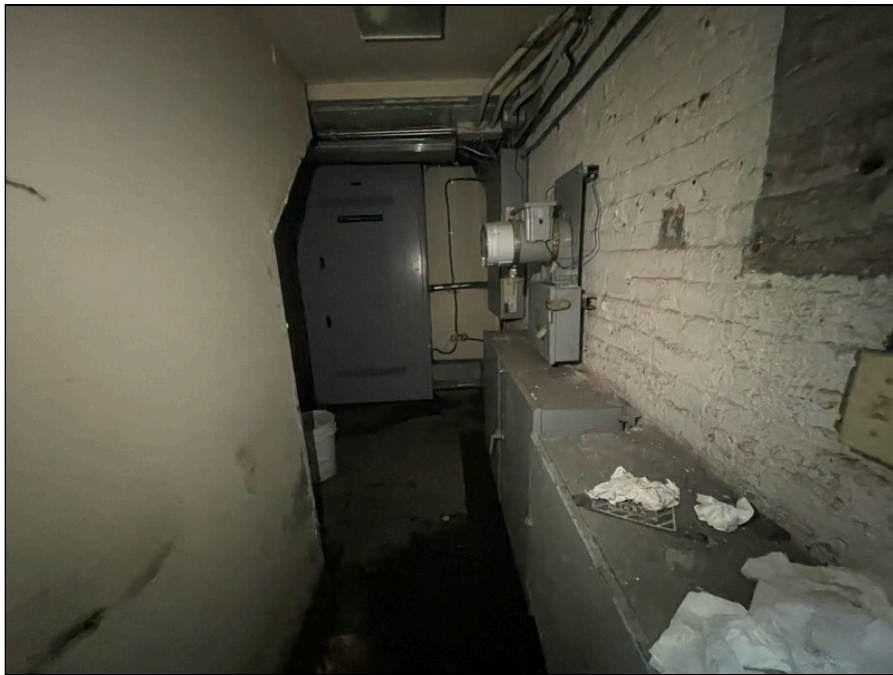
**Photo 164:** First floor electric

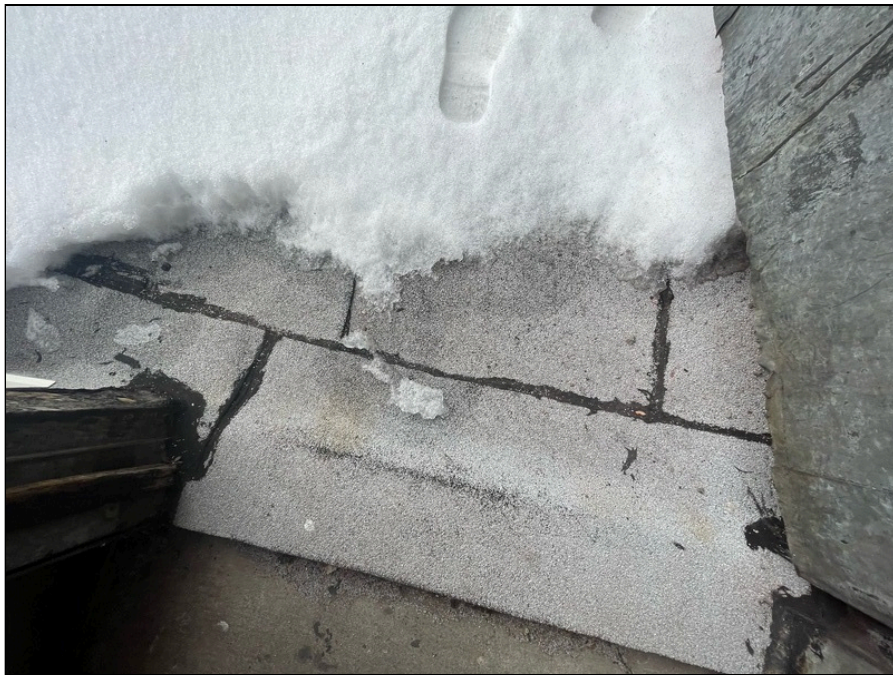
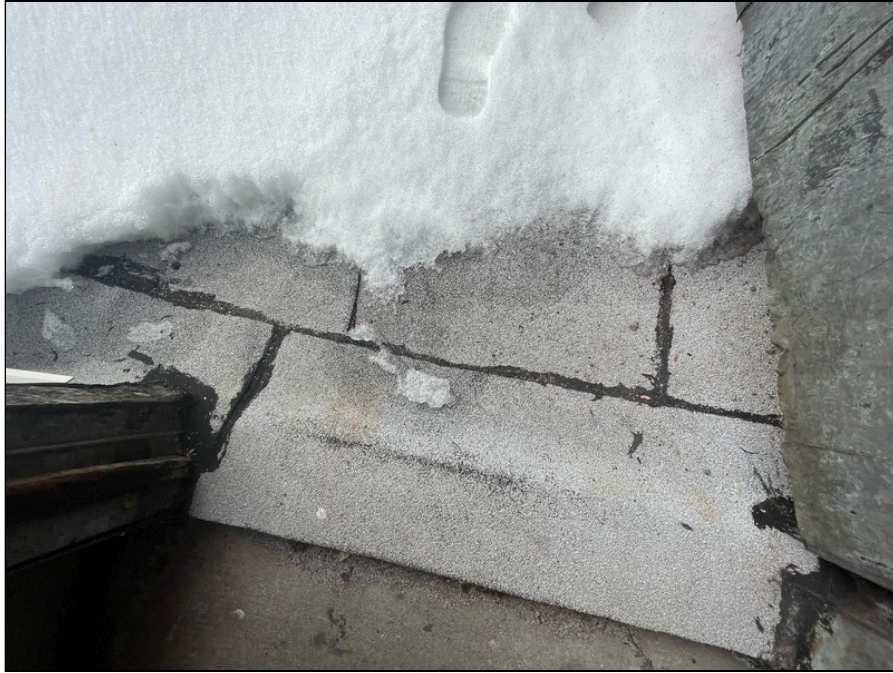
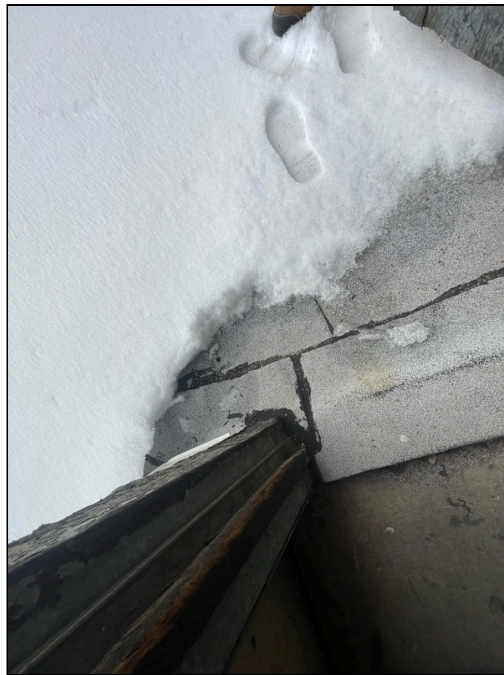
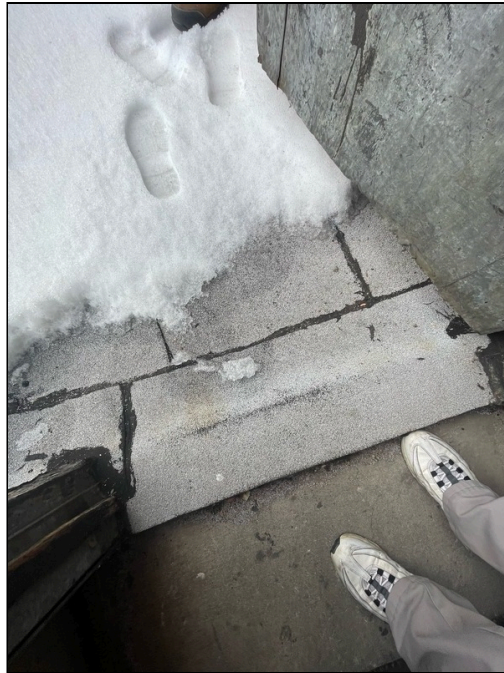
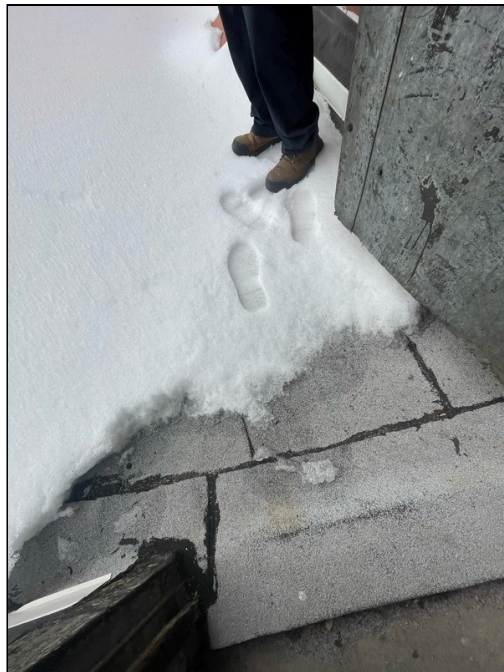
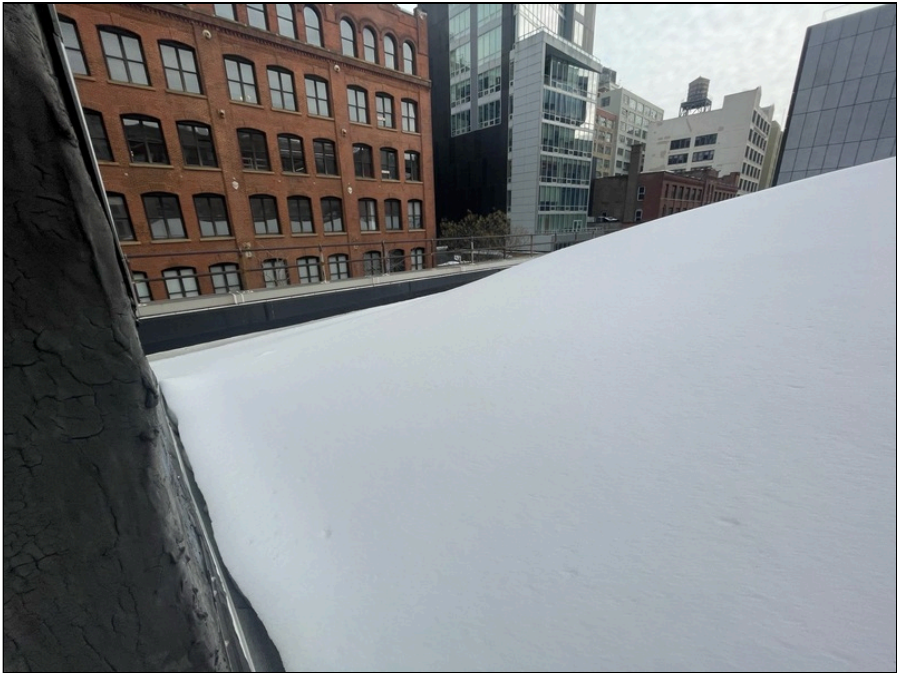
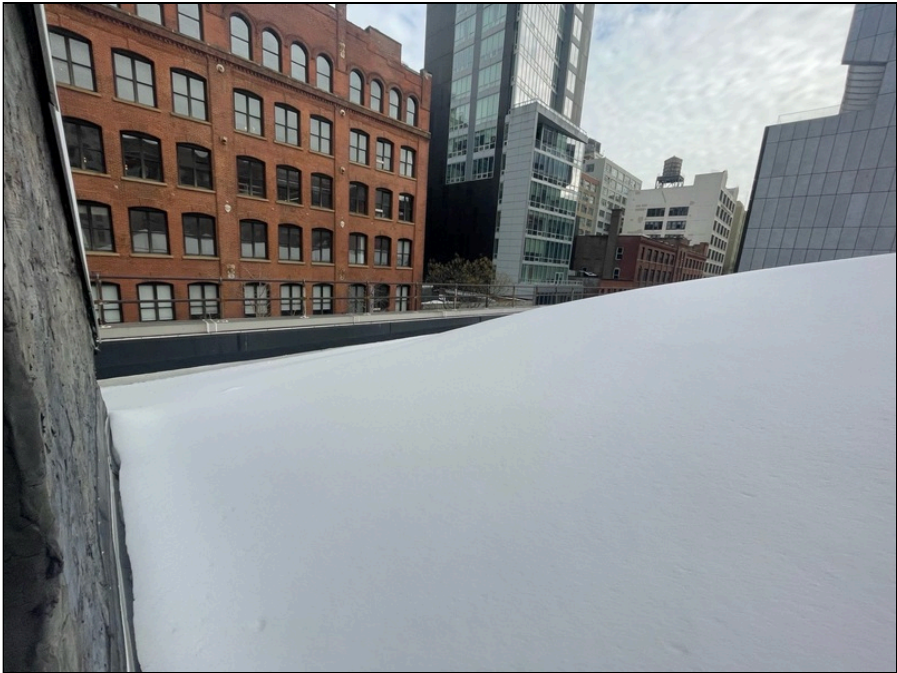
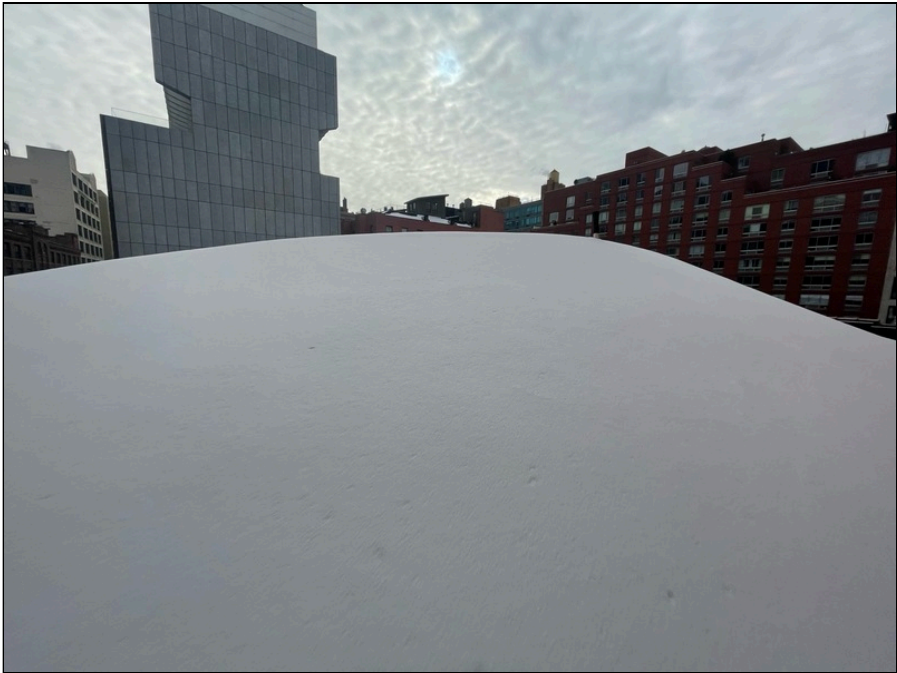
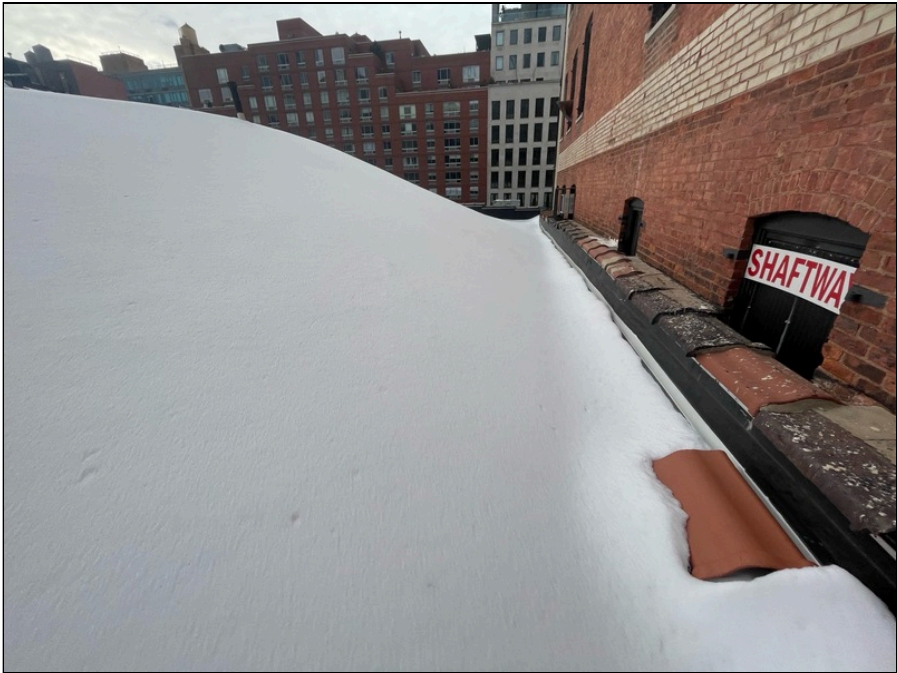
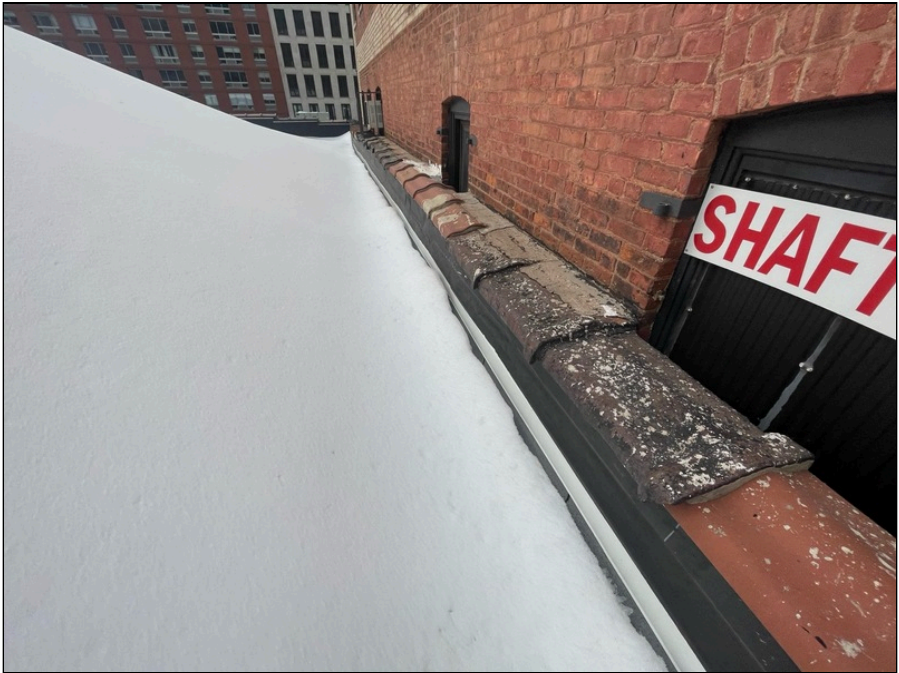
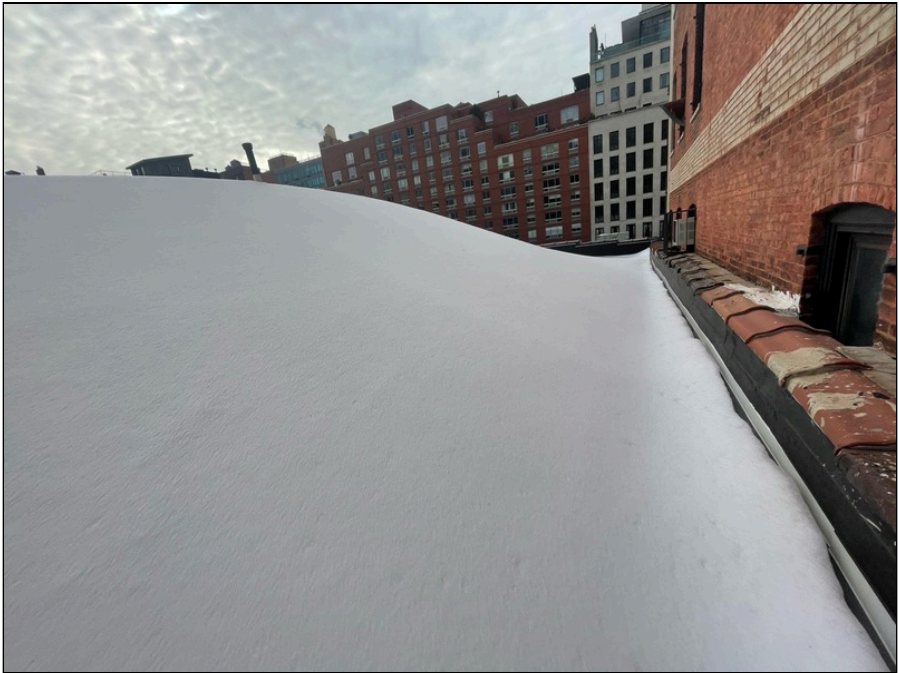
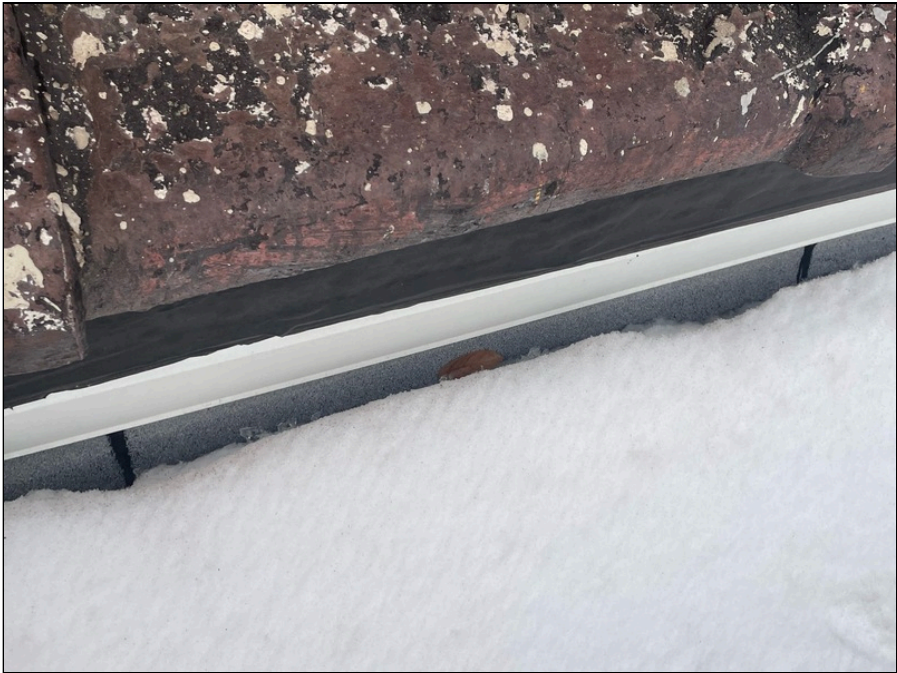
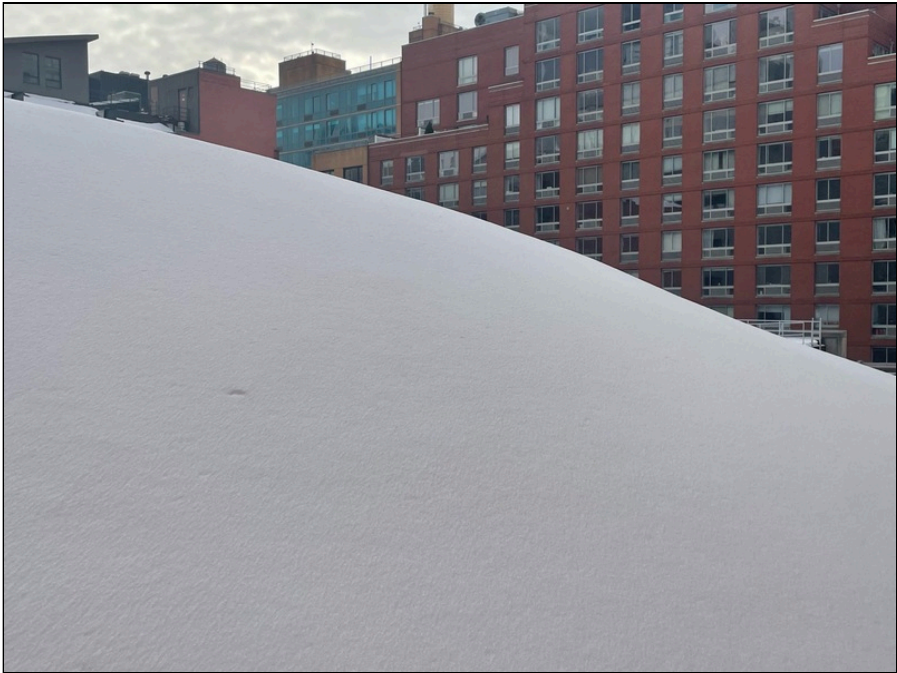
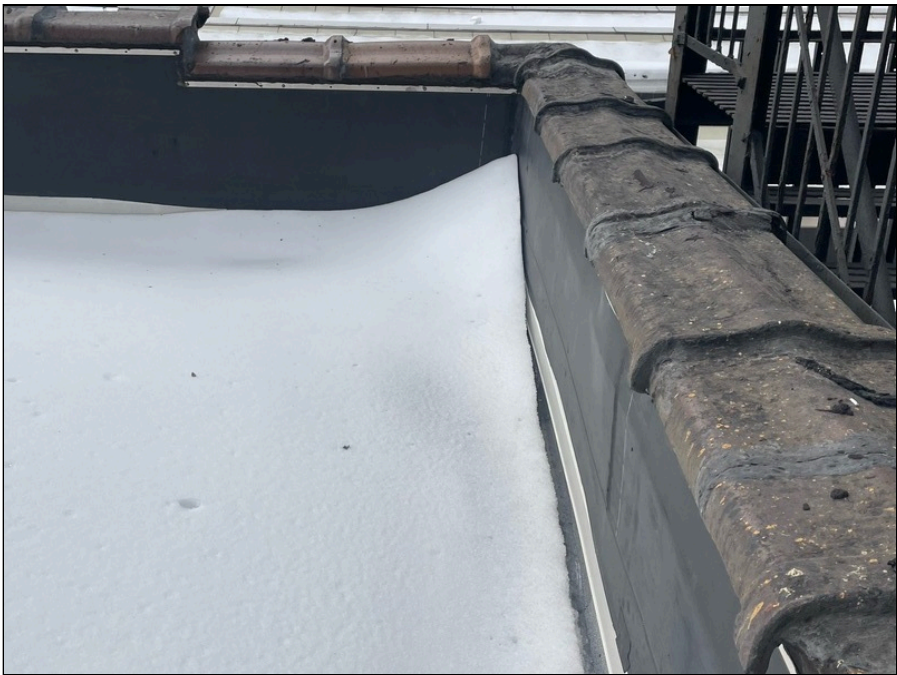
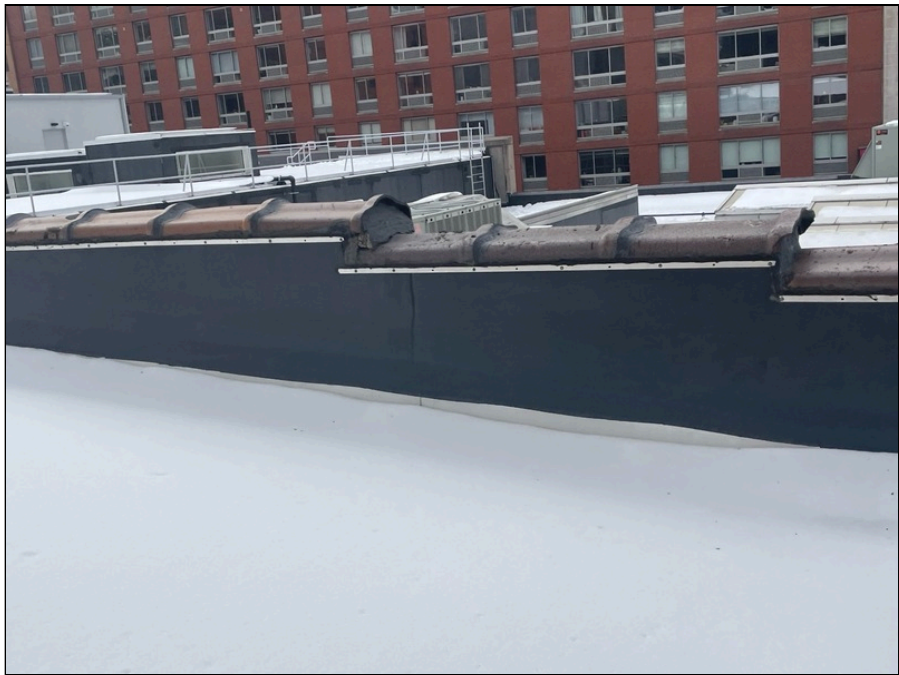
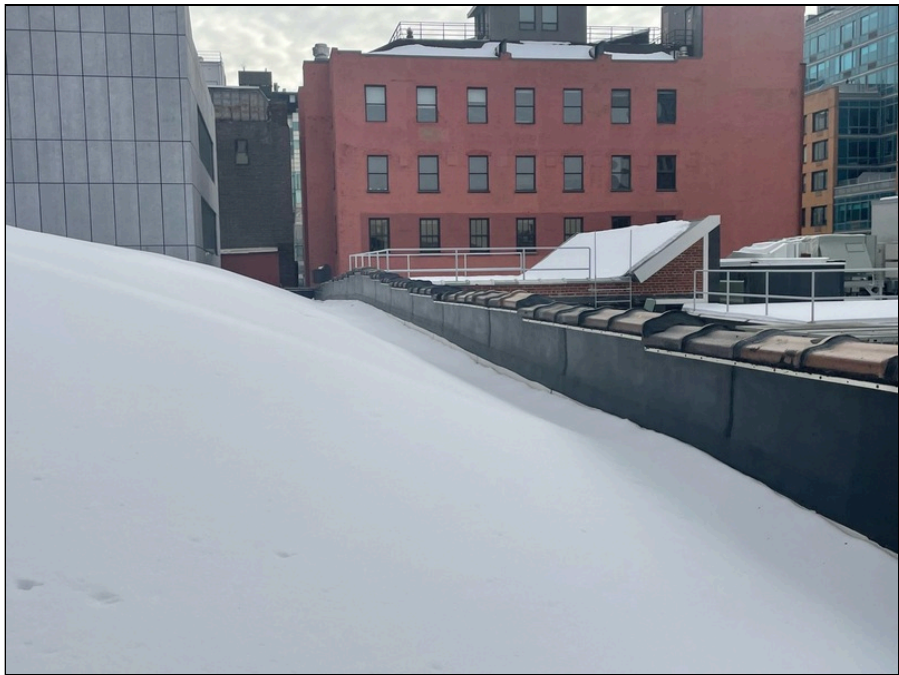
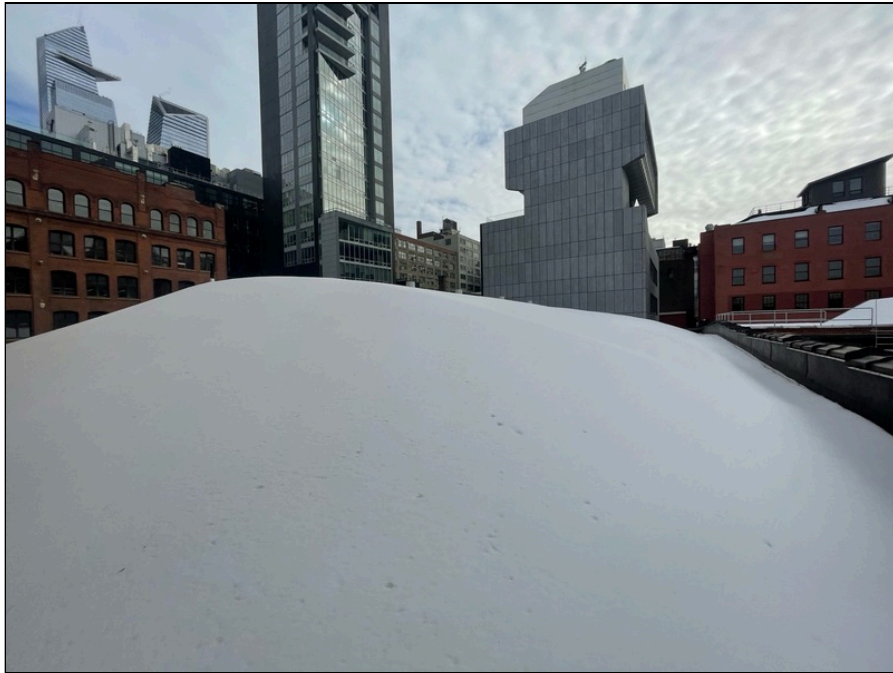
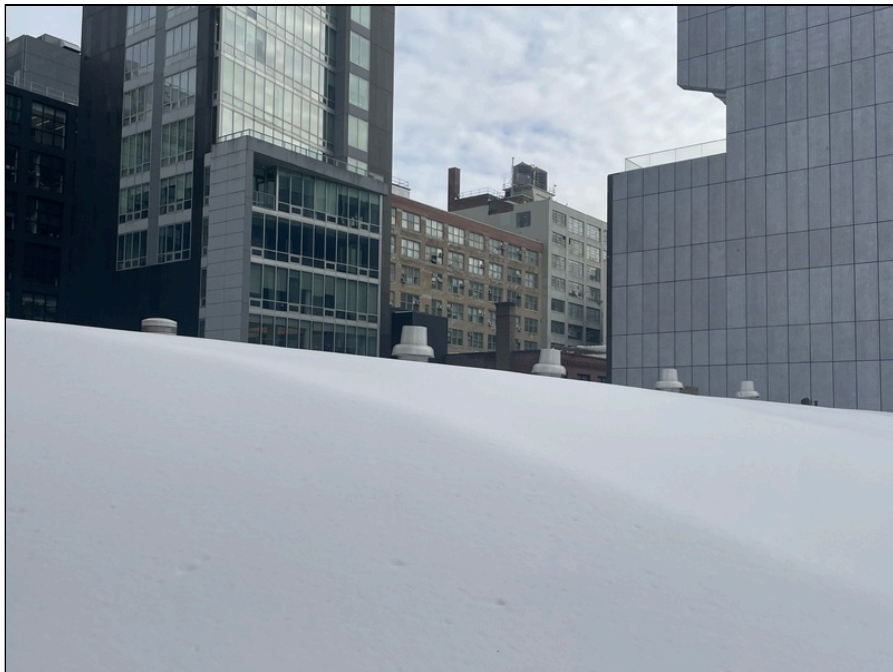
**Photo 178:** Roof

**Photo 179:** Roof

**Photo 180:** Roof

**Photo 181:** Roof

**Photo 182:** Roof

**Photo 183:** Roof

**Photo 184:** Roof

**Photo 185:** Roof

**Photo 186:** Roof

**Photo 187:** Roof

**Photo 188:** Roof

**Photo 189:** Roof

**Photo 190:** Roof

**Photo 191:** Roof

**Photo 192:** Roof

**Photo 193:** Roof

**Photo 194:** Roof

**Photo 195:** Roof

**Photo 196:** Roof
